**ON-SITE CHILD SAFETY SEAT CRASH INVESTIGATION
SCI TECHNICAL SUMMARY REPORT**

VERIDIAN CASE NO. CA01-056

SUBJECT VEHICLE - 2002 FORD TAURUS

CRASH DATE - DECEMBER 2001

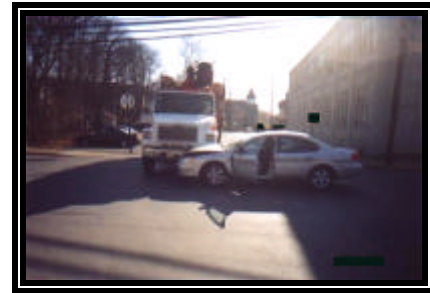
Figure 1. On-scene photograph

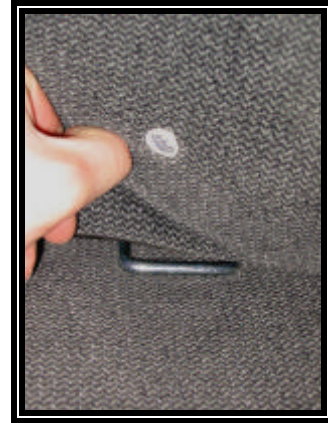
seat was in the full-rear track position. The rear seating was configured with a three-person bench seat with a 60/40 split folding back. The Ford Taurus was also equipped with tether anchors and lower anchor points for the LATCH (Lower Anchors and Tethers for Children) system at each rear seat position. CSS emblems were sewn onto the seat fabric to identify the location of the lower anchors (**Figure 5**).

Figure 5. Lower anchor for CSS and identifying emblem

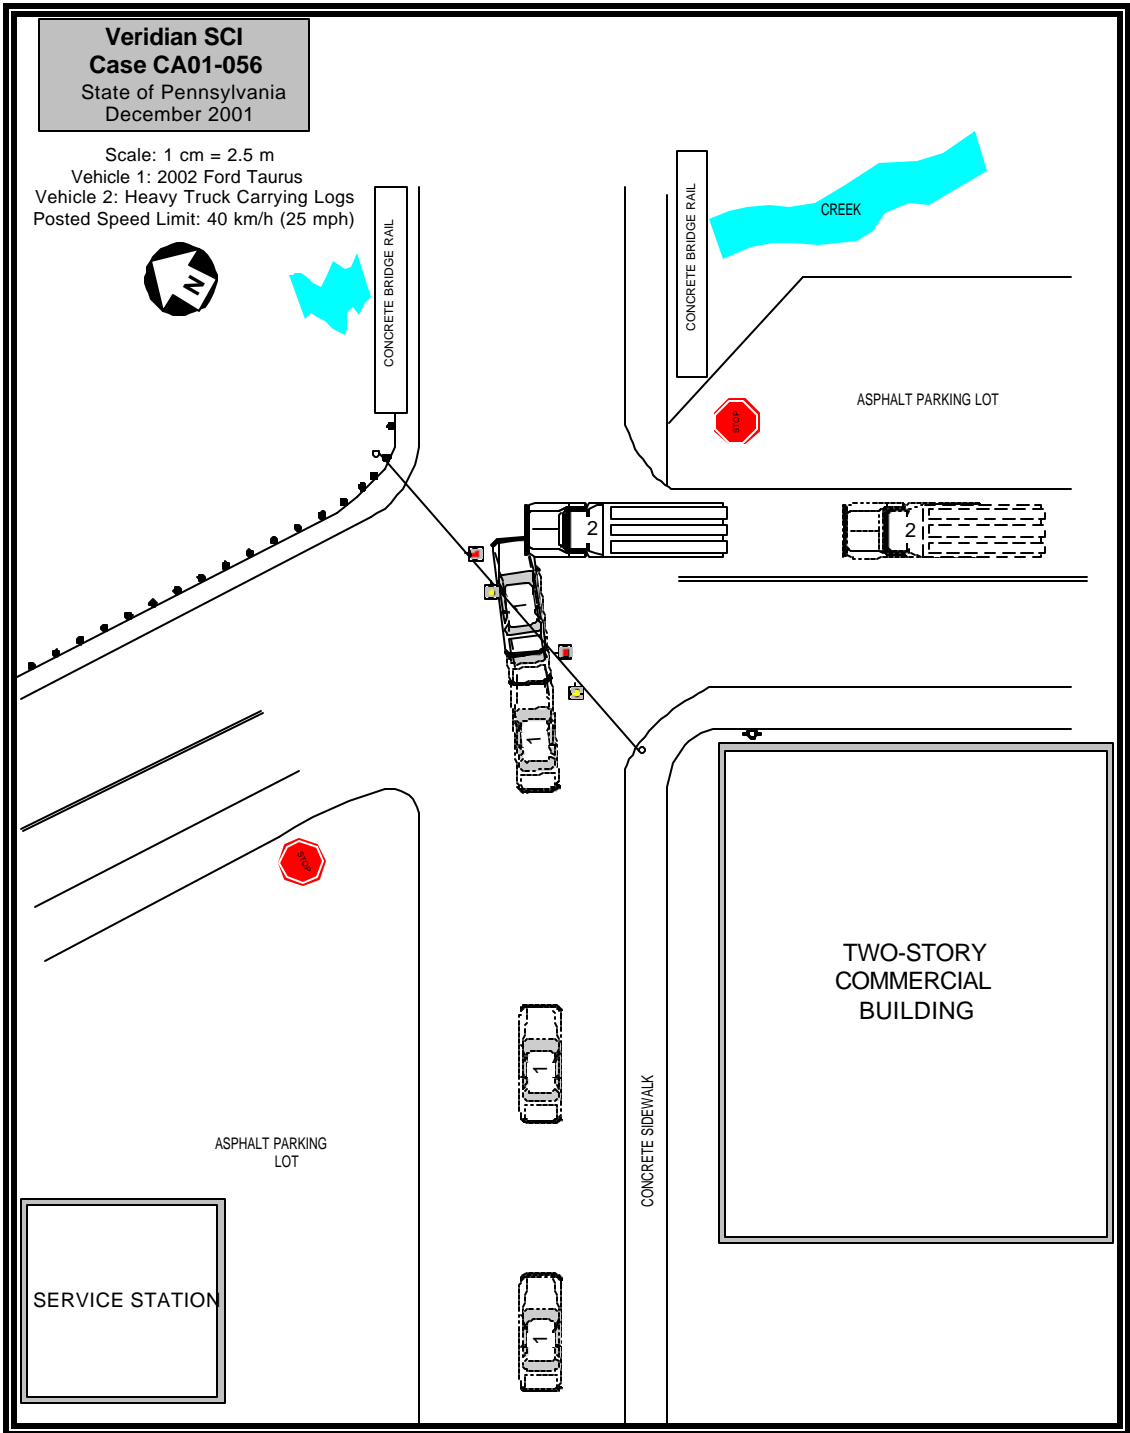
Figure 14. Scene schematic

This two-vehicle crash occurred during the daylight hours at the intersection of a two-lane state roadway and a two-lane local roadway. At the time of the crash, the asphalt roadway was dry and the weather was clear. The north/south state roadway consisted of two travel lanes that were separated by a double-yellow centerline. The east/west roadway consisted of two travel lanes that were undivided and had a slight negative grade for eastbound traffic approaching the intersection. The roadways were bordered by concrete curbs and sidewalks. A two-story building was located on the southwest corner which reduced westbound visibility for northbound traffic entering the intersection. Traffic flow through the intersection was controlled by stop signs for north/south traffic. Flashing overhead red signals were present for north/south traffic and flashing overhead amber signals were present for east/west traffic. The posted speed limit for the north/south roadway was 56 km/h (35mph). The speed limit increased to 72 km/h (45 mph) on the north leg of the intersection. The speed limit for east/west traffic was 40 km/h (25 mph). The scene schematic is included as **Figure 14**.
