**REMOTE ADVANCED 208-COMPLIANT VEHICLE INVESTIGATION  
SCI TECHNICAL SUMMARY REPORT**

**NASS/SCI COMBO CASE NO. 02-12-150E**

**VEHICLE – 2003 CHEVROLET SUBURBAN**

**CRASH DATE – NOVEMBER 2002**

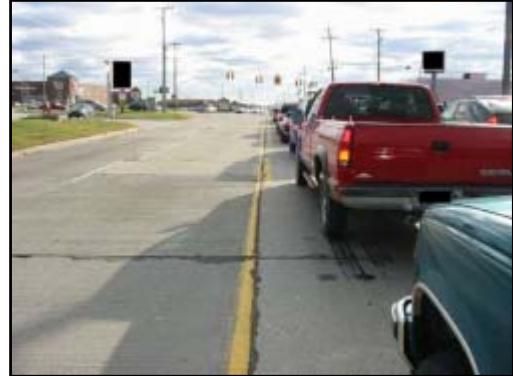
**Figure 2. Southbound approach for the Suburban prior to initiating the left turn**

The 67-year-old male driver of the 2003 Chevrolet Suburban was traveling southbound on the four-lane roadway and traveled onto the center left-turn lane in anticipation of making a left turn into a service station driveway (**Figure 2**). He stated that he had stopped the vehicle in the center left-turn lane and was waiting for a northbound traffic to clear. The 1997 Chevrolet pickup truck was traveling northbound on the outboard lane of the roadway and had cleared the intersection south of the Suburban's position (**Figure 3**). Based on the pre-crash data from the Suburban's EDR, the driver had slowed to 6 km/h (4 mph) in the center turn lane three seconds prior to the impact, and initiated the left turn (**Figure 4**). The EDR data indicated an increased throttle input and full disengagement of the brake switch. The driver of the Suburban did not detect the approaching pickup truck as he initiated the left turn.

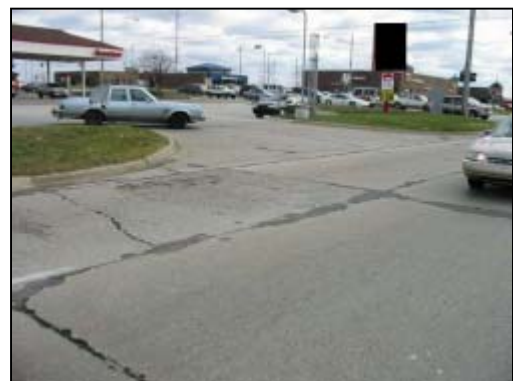
**Figure 4. Suburban's path of travel after initiating the left turn**

rapid CCW direction, which caused the right rear aspect of the Suburban to sideslap the left rear aspect of the pickup truck. The WinSMASH-computed delta-V for the sideslap impact was 6 km/h (4 mph) for the Suburban and 7 km/h (4 mph) for the pickup truck. The Suburban continued to rotate CCW and came to rest facing north in the center of the northbound lanes. Although the Suburban was equipped with the OnStar system, it was not reported if the driver subscribed to the service, or if the system activated as a result of the crash. The pickup truck was redirected slightly CW and departed the right roadside in a tracking mode. The vehicle ramped the curb, impacted a small tree on the roadside, and came to rest facing north on the roadside.

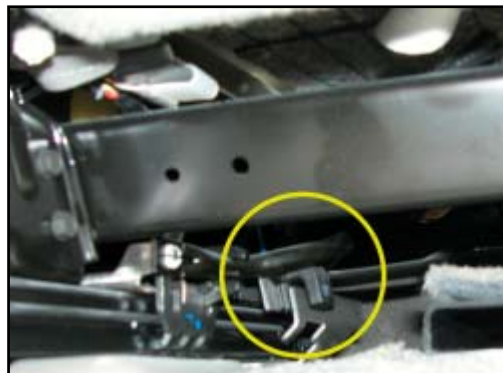
**Figure 12. View from the rear aspect of the front right seat of an exemplar vehicle, showing the horseshoe-shaped seat track position sensor**

Both front seating positions were equipped with seat track positioning sensors. Floor-mounted steel bars were present adjacent to the inboard seat tracks. Inverted horseshoe-shaped sensors were mounted to the underside of the seat cushions, which moved fore and aft along the steel bars with fore and aft movement of the seats (**Figure 12**). In the event of a crash, the position of the horseshoe-shaped sensor relative to the steel bar would provide inputs to determine the deployment stages of the frontal air bags and/or suppression, in addition to inputs from the weight sensor and safety belt buckle sensors.

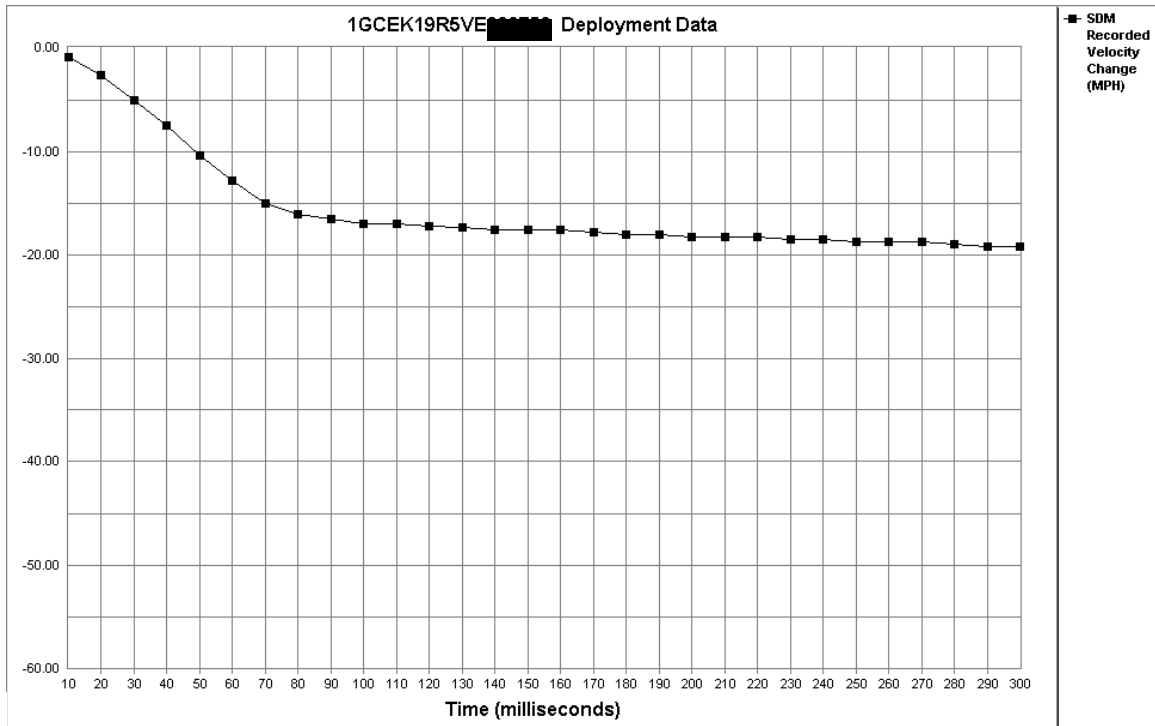
1GCEK19R5VE [REDACTED] System Status At Deployment	
SIR Warning Lamp Status	OFF
Driver's Belt Switch Circuit Status	BUCKLED
Passenger Front Air Bag Suppression Switch Circuit Status	Air Bag Not Suppressed
Ignition Cycles At Deployment	10158
Ignition Cycles At Investigation	10160
Time From Algorithm Enable To Deployment Command (msec)	15
Time Between Non-Deployment And Deployment Events (sec)	N/A

Time (milliseconds)	10	20	30	40	50	60	70	80	90	100	110	120	130	140	150
Recorded Velocity Change (MPH)	-0.88	-2.63	-5.05	-7.46	-10.31	-12.73	-14.92	-16.02	-16.46	-16.89	-16.89	-17.11	-17.33	-17.55	-17.55
Time (milliseconds)	160	170	180	190	200	210	220	230	240	250	260	270	280	290	300
Recorded Velocity Change (MPH)	-17.55	-17.77	-17.99	-17.99	-18.21	-18.21	-18.21	-18.43	-18.43	-18.65	-18.65	-18.65	-18.67	-19.09	-19.09

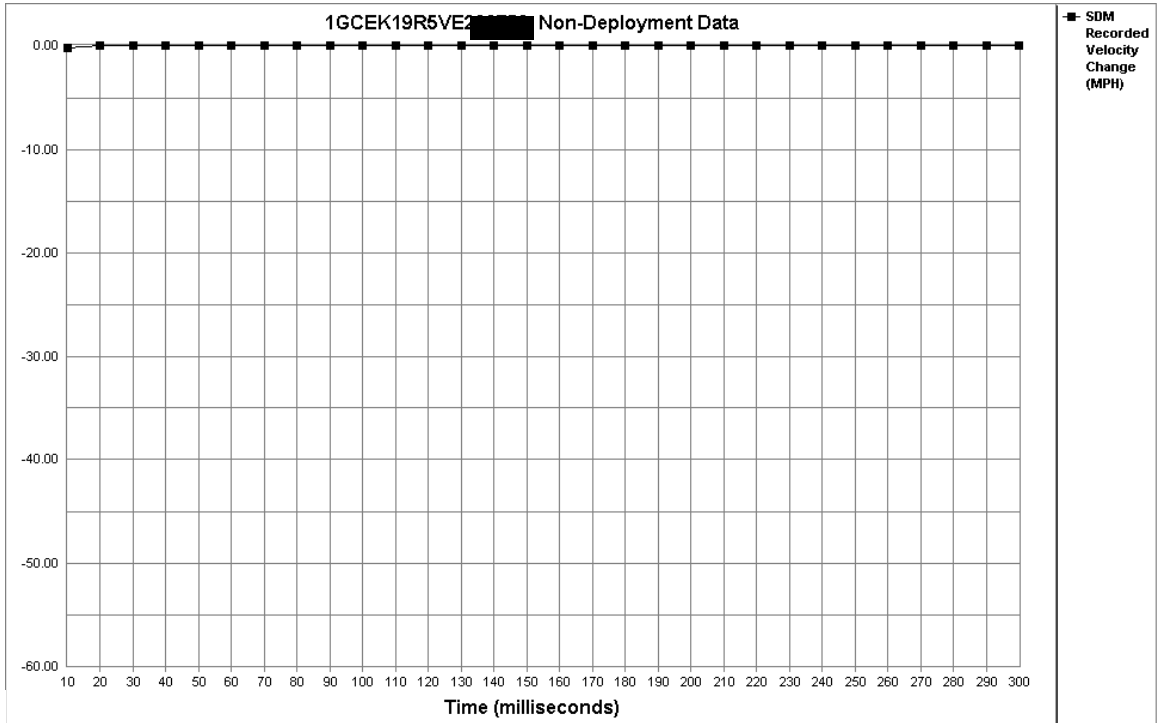
1GCEK19R5VE [REDACTED] System Status At Non-Deployment	
SIR Warning Lamp Status	OFF
Driver's Belt Switch Circuit Status	BUCKLED
Passenger Front Air Bag Suppression Switch Circuit Status	Air Bag Not Suppressed
Ignition Cycles At Non-Deployment	10158
Ignition Cycles At Investigation	10160
Algorithm Enable to Maximum SDM Recorded Velocity Change (msec)	3.75
Maximum SDM Recorded Velocity Change (MPH)	-0.22
A Deployment was Commanded Prior to this Event	Yes

Time (milliseconds)	10	20	30	40	50	60	70	80	90	100	110	120	130	140	150
Recorded Velocity Change (MPH)	-0.22	0.00	0.00	0.00	0.00	0.00	0.00	0.00	0.00	0.00	0.00	0.00	0.00	0.00	0.00
Time (milliseconds)	160	170	180	190	200	210	220	230	240	250	260	270	280	290	300
Recorded Velocity Change (MPH)	0.00	0.00	0.00	0.00	0.00	0.00	0.00	0.00	0.00	0.00	0.00	0.00	0.00	0.00	0.00
