ON-SITE SIDE IMPACT INFLATABLE OCCUPANT PROTECTION INVESTIGATION

CASE NUMBER - IN-02-002
LOCATION - ILLINOIS
VEHICLE - 2001 CHEVROLET IMPALA LS
CRASH DATE - July 2002

1. <i>Report No.</i> IN-02-002		2. <i>Government Accession No.</i>		3. <i>Recipient's Catalog No.</i>	
4. <i>Title and Subtitle</i> On-Site Side Impact Inflatable Occupant Protection Investigation Vehicle - 2001 Chevrolet Impala LS Location - Illinois			5. <i>Report Date:</i> April 26, 2005

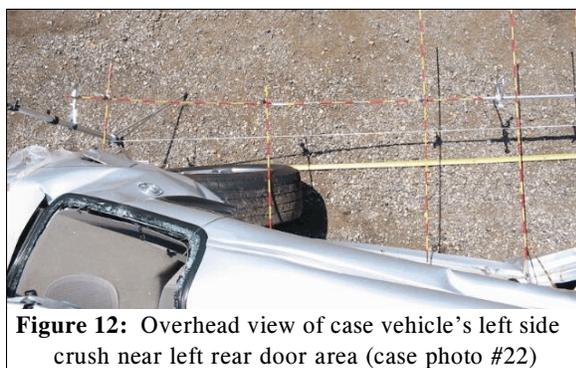
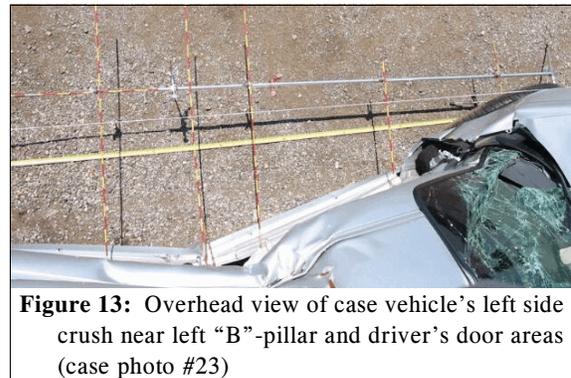
Exterior Damage: The case vehicle's contact with the 2001 Honda involved the left center of the vehicle (**Figures 6 and 7** above). Direct damage began 42 centimeters (16.5 inches) behind of the left front axle and extended 196 centimeters (77.2 inches) rearward, ending at the forward portion of the left rear wheel well (**Figures 12 and 13**). Residual maximum crush was measured as 51 centimeters (20.1 inches). The measurement was taken along the sill level and 35 centimeters (13.8 inches) forward of C₃. The case vehicle's contact with the 1996 Honda involved the right front and center areas of the vehicle (**Figures 10 and 11** above). Direct damage began 45 centimeters (17.7 inches) forward of the right rear axle and extend 138 centimeters (54.3 inches) forward along the right side (**Figure 14**). Maximum crush for this right side impact was measured as 34 centimeters (13.4 inches) at C₄.

The wheelbase on the case vehicle's left side was shortened 17 centimeters (6.7 inches) while the wheelbase on the right side was extended 3 centimeters (1.2 inches). The case vehicle's left side passenger area was heavily damaged, such that both the front and rear doors had to be pried/cut off by rescue personnel (**Figures 6 and 7** above). Damage to the case vehicle's right side

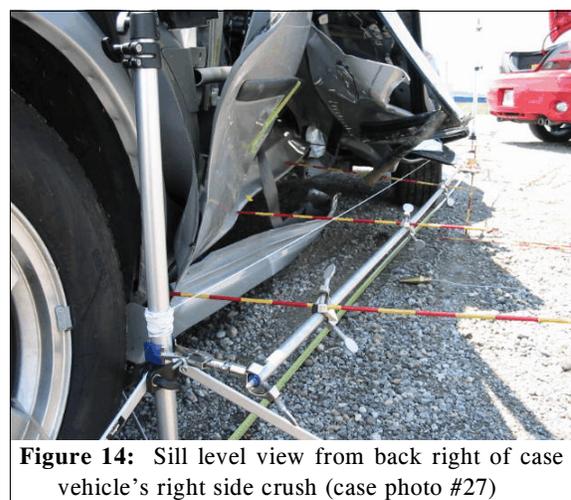
Units	Event	Direct Damage		Field L	C ₁	C ₂	C ₃	C ₄	C ₅	C ₆	Direct	Field L
		Width CDC	Max Crush								±D	±D
cm	1	196	57	308	6	55	48	53	25	3	-8	-28
in		77.2	22.4	121.3	2.4	21.7	18.9	20.9	9.8	1.2	-3.2	-11.0
cm	2	138	34	296	3	8	19	34	16	7	57	48
in		54.3	13.4	116.5	1.2	3.2	7.5	13.4	6.3	2.8	22.4	18.9
