On-site Child Seat Investigation / Vehicle to Vehicle
Dynamic Science, Inc. / Case Number: DS02002
1996 Honda Accord LX four-door
California
July, 2001

Dynamic Science, Inc.
Accident Investigation
Case Number: DS02002

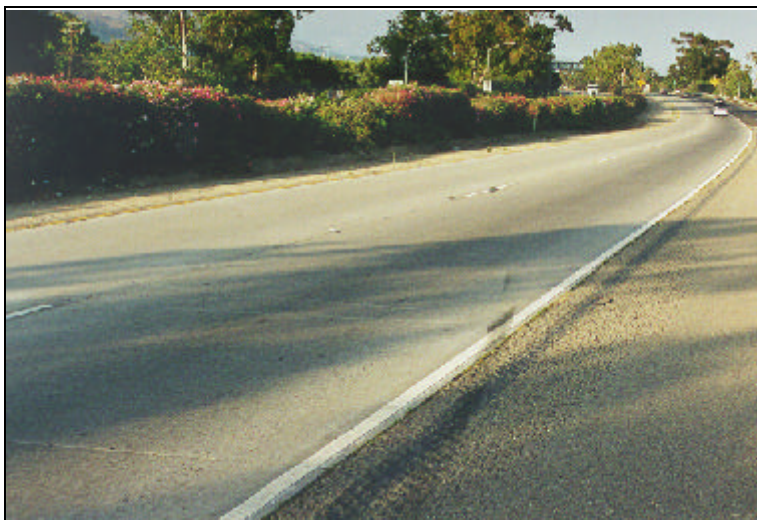
Figure 1. Travel path of case vehicle prior to departure through median in the left of the photo

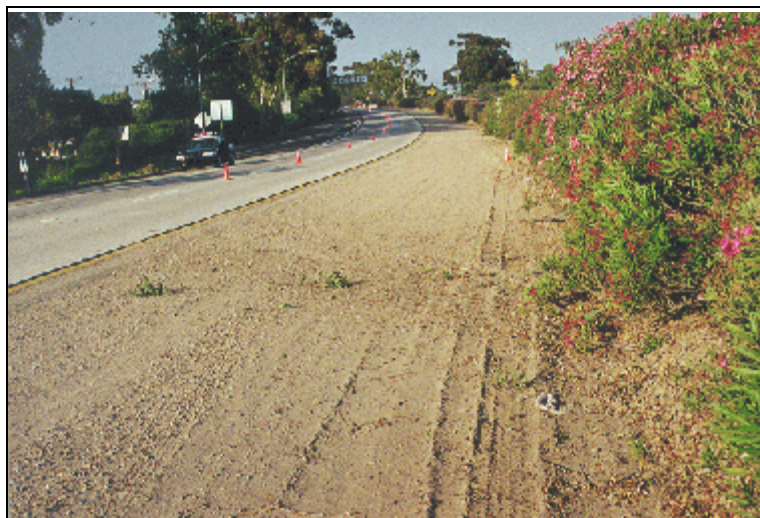
Figure 2. Path of case vehicle as it emerges from median and into path of the other vehicle.

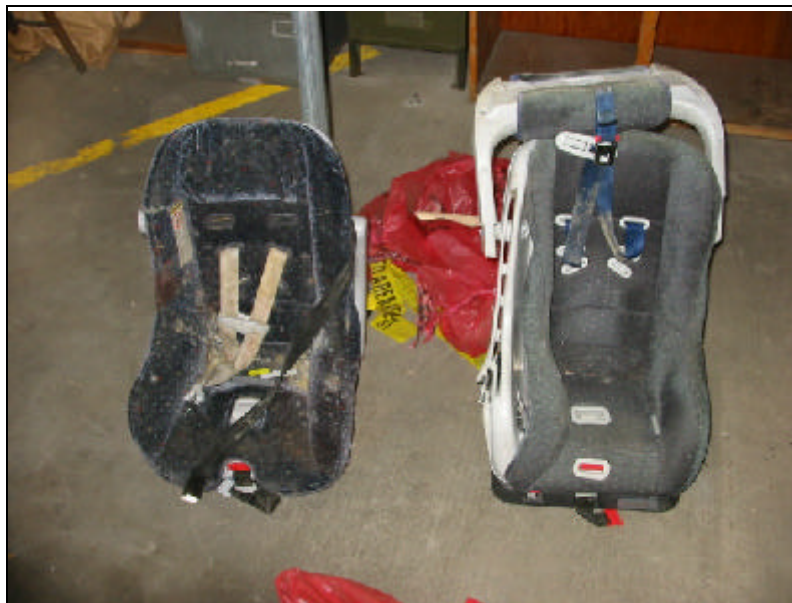
Figure 3. Configuration of child seats—Evenflo (left rear), Century (right rear).

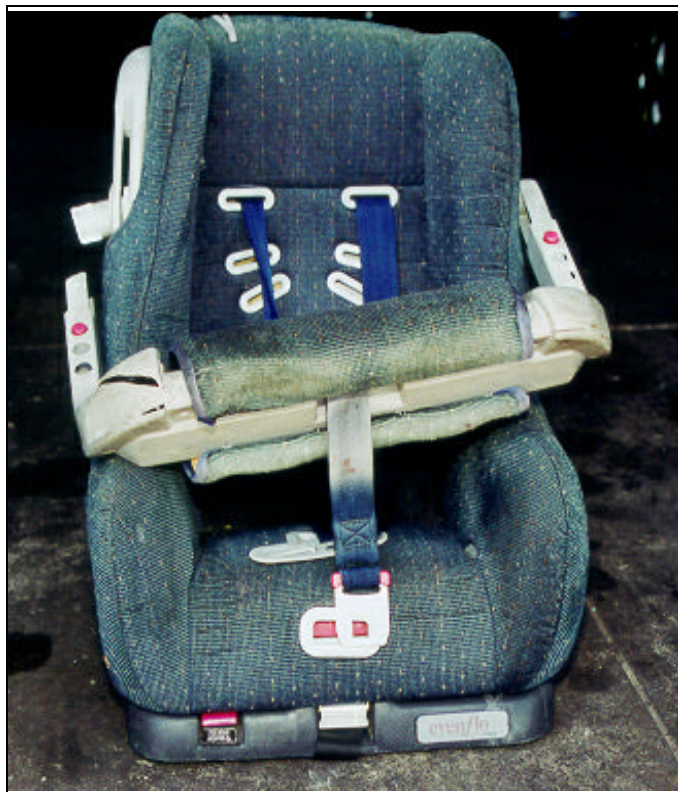
Figure 11. Left rear child seat (Evenflo).

The rear left fabric covered bench seat was occupied by a 5-year-old (23 kg/50 lbs) male who was seated in a forward facing Evenflo Ultara convertible child safety seat with tray shield. The maximum weight for the forward facing position is 18 kg (40 lbs). The seat was attached to the vehicle using the second seat rear left lap and shoulder belt. The belt is a type 2 continuous loop belt. This seat belt had a switchable ALR/ELR retractor. According to police investigators, the retractor had been switched to ALR mode and it was found in the locked ALR position. The child seat harness was positioned through the top most set of slots. The chest clip was present but its position is not known. No tethers were used. At impact, this occupant responded to the 3 o'clock direction of force by moving sharply to the right. As the right side of the vehicle was penetrated by the other vehicle, the right side surface pushed the right side child seat laterally and the two child seats engaged one another. The head injuries sustained by this occupant likely came about as a result of contact to the inner shell of his seat and the outer shell of the other child seat. As the intrusion continued, the base of this seat was compressed and pushed laterally—forcing the bottom to the left and the top to the right. Eventually, the seat was forced over onto its right side.

The left rear child seat remained in the vehicle. It was found lying on its right side with the seatbelt still latched and locked in ALR mode. Once the seatbelt is locked, the available length of the belt would remain fixed. As the right side of the vehicle (and the right side child seat), moved into the base of this child seat it was being compressed. The base is essentially a hollow object. As pressure was brought to bear, the base of this seat was compressed—allowing some rotational movement. The seat was pushed laterally—forcing the bottom to the left and the top to the right. Eventually, the seat was forced over onto its right side.

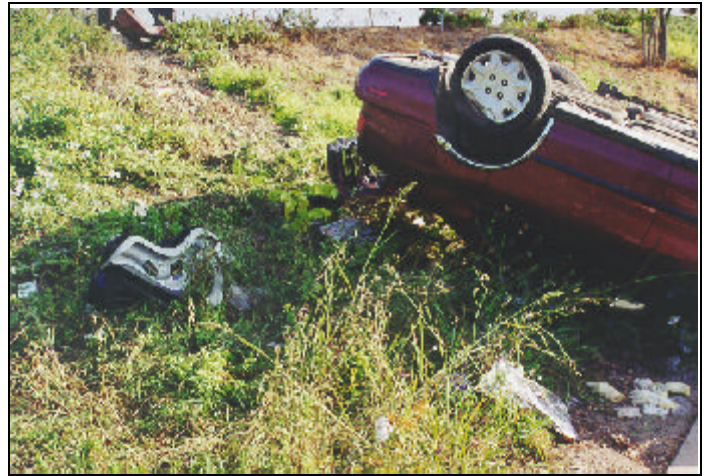
The case vehicle tripped and began a left side leading longitudinal rollover. The vehicle rolled six quarter turns. Between the third and fourth quarter turns, the right rear child and child seat were ejected through the right rear door area. The case vehicle came to rest on its roof facing north.

Figure 13. Reported final rest position of right rear child seat.

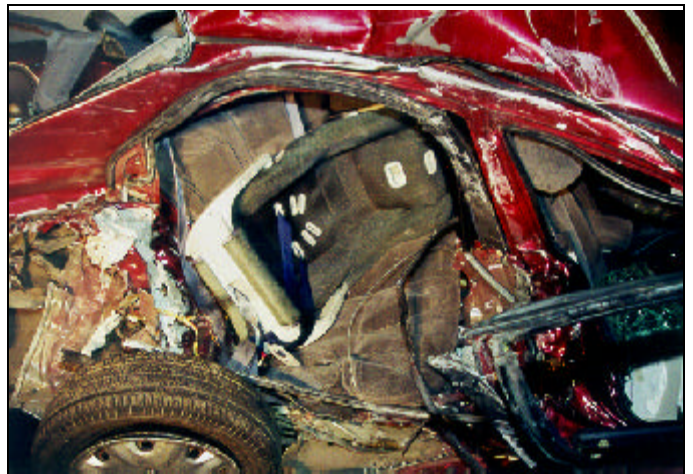
Figure 14. Final position of left rear child seat.

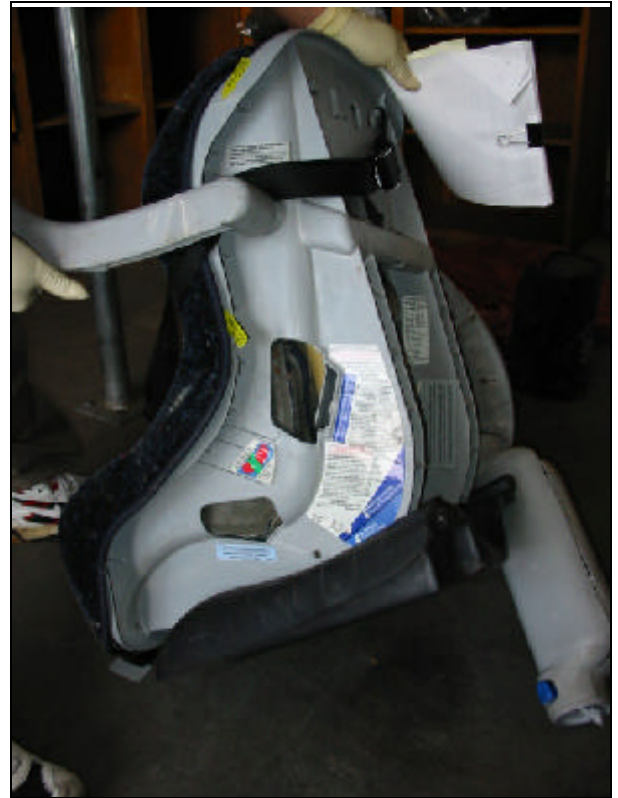
Both child seats had been placed in the vehicle and were attached to the vehicle using the available lap and shoulder belts. At impact, both child seats would have initially moved to the right. This movement was almost immediately negated by the massive intrusion through the right side. The right child seat (Century) was essentially driven into the side of the left child seat (Evenflo)—particularly the base of the seat. This internal impact caused fractures to the facing side of the child seat shells. It appears that some portion of the left child seat struck the vehicle buckle release on the seat belt securing the right child seat. The buckle came open as the vehicles separated and restitution began. As the case vehicle rolled, the right side child seat was ejected from the vehicle.

Figure 16. Left side, right rear child seat (Century).

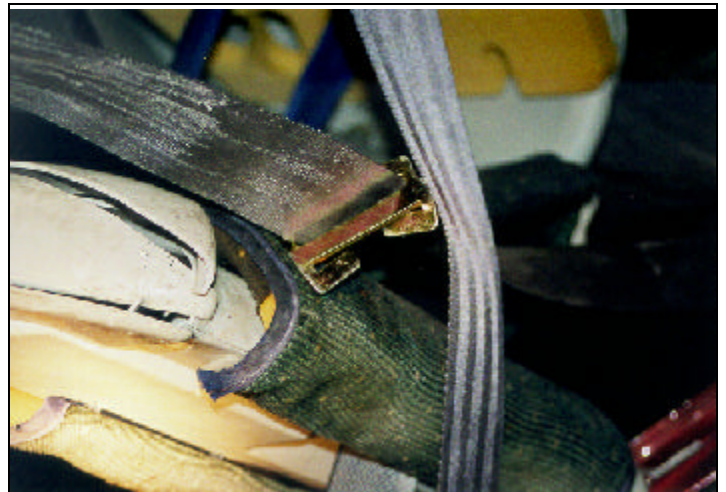
Both the right rear lap and shoulder belt and child safety seat locking clip were damaged during the crash. The damage to the seat belt was due to both lateral loading as the truck penetrated the passenger compartment and a tearing action from sharp metal surrounding the door. The seat belt was not severed. The damage to the clip was due to loading against the child seat shell as the seat was forced sideways. It is not known why the locking clip was being used since the seat belt at this seat position is equipped with a switchable retractor.

Figure 19. Locking clip attached to seat belt.
