# INDIANA UNIVERSITY

### **ON-SITE ADVANCED OCCUPANT PROTECTION SYSTEM INVESTIGATION**

CASE NUMBER - IN-02-005  
LOCATION - TEXAS  
VEHICLE - 2003 TOYOTA COROLLA LE  
CRASH DATE - July, 2002

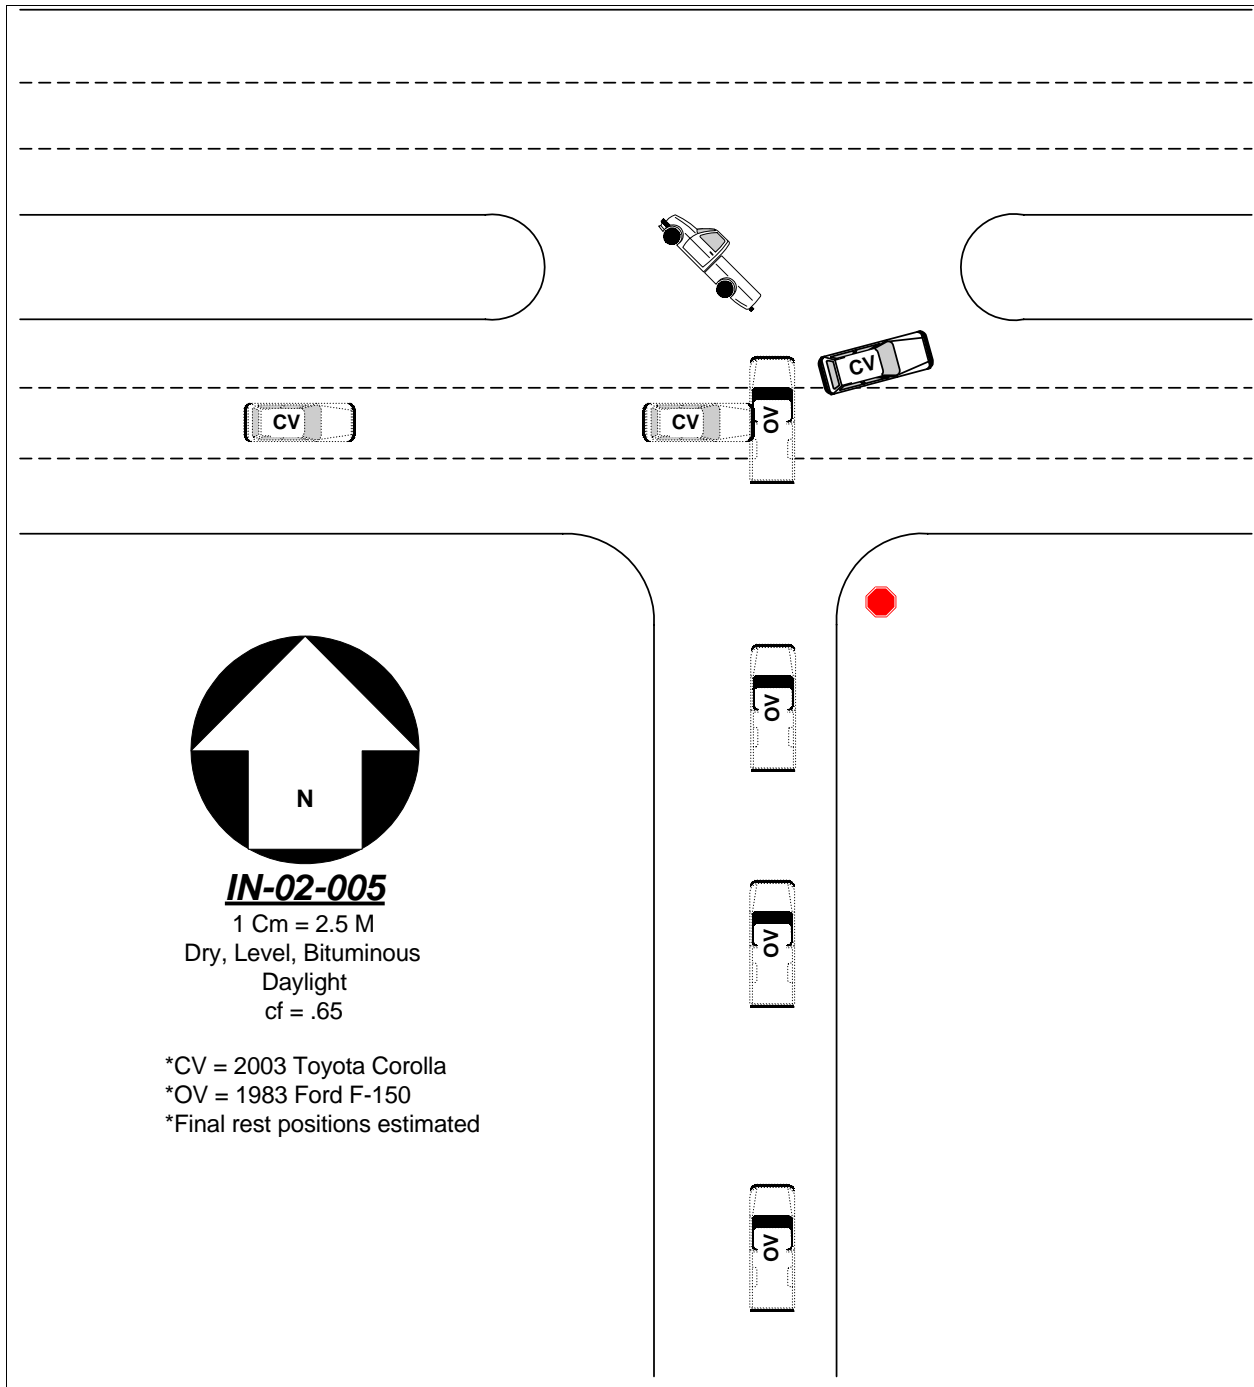
The Ford's contact with the case vehicle (1<sup>st</sup> event) involved the left side between its wheels. Direct damage began 78 centimeters (30.7 inches) rearward of the left front axle and extended 204 centimeters (80.3 inches), along the left side toward the left rear axle. Maximum crush was measured as 44 centimeters (17.3 inches) and was located 19 centimeters (7.5 inches) rearward of C<sub>4</sub>. The wheelbase on the Ford's left side was shortened 5 centimeters (2.0 inches) while the right side was unaltered from the crash. The pickup's left front door and the left side of the truck bed were directly damaged and crushed inward. Because the case vehicle underrode the pickup, there was direct contact to the left frame rail and gas tank areas (**Figure 13**). None of the Ford's tires were damaged, deflated, or physically restricted. The pickup's truck bed sustained induced damage as it was shifted rightward as a result of the left side impact. As a result of the rollover impact (2<sup>nd</sup> event), the entire right side of the Ford, rearward of the right front axle, was directly damaged (**Figure 14**).

**Figure 14:** Rollover damage to Ford pickup's right side as a consequence of the impact to its left side by case vehicle (case photo #79)
