**VERIDIAN ON-SITE ADVANCED OCCUPANT PROTECTION
SYSTEM (AOPS) INVESTIGATION**

VERIDIAN CASE NO. CA02-011

VEHICLE - 2000 FORD TAURUS SE

CRASH DATE - FEBRUARY, 2002

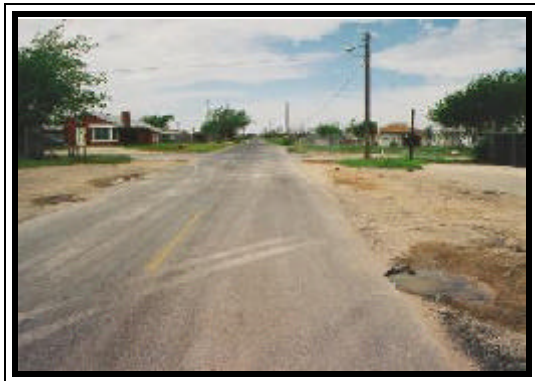
The 40 year old male driver of the 1990 Ford F-150 pickup truck was operating the vehicle westbound (**Figure 1**) at a (police reported) unknown speed, and on approach to the rural 4-leg intersection. For unknown reasons, the driver allowed the vehicle to cross the centerline and into the path of the eastbound Ford Taurus. The police reported no tire marks at the scene indicative of driver avoidance maneuvers.

Figure 1. Westbound approach for the 1990 Ford F-150 pickup truck.

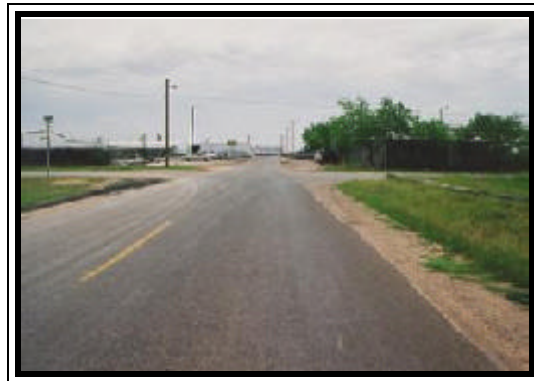
The 17 year old female driver of the 2000 Ford Taurus SE was operating the vehicle eastbound (**Figure 2**) at a (police reported) unknown speed and on approach to the 4-leg intersection. Anticipation of the crash was unknown as the vehicle proceeded straight through the intersection, and remained in the eastbound lane prior to the collision.

Figure 2. Eastbound approach for the 2000 Ford Taurus SE.
