On-scene Investigation / Vehicle to Vehicle  
Dynamic Science, Inc. / Case Number: DS02012  
2003 Toyota Matrix XR five door hatchback  
California  
May, 2002

1. Report No. <b>DS02012</b>	2. Government Accession No.		3. Recipient Catalog No.	
4. Title and Subtitle <b>In-Depth Accident Investigation</b>		5. Report Date

**Dynamic Science, Inc.**  
**Accident Investigation**  
**Case Number: DS02012**

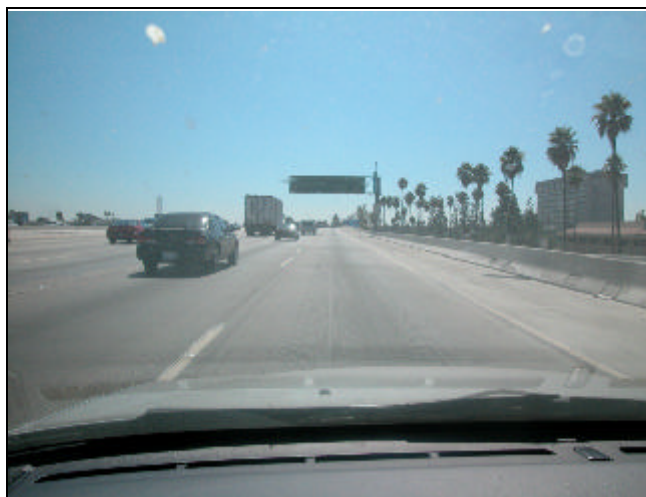
**Figure 1.** Approach to area of impacts–south

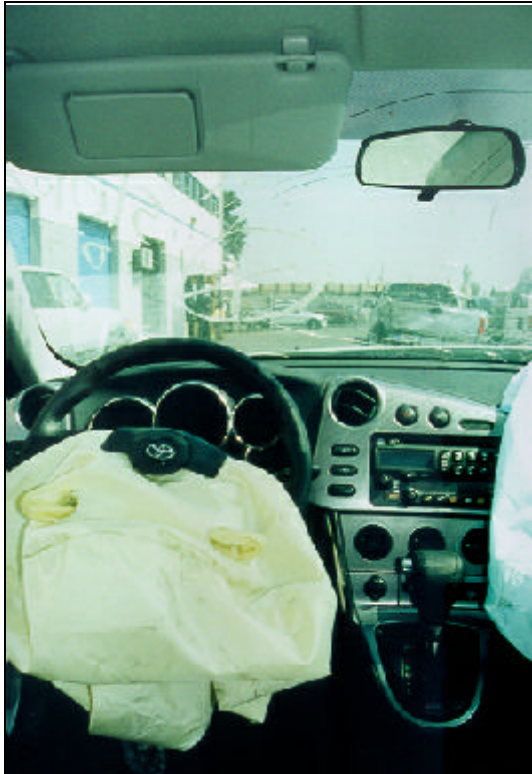
**Figure 9.** Driver's seated area

The front seat belt pretensioners at both outboard seats also fired at this time. Scuffing was found on the belts at the location where they loop into the D rings. The trim panels for both B-pillars were displaced laterally.

The 47-year-old female driver of the case vehicle was seated in a normal, upright position. The fabric covered bucket seat was adjusted to between its middle and rear most track position. She was wearing the available lap and shoulder belt. The driver was looking straight ahead. As the other vehicle changed lanes to the right, its right side struck the left front of the case vehicle. This was a minimal impact. The driver reacted to the impact by steering sharply to the right and braking. The case vehicle began a clockwise rotation and the driver attempted to steer back to the left. By this time the case vehicle had departed the roadway. The front of the case vehicle struck a concrete barrier. At impact, the driver's air bag deployed. The driver of the case vehicle reacted to the 10 o'clock direction of force by moving forward and the left. She loaded the lap and shoulder belt webbing—sustaining an abdominal contusion. Her face engaged the deployed air bag. She did not sustain any facial injuries, but the flexion/extension associated with the air bag contact resulted in a neck strain.

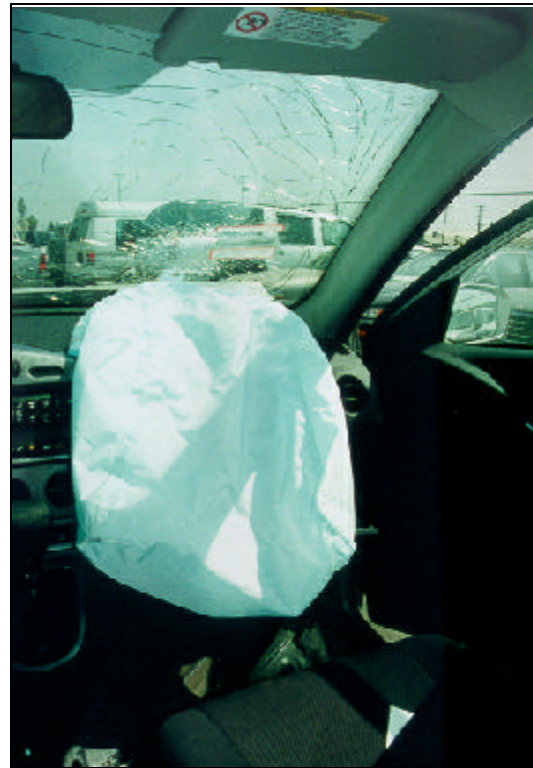
**Figure 8.** Front right occupant's seated area

The 45-year-old female front right passenger of the case vehicle was seated in a normal, upright fashion. The fabric covered bucket seat was adjusted to between its middle and rear most track position. She was wearing the available lap and shoulder belt. The front of the case vehicle struck a concrete barrier. At impact, the front right passenger's air bag deployed. The front right occupant of the case vehicle reacted to the 10 o'clock direction of force by moving forward and the left. Her face engaged the deployed air bag. She did not sustain any facial injuries, but the flexion/extension associated with the air bag contact resulted in a neck and upper back strain.
