**ON-SITE ADVANCED OCCUPANT PROTECTION SYSTEMS/CHILD SAFETY SEAT
CRASH INVESTIGATION
SCI TECHNICAL SUMMARY REPORT**

VERIDIAN CASE NO. CA02-018

VEHICLE - 2002 DODGE CARAVAN

CRASH DATE - MARCH 2002

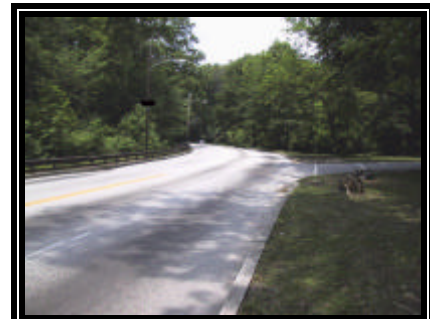
The 36-year-old male driver of the Caravan was operating the vehicle in a north direction on the inboard lane of the four-lane roadway on approach to the left curve and T-intersection (**Figure 2**). The driver stated that the approximate speed of the vehicle was 48 km/h (30 mph) prior to the impact. The 18-year-old female driver of the Honda Accord was operating the vehicle in a south direction on approach to the right curve and T-intersection (**Figure 3**). For unknown reasons, the driver of the Accord lost control of the vehicle and failed to negotiate the right curve. Due to the wet roadway conditions, the Accord initiated a slight counterclockwise (CCW) yaw, crossed the centerline, and encroached into the opposite lane into the path of the Caravan. The driver of the Accord reportedly applied the brakes in full-lockup and steered right in an attempt to regain control of the vehicle. The driver of the Caravan detected the Accord encroaching into the lane and steered right and lightly applied the brakes (no lock-up) in an attempt to avoid the collision.

Figure 2. Northbound approach for the Dodge Caravan

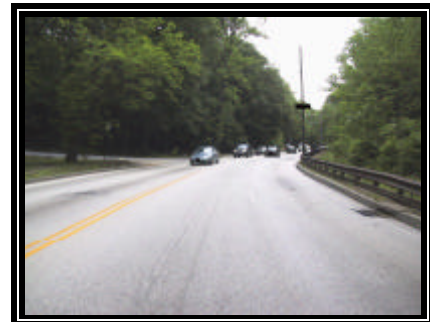
Figure 3. Southbound approach for the Honda Accord

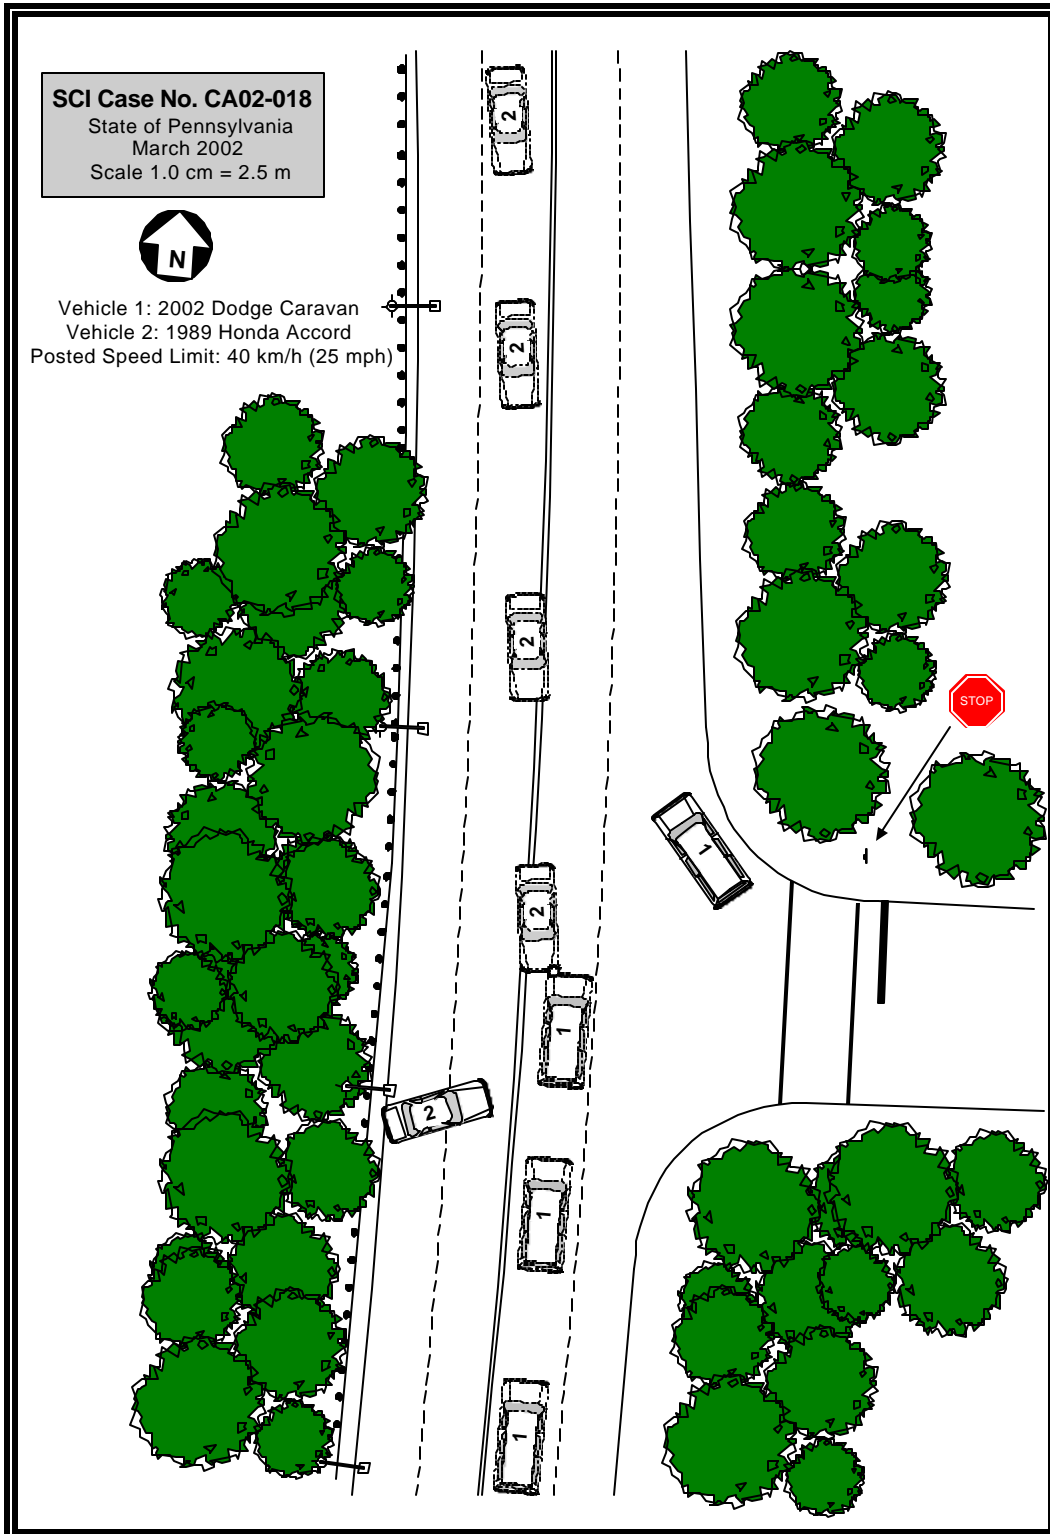
This two-vehicle crash occurred on a four-lane local roadway at the intersection of a two-lane local roadway during nighttime hours. At the time of the crash, light rain was falling, and the asphalt roadway was wet. The four-lane roadway was illuminated by overhead lights attached to utility poles on the west roadside. The north/south roadway consisted of two travel lanes in each direction separated by a double-yellow centerline. The roadway was bordered on the west side by a concrete curb and W-beam guardrail. The east side was bordered by concrete curbs, grassy areas and trees. From the northbound approach, the north/south roadway curved to the left. The two-lane local roadway intersected the four-lane roadway in a T-configuration at the south aspect of the curve. A stop sign was present for westbound traffic on the two-lane roadway approaching the T-intersection. The posted speed limit for both roadways was 40 km/h (25 mph). The scene schematic is included as **Figure 11** of this report.

Figure 11. Scene schematic
