Advanced Occupant Protection System Crash Investigation / Vehicle to Vehicle
Dynamic Science, Inc. / Case Number: DS02020
2003 Toyota Corolla CE four door
Washington
August, 2002

1. Report No. DS02020		2. Government Accession No.		3. Recipient Catalog No.	
4. Title and Subtitle Advanced Occupant Protection System Crash Investigation				5. Report Date October 8, 2003

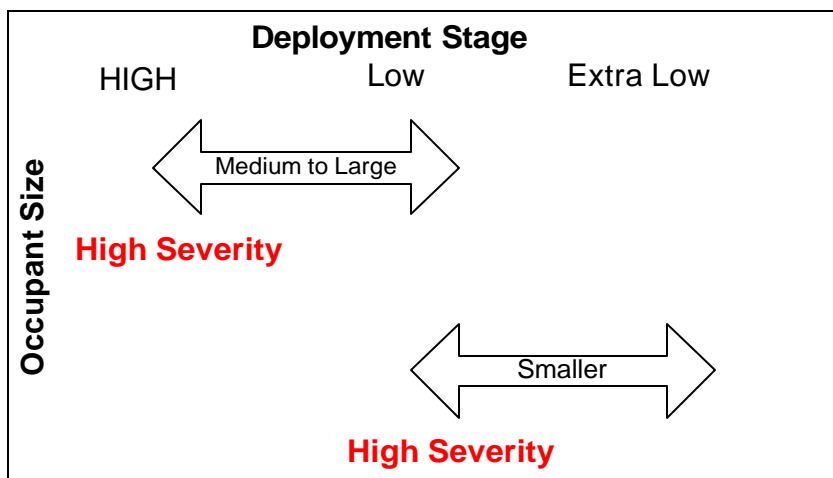
Figure 8. Driver's air bag deployment logic

The driver's air bag has a three-stage deployment sequence based on impact severity and the position of the driver seat. A seat position sensor judges the size of the occupant based on the seat position. The driver's air bag will deploy at a faster rate (high stage) or slower rate (low stage) for medium and large size occupants, depending on impact severity. The driver's air bag will deploy at low stage, or extra-low stage for smaller occupants, depending on impact severity. Based on the known seat track position (fully forward), the air bag should have deployed at a low or extra low stage with the latter being the most likely.

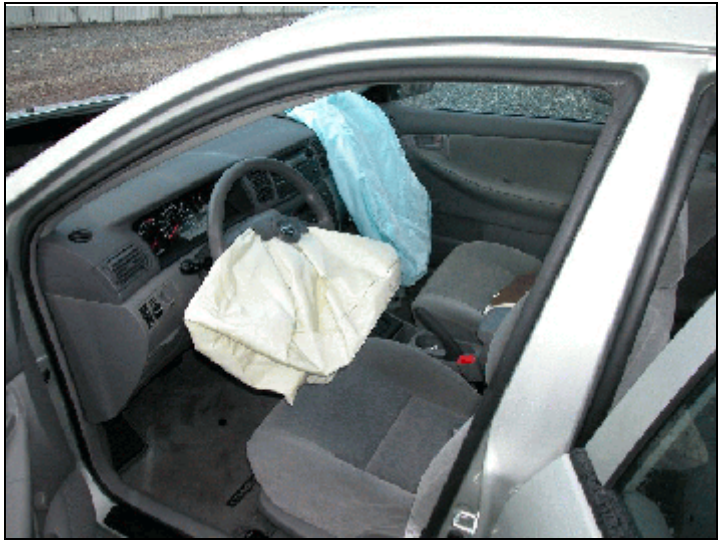
Figure 10. Driver's seated area

The 23-year-old female driver of the case vehicle was seated in a fabric covered bucket seat that had been adjusted to the forward most track position. She was seated in a normal, upright fashion, and was facing straight ahead with her hands at the 10 and 2 o'clock positions on the steering wheel rim. She was using the available lap and shoulder belts with the shoulder belt upper anchorage adjustment in the full down position. She was wearing metal framed sunglasses and contact lenses. Prior to impact, the driver began braking and steering to the left. The braking motion likely began loading the seatbelt. Upon impact, both front pretensioners actuated and the frontal air bags deployed. The driver responded to the 1 o'clock direction of force by exhibiting a forward and slightly right trajectory and loading the pretensioned and locked manual restraint system. Her upper torso contacted the deployed driver air bag and her knees contacted the lower instrument panel. The driver sustained contusions to both knees from the instrument panel contact. She also sustained chest and middle abdomen contusions from contact with the seatbelt.
