Child Safety Seat Fatality/ Vehicle to Object
Dynamic Science, Inc. / Case Number: DS02024
1998 Honda Accord
California
September, 2002

**Dynamic Science, Inc.
Crash Investigation
Case Number:DS02024**

This on-site investigation focused on two child safety seats that were installed in the rear seat of a 1998 Honda Accord. This single vehicle, rollover type collision occurred in California in September, 2002 at 0242 hours. The crash occurred on the roadside of an interstate highway. The case vehicle is a 1998 Honda Accord four door sedan that was driven by a 23-year-old male. The front right seat was occupied by a 21-year-old female. The 2nd row left seat position was occupied by a 20-month-old male seated in a forward facing child safety seat. The 2nd row right seat position was occupied by a 6-week-old female that was seated in a rear facing child safety seat. The case vehicle was traveling southbound and for an unknown reason drove off the interstate, into the right shoulder area. It struck a metal/wood guardrail and rolled over. The vehicle then struck a concrete bridge abutment with its roof/top (see Figure 1). The case vehicle was equipped with a driver and a front right pas

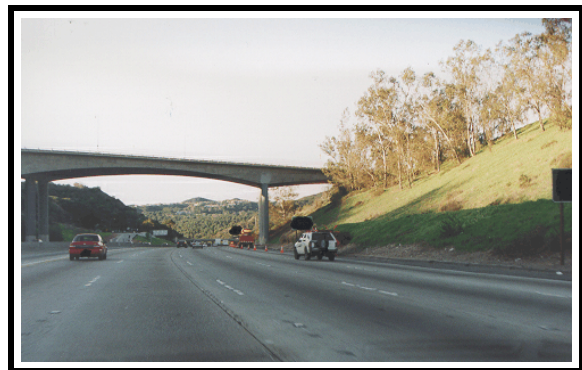
Figure 2. Approach to point of impact—south

This single vehicle crash occurred on the roadside of a six lane freeway in California at 0242 hours (see Figure 2). The weather was clear and the rain grooved concrete roadway surface was dry. It was dark at the time of the collision, however, the area of the crash was illuminated by streetlights. The speed limit is 105 km/h (65 mph).
