**TRANSPORTATION SCIENCES
CRASH DATA RESEARCH CENTER**

**ON-SITE SIDE IMPACT INFLATABLE OCCUPANT PROTECTION
INVESTIGATION**

GENERAL DYNAMICS CASE NO: CA02-029

VEHICLE: 2002 VOLKSWAGEN PASSAT

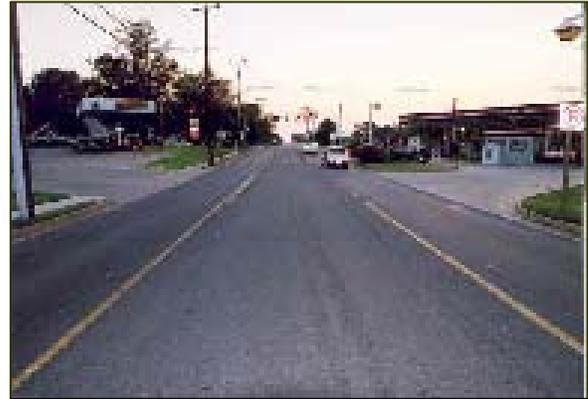
The crash occurred on a three-lane road in a suburban area during daylight hours. The east and westbound travel lanes were separated by a dual direction left turn lane that transitioned into a designated left turn lane for westbound traffic. A signalized four-leg intersection was located approximately 50 m (164') west of the crash site. The asphalt surfaced roadway was 10.8 m (35.4') in width, inclusive of a 3.1 m (10.2') wide westbound travel lane, a 4.2 m (13.9') center left turn lane, and a 3.5 m (11.5') eastbound travel lane. Both edges were bordered 0.6 m (2.0') wide concrete rain gutters that terminated at 15 cm (6") barrier curbs. Grass and sidewalks bordered the curb lines. Commercial driveways intersected the travel lanes. The Passat was attempting to exit a 14.3 m (47.0') wide driveway at the north curb line. In the vicinity of the crash site, the roadway was straight with a sag (bottom of two slopes). The posted speed limit was 40 km/h (25 mph). **Figure 2** is a view of the crash site from the Escort's path of travel.

Figure 2. Westbound view of the crash site from the left turn lane.

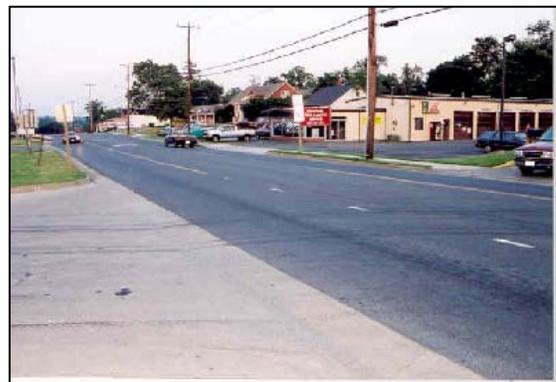
The driver of the 2002 Volkswagen Passat was attempting to exit a driveway for a service station and initiate a left turn onto the three-lane road to travel in an easterly direction. As she stopped at the mouth of the driveway (**Figure 3**), westbound traffic had backed-up for the signalized intersection that was located 50 m (164') west of the driveway. The driver of a large sport utility vehicle stopped his vehicle east of the driveway and waved the Passat driver out of the driveway, across the westbound travel lane. As she exited the driveway and traversed the westbound lane, the Passat driver initiated a left turning maneuver across the center left turn lane. The 22-year old female driver of the Ford Escort was

Figure 3. Passat driver's view of approaching westbound traffic.

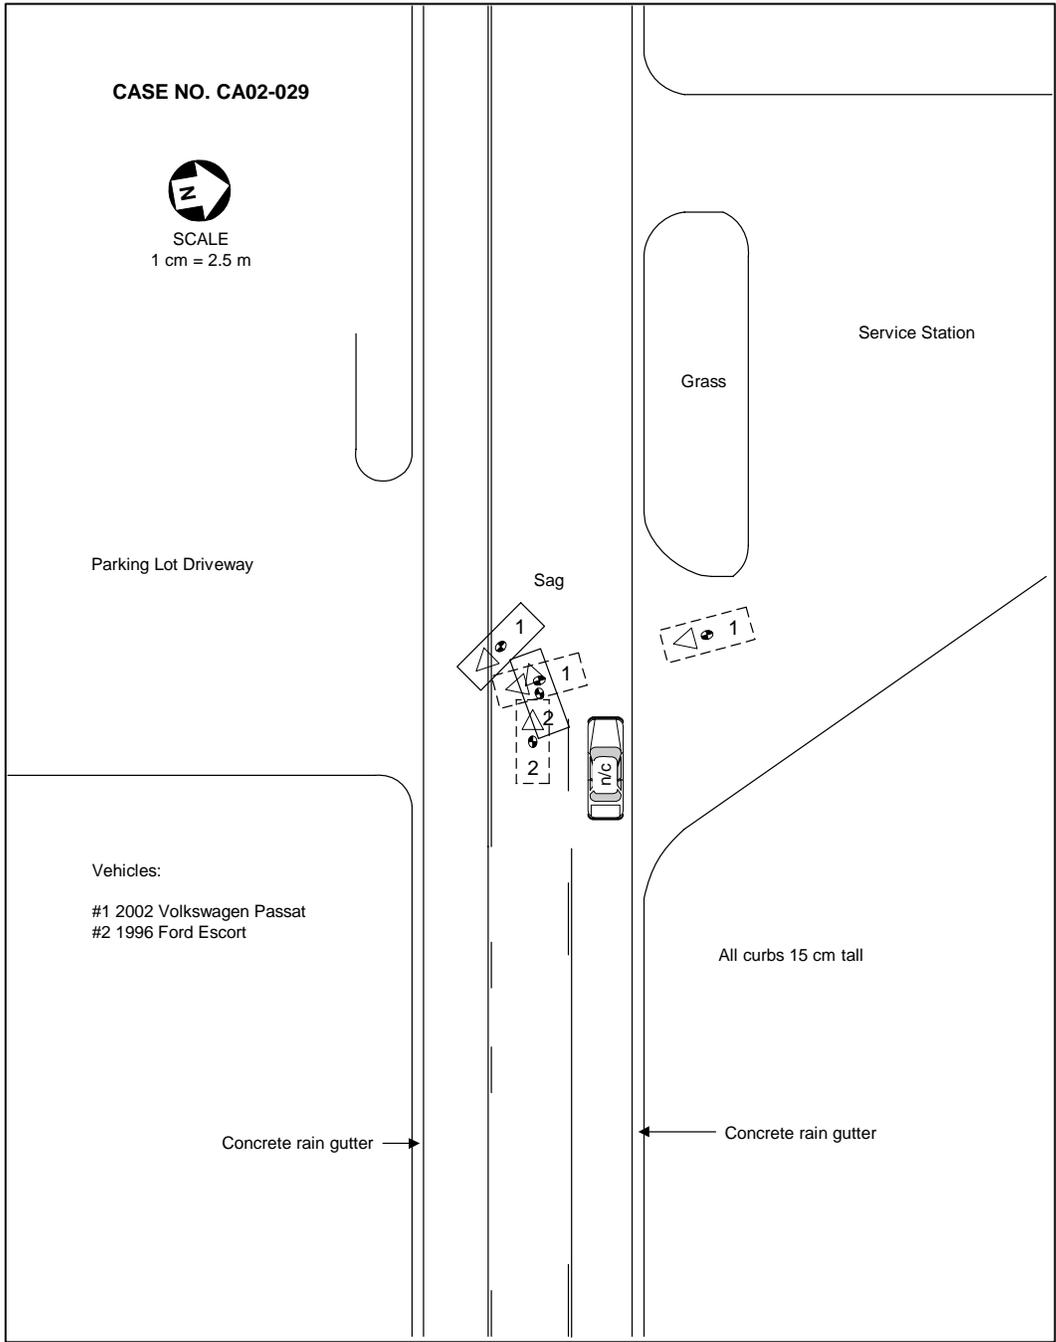
FIGURE 14. CRASH SCHEMATIC.
