**VERIDIAN ON-SITE SIDE IMPACT INFLATABLE OCCUPANT PROTECTION
INVESTIGATION
SCI TECHNICAL SUMMARY REPORT**

CASE NO. CA02-048

VEHICLE – 2001 SAAB 9-5

CRASH DATE – OCTOBER 2002

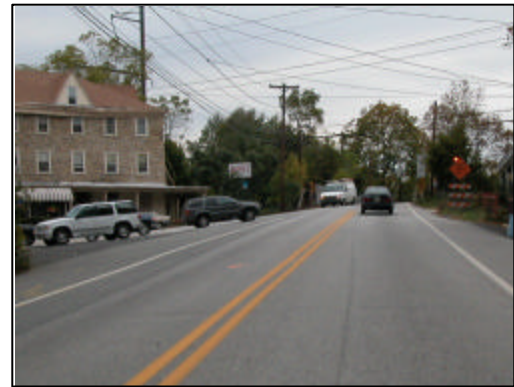
The 45-year-old female driver of the Saab 9-5 was operating the vehicle in a northbound direction on the two-lane roadway on approach to the T-intersection (**Figure 2**). The driver applied the brakes and brought the Saab to a complete stop in the intersection and waited for southbound traffic to clear prior to attempting a left turn on to the east/west roadway. The male driver of the Ford F-150 pickup truck was traveling eastbound on approach to the intersection (**Figure 3**). He applied the brakes and brought the vehicle to a complete stop at the stop line. Due to the positive grade at the intersection and limited sight distance, the driver of the pickup truck slowly traveled into the intersection to attempt to make a left turn when the north/south traffic cleared. As the southbound traffic cleared the intersection, the driver of the Saab 9-5 initiated a left turn across the path of the pickup truck. The driver of the pickup truck also initiated a left turn into the path of the Saab.

Figure 2. Northbound approach for the Saab 9-5

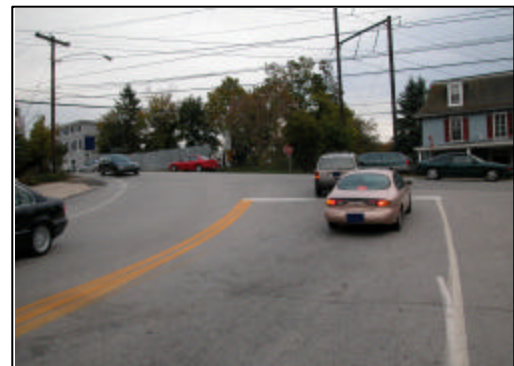
Figure 3. Eastbound approach for the Ford F-150

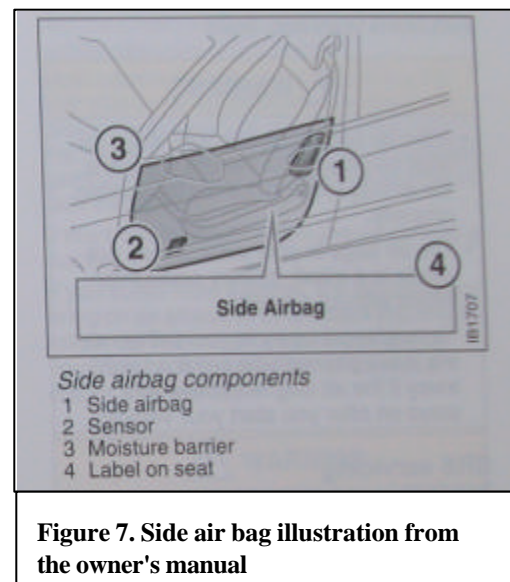
The 2001 Saab 9-5 was equipped with side impact air bags that were located in the front seat backs. The owner's manual stated that the side impact air bag sensors were located in the front side doors. The side impact air bag system illustration from the owner's manual is shown in **Figure 7**. The driver's side impact air bag deployed from the driver's seat back as a result of the impact with the Ford F-150 pickup truck. The Air Bag light on the instrument panel was continuously illuminated when the ignition was keyed at the time of the vehicle inspection. The tear seam along the front outboard aspect of the driver's seat back measured 70.0 cm (27.5") in length.

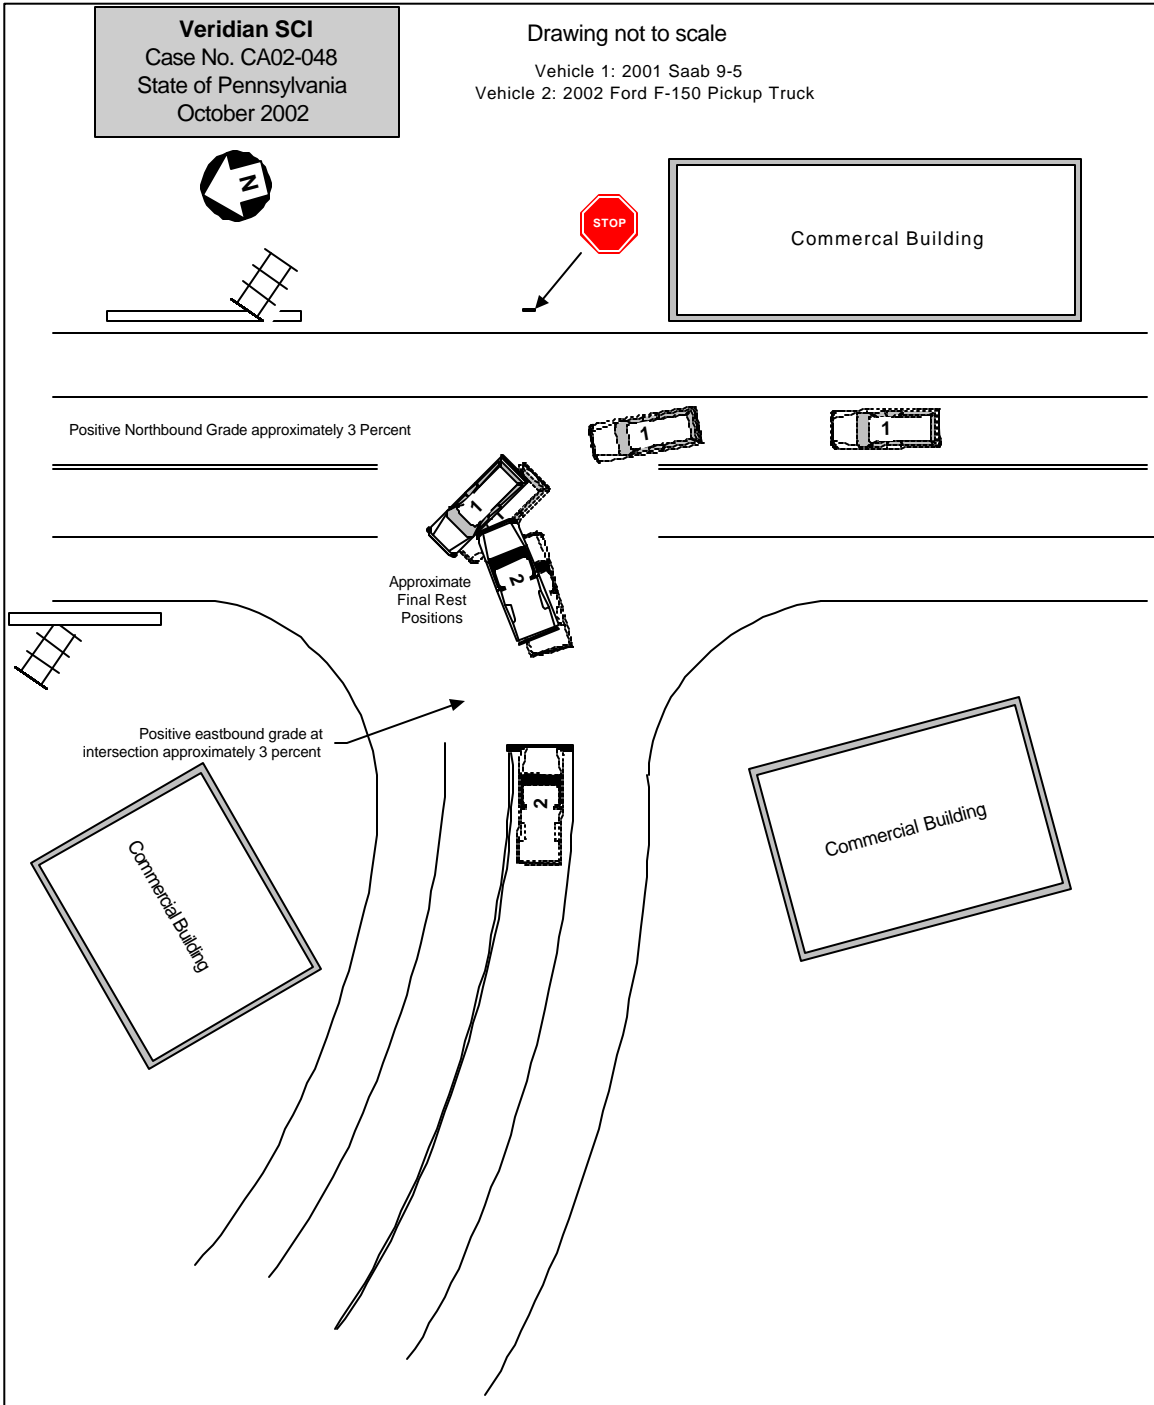
Figure 12. Scene schematic

This two-vehicle crash occurred at a T-intersection of two local roadways during the daylight hours of October 2002. At the time of the crash, the weather was clear and the asphalt roadway surface was dry. The north/south roadway was straight with an approximate 3 percent positive northbound grade. It configured with one travel lane in each direction separated by a double-yellow centerline and bordered by asphalt shoulders. The east/west roadway was curved and had an approximate 3 percent positive eastbound grade at the mouth of the intersection. The east/west roadway was configured with one travel lane in each direction separated by a double-yellow centerline and bordered by asphalt shoulders. Traffic flow into the intersection from the west leg was controlled by a stop sign that was located on the east roadside across from the west leg of the T-intersection. A white painted stop line was present at the mouth of the intersection on the eastbound lane. The scene schematic is included as **Figure 12** at the end of this report.
