**VERIDIAN ON-SITE INFLATABLE SAFETY CANOPY  
CRASH INVESTIGATION  
SCI TECHNICAL SUMMARY REPORT**

**VERIDIAN CASE NO. CA02-059**

**VEHICLE: 2002 MERCURY MOUNTAINEER**

**CRASH DATE: NOVEMBER 2002**

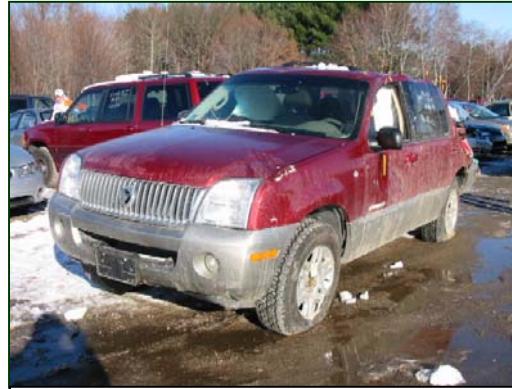
**Figure 1.** Front left three-quarter view of the Mercury Mountaineer.

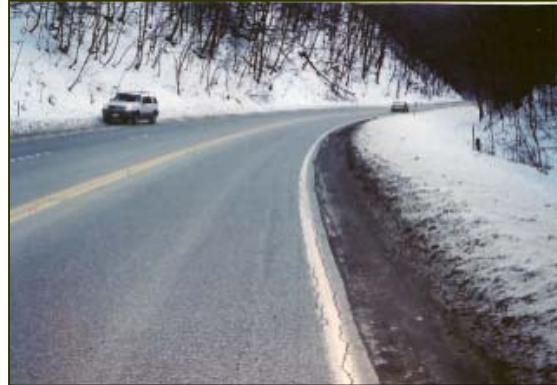
This rollover crash occurred was initiated on a three lane state route with a moderate right curve and a 3 percent negative grade for southbound traffic (**Figure 2**). The lanes were configured with two northbound and a single southbound lane. The outboard northbound lane was 3.2 m (10.5') in width, with a 3.4 m (11.2') wide inboard lane, and a 3.8 m (12.5') wide southbound lane. A 1 m (3.2') paved shoulder bordered the northbound lanes while a 1.2 m (3.9') wide asphalt shoulder bordered the southbound lane. Snow banks bordered both shoulders at the time of the crash. A negative embankment, with a slope of approximately 30 degrees, bordered the southbound shoulder. The embankment terminated into a shallow drainage ditch with a treed embankment ascending from the ditch. Several large rocks were scattered throughout the embankment and within the ditch. A small diameter tree that was struck by the left side of the Mountaineer was located on the embankment on the far side of the ditch. Branches were broken from this tree.

**Figure 2.** Southbound trajectory of the Mercury Mountaineer.

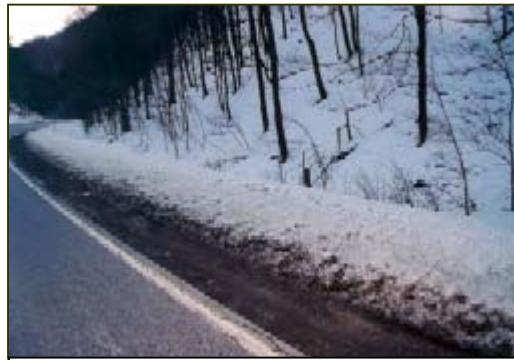
**Figure 3.** Right side road departure.

right road edge (**Figure 3**), leading with its left side. Due to the winter conditions and mountainous elevations of the crash site, a shallow snow bank was present at the edge of the shoulder. The left side tires and wheels probably furrowed through the snow bank, which tripped the Mountaineer into a lateral side-over-side rollover event. The Crash Schematic is attached as **Figure 12**, Page 14 of this Summary Report.
