**GENERAL DYNAMICS REMOTE CERTIFIED ADVANCED 208-COMPLIANT
VEHICLE CRASH INVESTIGATION**

SCI TECHNICAL SUMMARY REPORT

NASS/SCI COMBO CASE NO. 03-43-273E

VEHICLE – 2003 CHEVROLET SUBURBAN

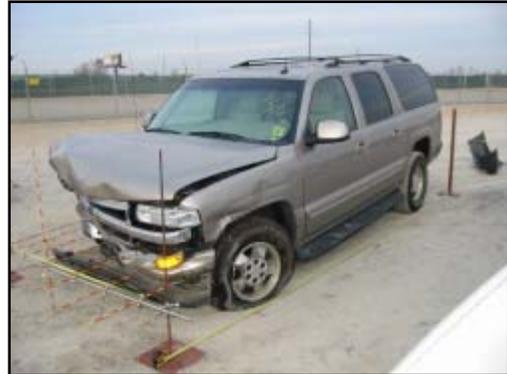
Figure 1. Subject 2003 Chevrolet Suburban.

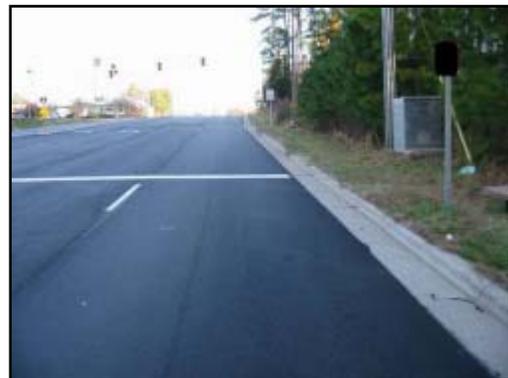
Figure 2. Chevrolet's northbound approach.

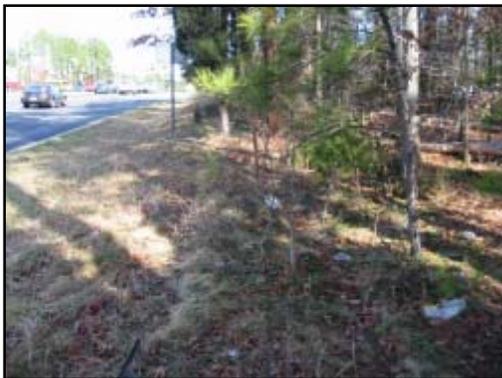
Figure 5. Events 4-7 with small diameter trees.

The fourth event involved the front of the Chevrolet impacting a 3.0 cm (1.2”) diameter tree. The direct damage could not be identified from this impact due to the overlapping impacts.

The fifth event involved the front of the Chevrolet impacting a 4.0 cm (1.6”) diameter tree. The direct damage from this impact was unknown due to the multiple overlapping impacts.

The sixth event involved the front of the Chevrolet impacting a subsequent 4.0 cm (1.6”) diameter tree. The direct damage could not be identified from this impact due to the multiple overlapping impacts.

The seventh event involved the front of the Chevrolet impacting a 5.0 cm (1.9”) tree. The direct damage was masked from this impact due to the overlapping impacts.

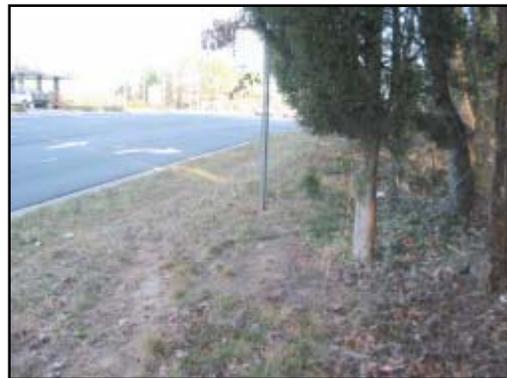
Figure 6. Events 8 and 9 to tree and signpost.

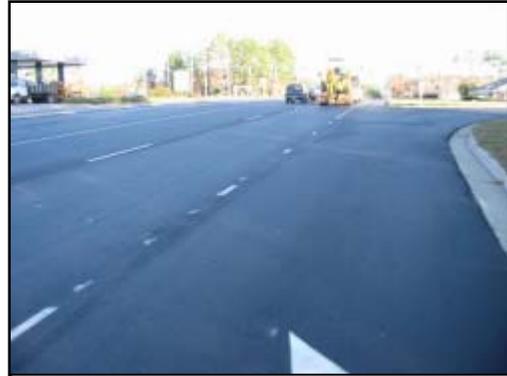
Figure 7. Area of impact between the Chevrolet and the Geo.

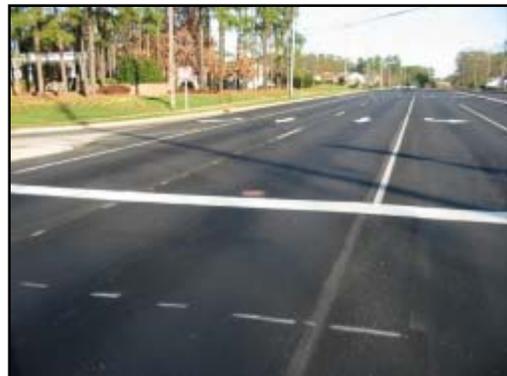
Figure 8. Area of impact between the Chevrolet and the Toyota.

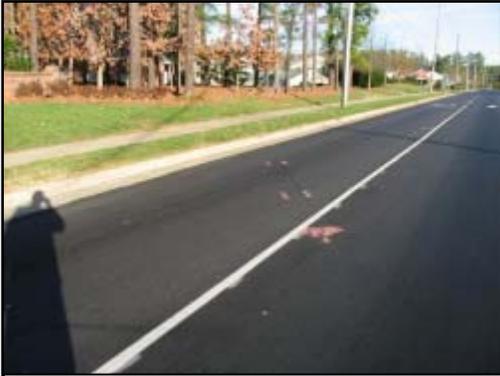
Figure 9. Chevrolet's curb impact on approach to rest.

The twelfth event involved the front wheels impacting a curb. The direct damage consisted of the sidewall being punctured and deformation of the front alloy rims.

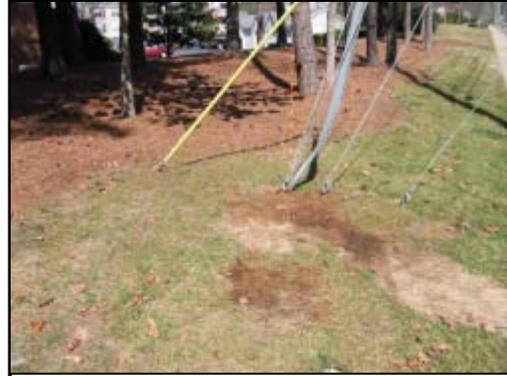
Figure 10. Chevrolet's impact to guy wires and final rest.

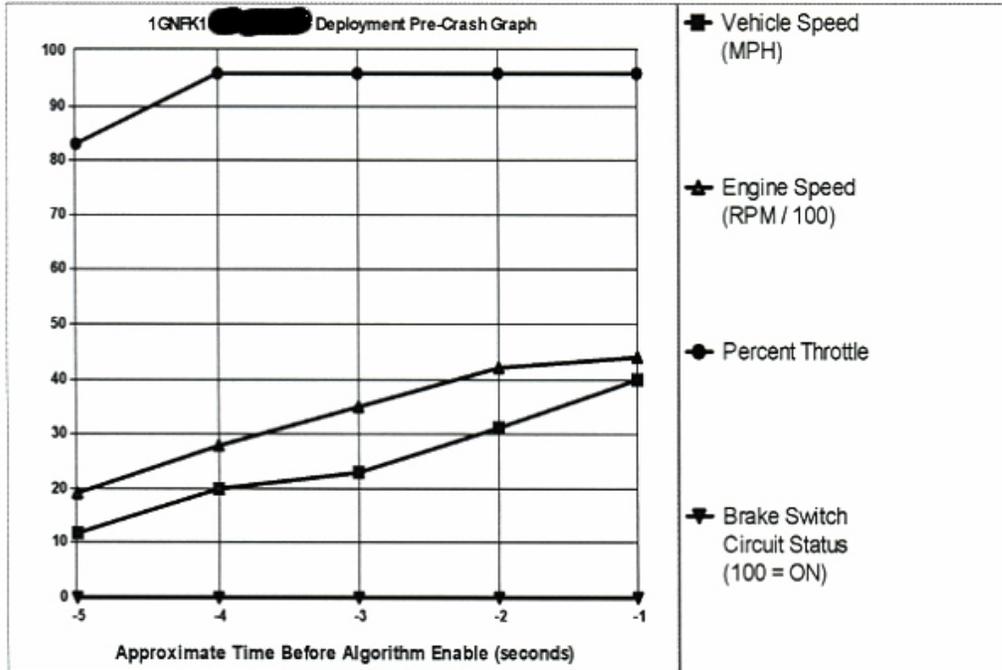
Seconds Before AE	Vehicle Speed (MPH)	Engine Speed (RPM)	Percent Throttle	Brake Switch Circuit Status
-5	12	1856	83	OFF
-4	20	2816	96	OFF
-3	23	3520	96	OFF
-2	31	4160	96	OFF
-1	40	4352	96	OFF

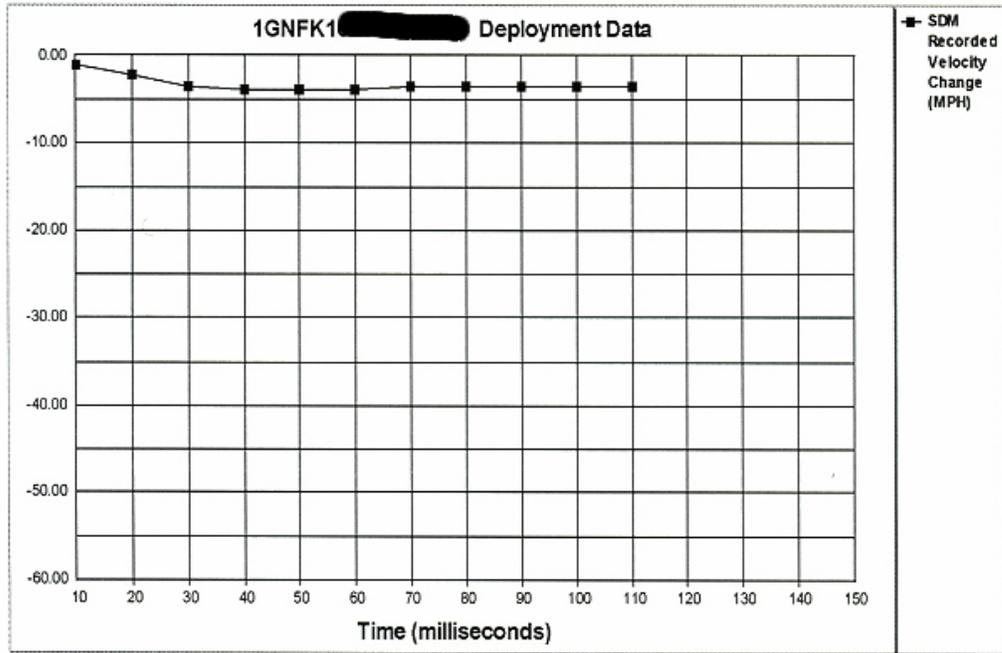
Time (milliseconds)	10	20	30	40	50	60	70	80	90	100	110	120	130	140	150
Recorded Velocity Change (MPH)	-0.93	-2.17	-3.41	-3.72	-3.72	-3.72	-3.41	-3.41	-3.41	-3.41	-3.41	N/A	N/A	N/A	N/A

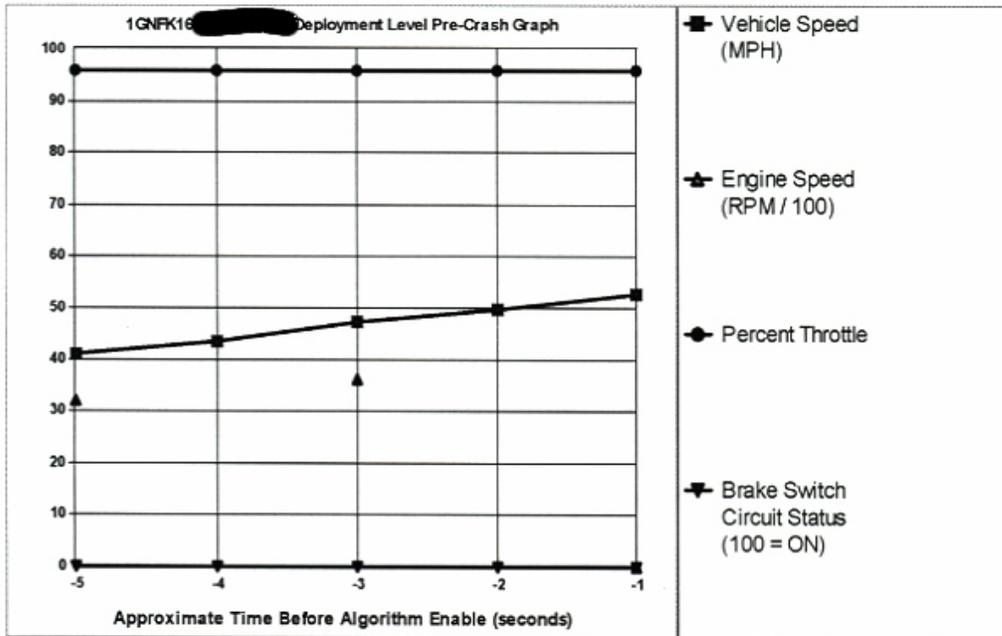
Seconds Before AE	Vehicle Speed (MPH)	Engine Speed (RPM)	Percent Throttle	Brake Switch Circuit Status
-5	41	3200	96	OFF
-4	44	Invalid	96	OFF
-3	47	3584	96	OFF
-2	50	Invalid	96	OFF
-1	53	0	96	OFF

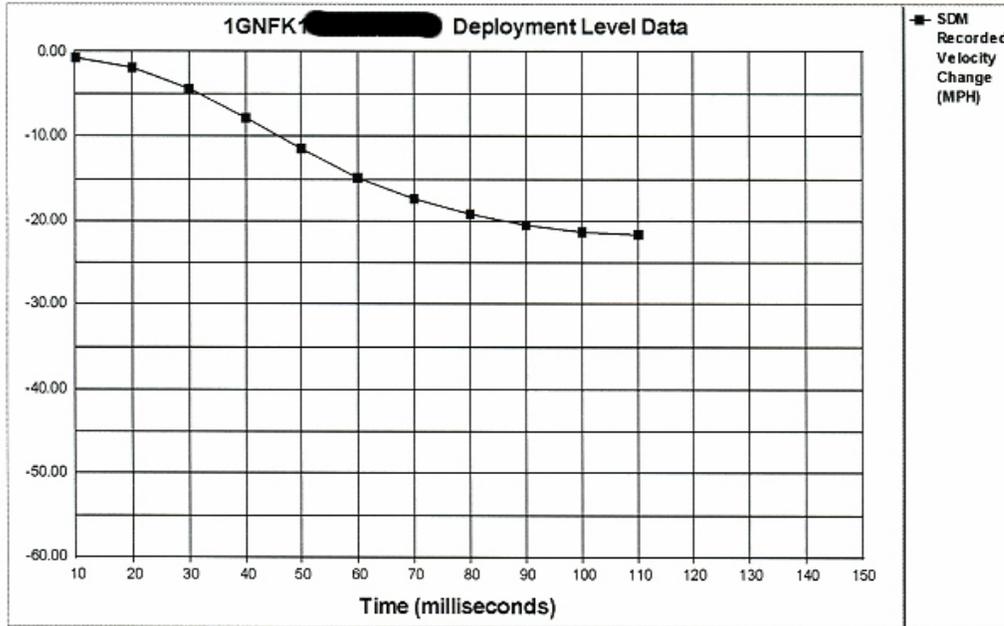
Time (milliseconds)	10	20	30	40	50	60	70	80	90	100	110	120	130	140	150
Recorded Velocity Change (MPH)	-0.62	-1.86	-4.34	-7.75	-11.47	-14.88	-17.36	-19.22	-20.46	-21.39	-21.70	N/A	N/A	N/A	N/A
