**TRANSPORTATION SCIENCES  
CRASH DATA RESEARCH CENTER**

**OFFICE OF DEFECTS INVESTIGATION**

**2000 FORD CROWN VICTORIA POLICE INTERCEPTOR REAR IMPACT CRASH**

**VERIDIAN CASE NO: CA03-002**

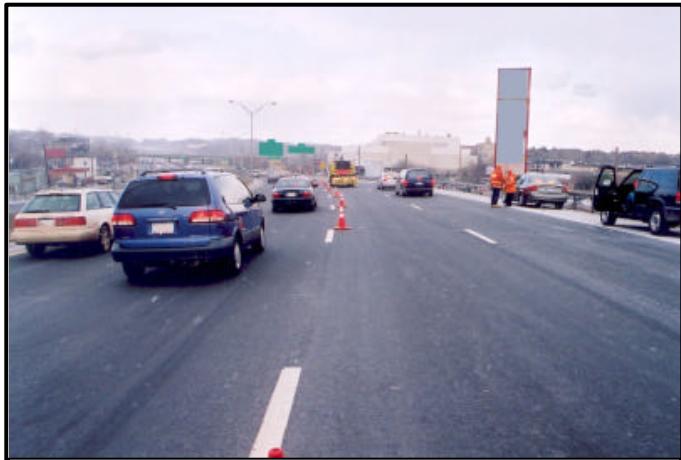
**Figure 1: Northbound trajectory view approximately  
46 m (150 ft) south of the point of impact.**

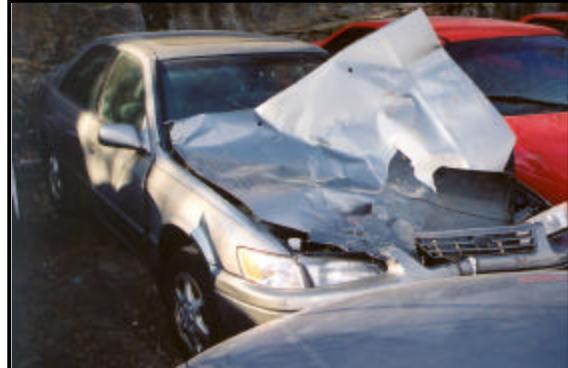
**Figure 7:** Front view of the Toyota Camry.

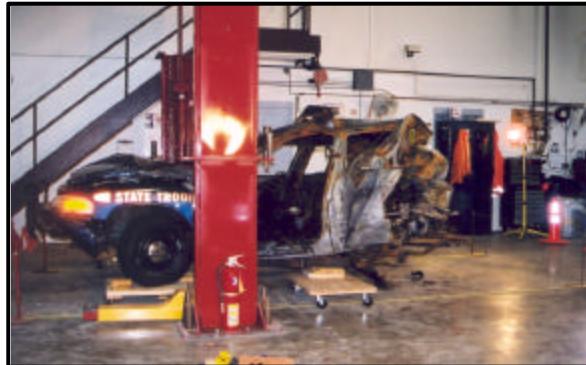
The 2000 Ford Crown Victoria, **Figure 8**, was identified by the Vehicle Identification Number (VIN): 2FAFP71W7YX (production sequence deleted). The 4-door, body on frame, sedan was equipped with the Police Interceptor Package. The power train consisted a 4.6 liter/V8 engine linked to a four-speed automatic transmission. The service brakes were four-wheel disc with ABS. The Ford's odometer reading and refuel history were not available.

**Figure 8: Left side view of the Ford.**

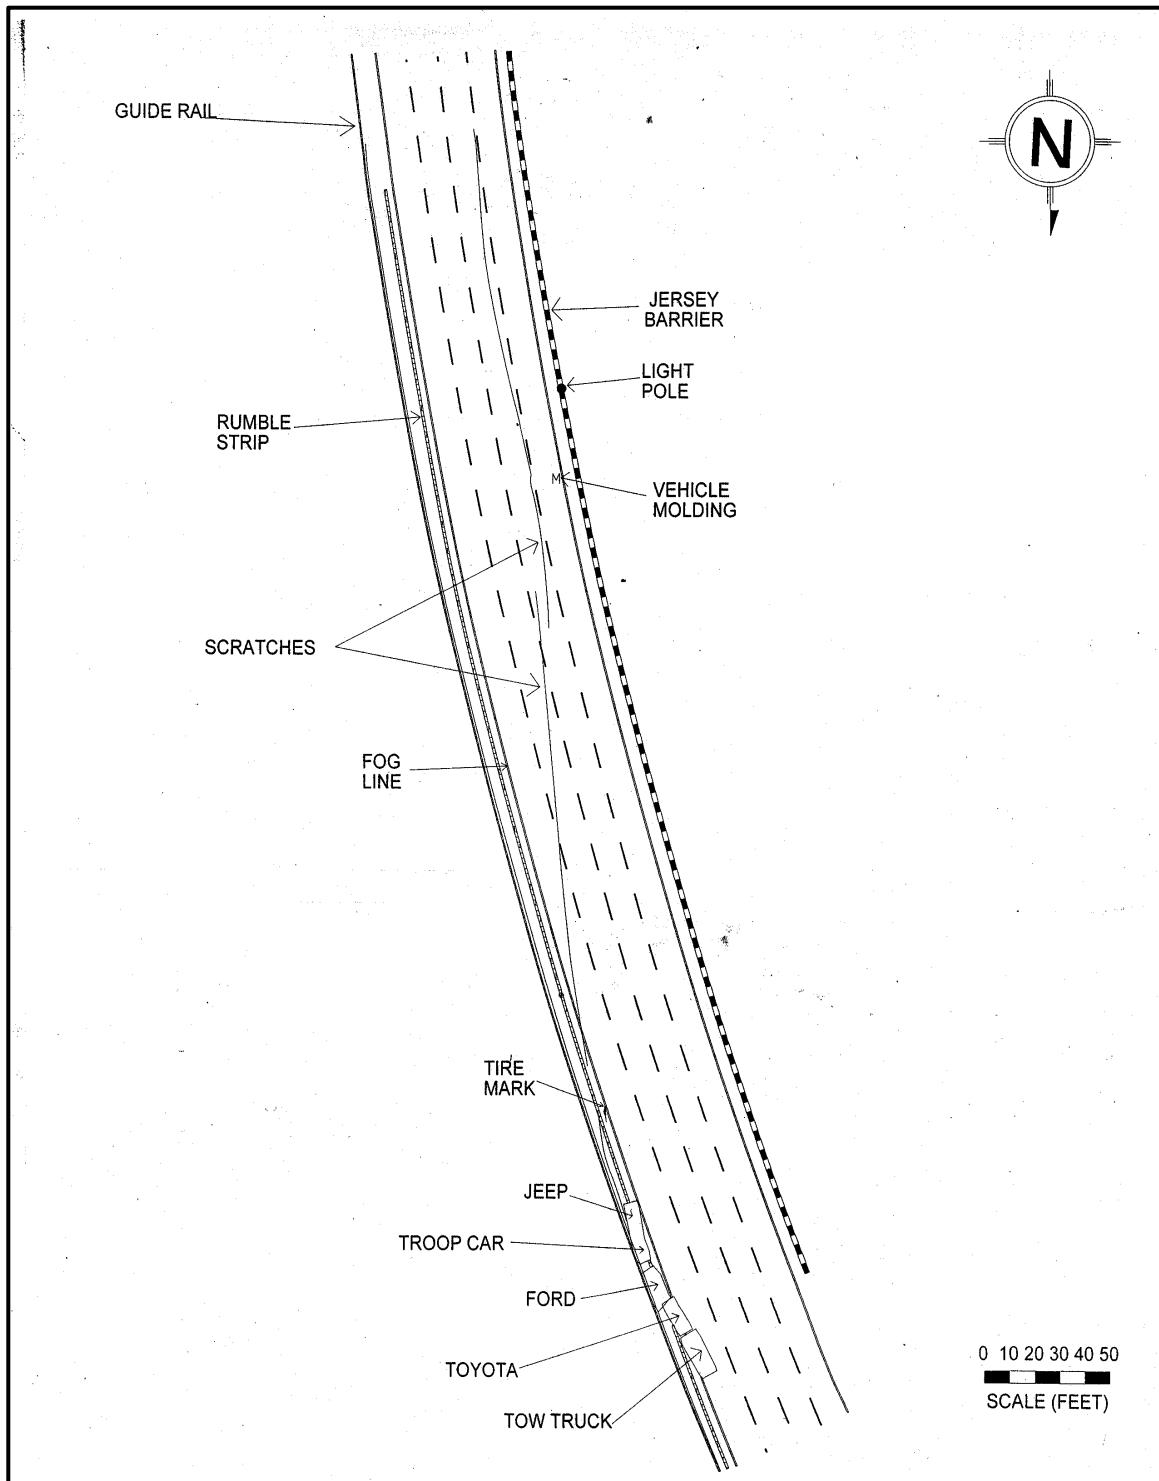
Figure 22: NYSP Crash Schematic.

The impact momentum of the Jeep displaced the 2000 Ford Police Interceptor forward into a secondary collision with the 1990 Ford Crown Victoria. The front plane of the 2000 Police Interceptor impacted and overrode the back plane of the 1990 Ford causing the crush and displacement of its trunk lid to the backlight, **Figure 6**. The 1990 Ford in-turn was displaced forward and impacted the back plane of the Toyota Camry, **Figure 7**. These vehicles remained in sustained contact and the front aspect of the Toyota then impacted work boom of the tow truck. The driver of the Toyota was standing in front of the 1990 Ford during this secondary collision sequence and was struck by the front of the vehicle, wrapping onto the hood, and then displaced into the Ford's windshield. This driver was fatally injured as a result of this impact. The operator of the tow truck was in the process of hooking up to the Toyota and was also injured in this secondary collision sequence. A schematic of the crash developed by the NYSP is attached as **Figure 22** at the end of this report.
