ON-SITE CHILD SAFETY SEAT INVESTIGATION

CASE NUMBER - IN-03-018
LOCATION - ALABAMA
VEHICLE - 2001 HONDA CIVIC EX
CRASH DATE - March 2003

May 24, 2007

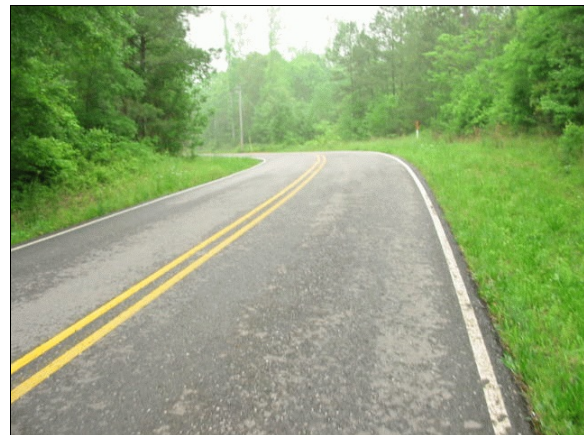
Crash Environment: The trafficway on which the case vehicle was traveling was a two-lane, undivided, county road, traversing generally in a north-northeasterly and south-southwesterly direction. The north-south roadway had one through lane in both the northern and southern directions (**Figure 1**). The county roadway was curved to the left for southerly traffic (**Figure 1**) and for the pre-crash segment of the roadway there was a 2.5% grade positive to the south-southwest (i.e., an upgrade in the case vehicle's direction of travel). Near the area of impact the roadway was level (i.e., actual slope was less than

Figure 1: Case vehicle's uphill, south-southwesterly travel path at entrance to left-hand curve (case photo #01)

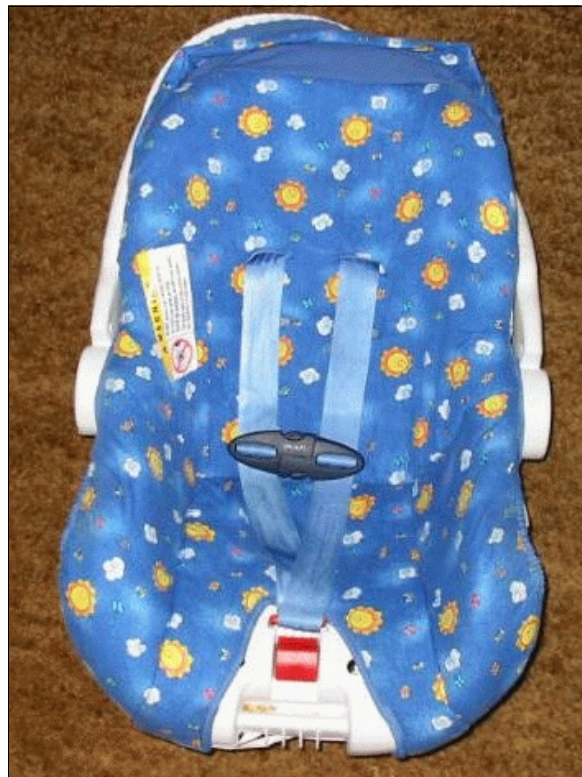
The back right passenger was seated in an infant child safety seat that was positioned rear-facing. The child safety seat was manufactured by Evenflo on May 24, 2002 and was identified by Model name "Discovery" and Model number **2121012 P1**. The infant seat was designed with a three-point harness which attached between the child's legs into a recessed buckle (**Figure 17**). The seat did not have a top tether, and there were two sets of slots to thread the harness through.

Figure 17: Overhead view of front of Evenflo Discovery infant seat used by case vehicle's back right passenger (case photo #49)

The harness straps were threaded through the top slots, which is in accordance with the manufacturer’s instructions. The child seat was in the reclined position.
