## REMOTE CHILD AIR BAG-RELATED FATALITY INVESTIGATION

CASE NUMBER - IN-03-021  
LOCATION - Georgia  
VEHICLE - 1999 DODGE NEON  
CRASH DATE - June 2001

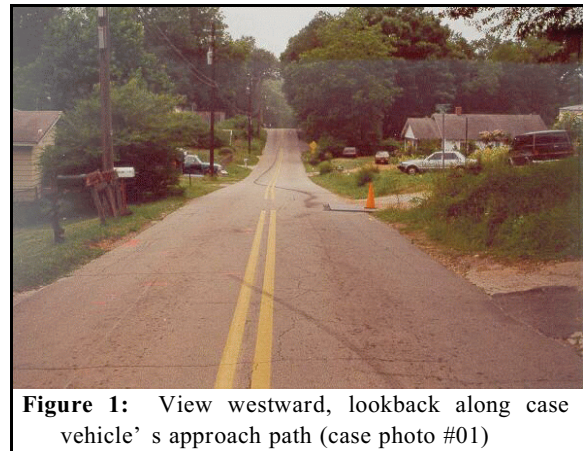
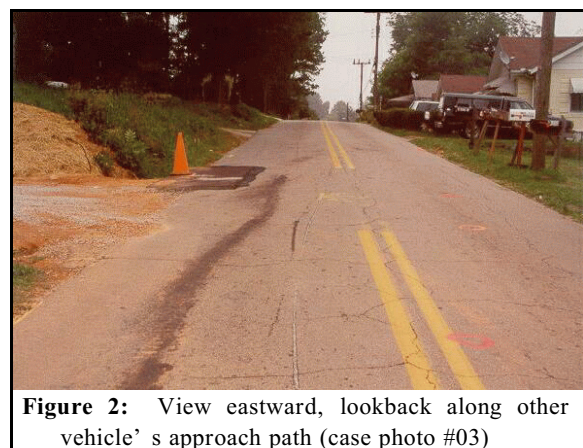
The case vehicle's left front corner was impacted by the Ford's front left corner, with the two vehicles' left front wheels snagging and breaking, causing the case vehicle's driver and front right passenger air bags to deploy. The Ford's dual frontal air bags also deployed. The case vehicle continued forward approximately 9 meters [29 feet] and came to rest (the police report
