**TRANSPORTATION SCIENCES
CRASH DATA RESEARCH CENTER**

ON-SITE SIDE IMPACT AIR BAG OCCUPANT PROTECTION INVESTIGATION

GENERAL DYNAMICS CASE NUMBER: CA03-021

VEHICLE: 2002 CHEVROLET VENTURE

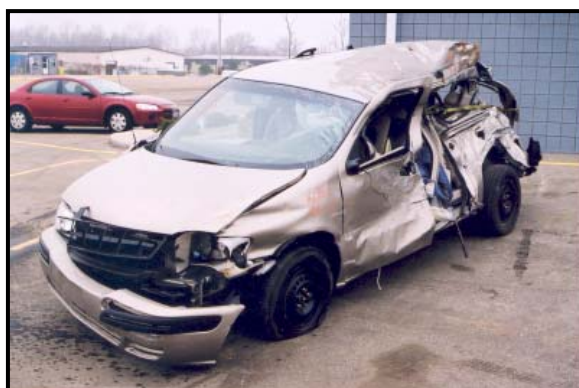
Figure 1: Left front view of the Chevrolet Venture.

This on-site investigation focused on the crash severity and the performance of a Century Bravo convertible Child Safety Seat (CSS), and an occupied integrated CSS in a 2002 Chevrolet Venture, **Figure 1**. In addition, this investigation also focused on the performance of the side impact air bag system in the Venture. The Chevrolet was involved in an angular left side impact with a 1999 Ford E350 van that was towing a loaded enclosed trailer. The impact resulted in severe left side damage to the Venture with extensive intrusion into the second and third row seating areas. The 34 year old male driver of the Chevrolet sustained injuries to his left flank

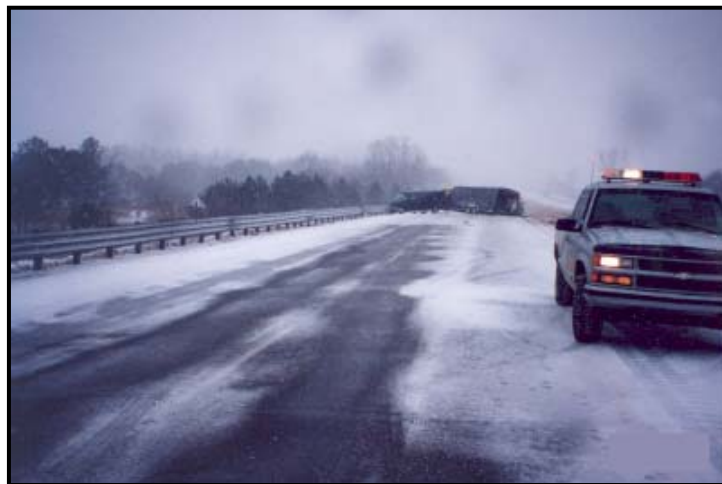
Figure 4: View looking west at the final rest position of the Ford and trailer in the eastbound lanes.

After separation with the Chevrolet, the front plane of the Ford struck and deformed the south guardrail, and came to rest blocking the eastbound travel lanes. **Figure 4** is a view looking west along the eastbound traffic lanes depicting the road conditions and the final rest position of the van and trailer. As a baseline analysis the WINSMASH model was used as a crash severity indicator. The total delta V's of the Chevrolet and Ford calculated by the Missing Vehicle Algorithm of the WINSMASH collision model were 52.0 km/h (32.3 mph) and 22.0 km/h (13.7 mph), respectively. The WINSMASH results are for anecdotal purposes only due to the trailer altering the weight of the Ford, and should not be considered representative of this crash.

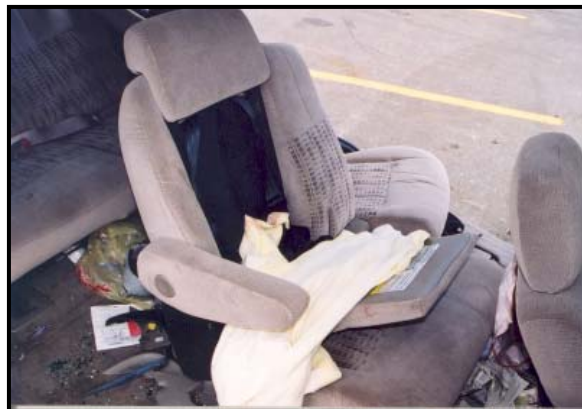
Figure 12: View of the integrated Child Safety Seat.

The second row right seat was not damaged in the impact, **Figure 12**. The seat was adjusted to a full rear track position. The adjustable head restraint was in the full down position. The seat back was reclined 22 degrees. The width of the seat cushion measured 61 cm (24 in). The OEM integrated Child Safety Seat (CSS) with a 5-point harness was located within this seat back. The seat was labeled for use by a child that weighed 10 to 18 kg (22 to 40 lb) and a height of 85.1 cm to 101.6 cm (33.5 in to 40.0 in). A 30 cm x 41 cm (12 in x 16 in) section of the seat back folded down and became the integrated CSS seat cushion. This cushion measured 4.6 cm (1.8 in) in thickness.

Initial observation of the 5-point harness revealed the right shoulder strap was cut during the removal of the child and the right crotch latch clip was missing. Examination of the straps and the hardware revealed evidence of historical use. The crotch straps exhibited slight creasing/ropeing at the latch clips that appeared to be more related to routine use than crash loading. There was no crash related evidence on the shoulder straps or harness retainer clip. The location of the clip measured 26.9 cm (10.6 in) below the entrance to the slot in the seat back. The driver reported that the child was restrained at the time of the crash and the retainer clip was located at the level of the child's arm pit. A blood stained yellow blanket located on the cushion was entangled in the harness straps. Reportedly, this blanket was used during the first aid efforts for the child and was originally located in a diaper bag on the floor at the time of the crash. SCI inspection of the integrated CSS determined the 33 month old child was restrained at the time of the crash.

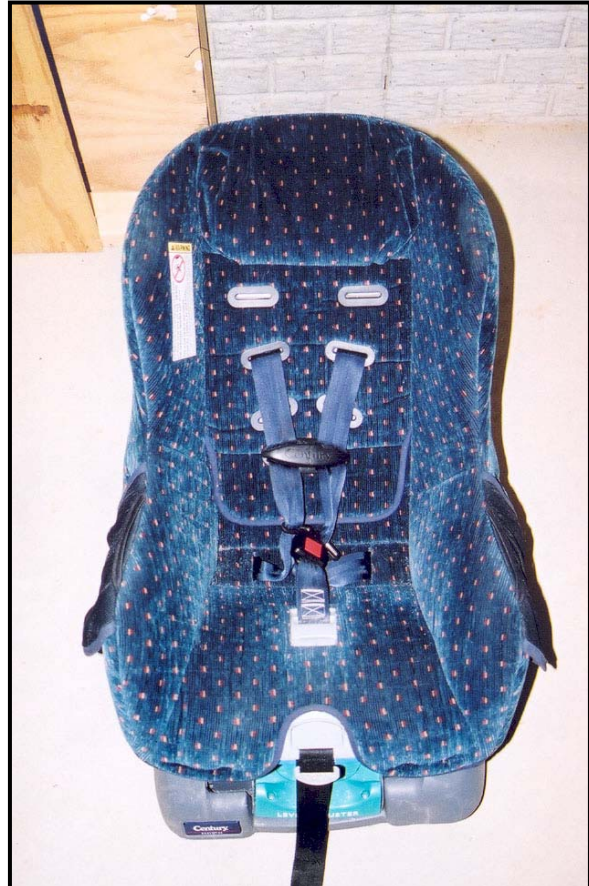
Figure 17: Front view of the Century CSS.

The 7 month old infant was restrained in a Century Bravo SE Convertible Child Safety Seat, **Figure 17**, that was identified by the Model No: 44622NYK and was manufactured on 10/09/2000. The convertible child restraint was installed in a rear-facing orientation in the third row of the Venture. Reportedly, the seat was purchased new for the family's first child in the later part of 2000. The driver reported that he had read the CSS manual.

The CSS was fastened in a rear-facing position to the center of the vehicle's third seat by the lap belt. The lap belt was equipped with a locking latch plate. The seat was adjusted into the reclined position and the adjustable foot was extended. The driver reported that he had used one rolled towel under the foot at the seat bight to ensure CSS was reclined at the proper angle. He indicated that the level indicator was within the "green limits". He further stated that he took care to ensure an adequate installation by compressing the vehicle seat and cinching the lap belt tight. The rear-facing belt path was used. He indicated that the tether strap was attached to the base frame of the second row of seats. The tether strap on the back of the CSS was cut during its removal. The use of the tether strap was not observed during the SCI vehicle inspection. It should be noted that the manufacturer's instruction manual for the CSS do not instruct the user to install a tether strap in a rear-facing installation.

The 5-point harness straps were in good condition upon inspection. The straps were routed through the middle slots and the driver stated that in this position the straps were at the infant's shoulder height. Minor roping of the straps was observed at the latch clips in the hip portion of each strap. No crash related evidence was identified. The harness retainer clip was intact and operational. The driver indicated that the retainer clip was at the level of the infant's arm pits when buckled.

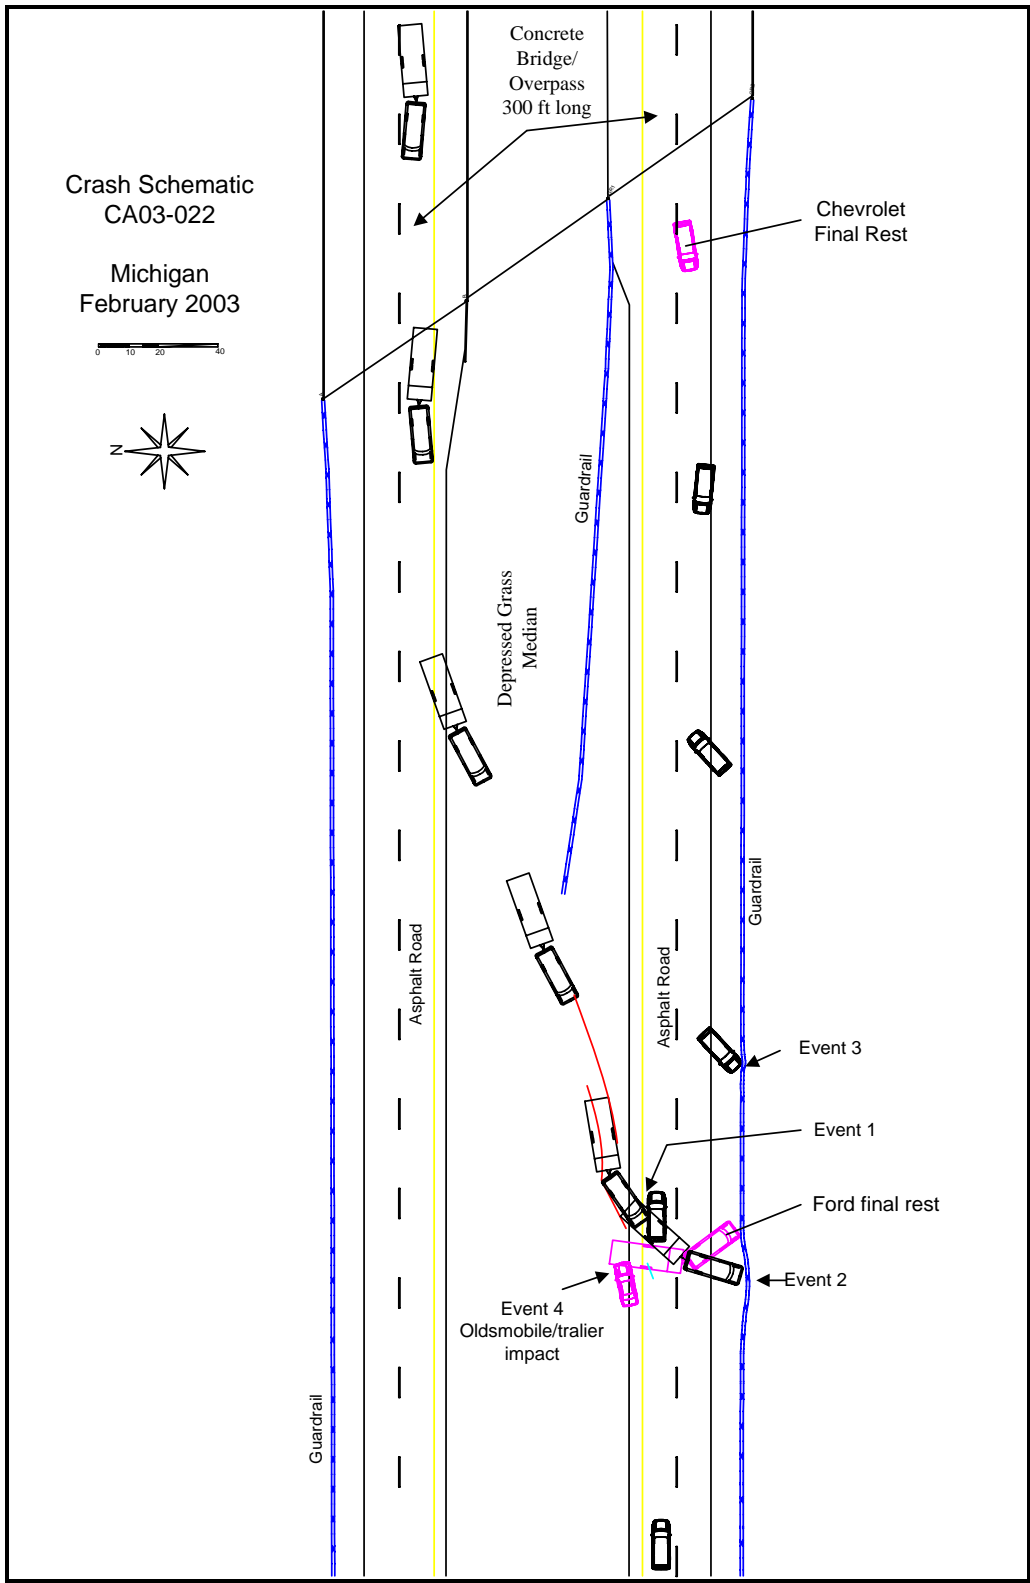
Figure 21: Crash Schematic

A schematic of the crash sequence is attached to the end of this report, **Figure 21**, Page 18. The crash occurred with the front left corner of the van impacting the left side of the Venture at its B-pillar. The directions of force were in the 10 and 1 o'clock sectors for the Chevrolet and Ford, respectively. The side impact air bag in the Chevrolet Venture deployed due to the force of the impact. The force of the impact rearward of the Chevrolet's center of gravity caused the Venture to rotate counterclockwise (CCW) and displaced the vehicle laterally. The Venture rotated approximately 200 degrees CCW and struck the W-beam guardrail bordering the south roadway edge with its front left corner. This guardrail impact was located 15 m (50 ft) east of the initial point of impact and was evidenced by a deflection in the guardrail. The Chevrolet then slid approximately 85 m (280 ft) eastward along the highway to rest, while rotating an additional 360 degrees. The Venture came to rest facing west in the outboard lane of the highway.
