On Site Certified Advanced 208-Compliant Investigation / Vehicle to Object  
Dynamic Science, Inc. / Case Number: DS03025  
2003 GMC 1500 Yukon  
Texas  
May, 2003

1. Report No. DS03025	2. Government Accession No.	3. Recipient Catalog No.	
4. Title and Subtitle Certified Advanced 208-Compliant Investigation		5. Report Date

**Dynamic Science, Inc.**  
**Crash Investigation**  
**Case Number: DS03025**

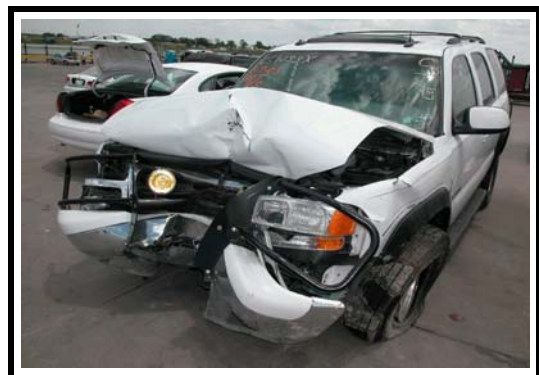
**Figure 2.** Front, three-quarter view of 2003 GMC 1500 Yukon SUV

Damage Description: Moderate/ Primary Frontal Impact (Highest Delta V):  
Longitudinal displacement deformation to the front bumper, brush guard, grille and hood. In addition the front, right headlight was broken and deformation was noted to the left fender.

Minor/ Secondary Front Wheel/Tire Impacts (Second Highest Delta V): Both the front right and front left tires were deflated due to the initial curb impact. Additionally, the rims on both front wheel assemblies sustained residual damage.

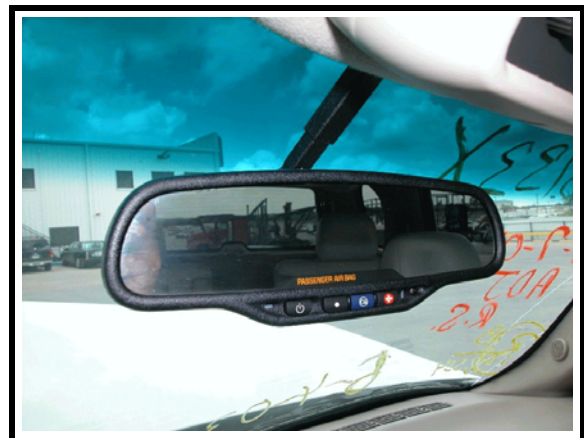
**Figure 6.** Close-up view showing passenger air bag sensing system and OnStar
