**GENERAL DYNAMICS ON-SITE CHILD SAFETY SEAT CRASH INVESTIGATION
SCI TECHNICAL SUMMARY REPORT**

CASE NO: CA03-029

VEHICLE: 2001 CHRYSLER PT CRUISER

CRASH DATE: MAY 2003

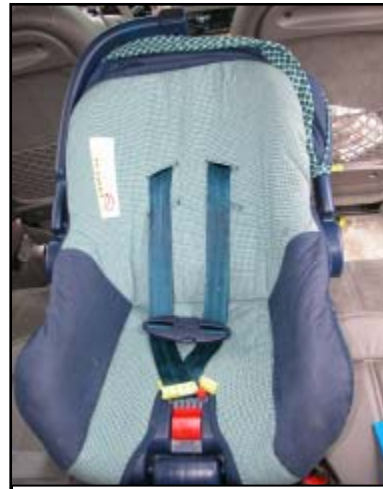
Figure 17. Evenflo Discovery CSS

The Evenflo Discovery rear-facing CSS (**Figure 17**) was identified by the model number: 4791255P1. The date of manufacture was 03 Jul 02. The CSS instruction manual was located on the rear aspect of the CSS at the time of the inspection. The CSS was designed for rear-facing use for infants who weighed between 2.3 – 9.0 kg (5.0 – 20.0 lb) and measured 48 – 66 cm (19 – 26”) in height. The CSS was designed for use with or without the detachable base. The CSS was configured with a single-loop, 3-point harness system and a two-piece snapping harness retainer clip. The harness adjustment was located on the upper rear aspect of the CSS. A spring-loaded release handle was located on the top rear aspect of the CSS to release the CSS from the base. The CSS did not have an angle adjustment indicator, however, labels were located on the circular base of the carrying handle, which stated that the colored arrows must point up when used in the vehicle.

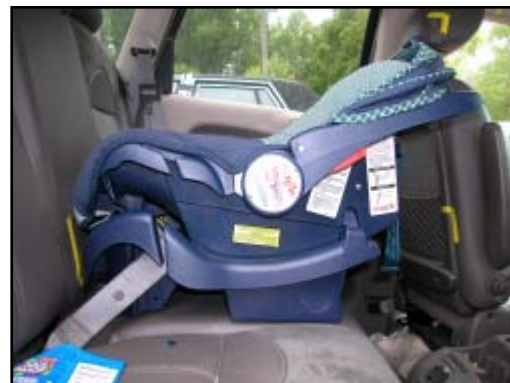
Figure 18. Pre-crash position of the CSS in the PT Cruiser

The Evenflo Discovery CSS was installed in the rear center position of the 2001 Chrysler PT Cruiser. **Figure 18** depicts the approximate position of the CSS in the PT Cruiser. The driver stated that the CSS manual was consulted for the installation, as well as the vehicle’s owner’s manual. She stated that both manuals were confusing.

The CSS was installed with the center position 3-point lap and shoulder belt. The 3-point lap and shoulder belt was routed through the rear-facing belt path on the CSS base. The driver’s spouse stated that the base was installed by pre-loading the base with his knee to compress it into the seat, and pulling on the safety belt webbing to remove the slack and tighten. The driver stated that after installation, the CSS base was not tight enough, and a locking clip was placed on the safety belt (opposite side from the buckle) to tighten the installation and limit lateral movement to less than 2.5 cm (1.0”). During the interviews with the driver and spouse, neither ever indicated any attempt to engage the ALR. Based on the description of the installation by the parents, the ALR was probably not engaged. The CSS was checked on a daily basis to ensure tightness in the vehicle. The driver stated that nothing was used under the CSS to adjust

the recline angle in the PT Cruiser (they noted that a rolled towel was necessary for use in another family vehicle). The driver said that the carrying handle was positioned forward and the harness retainer clip was positioned at the infant's armpits, per the CSS instructions. The driver stated that the shoulder harnesses were slightly above the child's shoulders in the top slots. Although the driver's spouse stated that the CSS was checked at a local car dealer a few months prior to the crash where local fire and police personnel perform periodic CSS checkpoints, the driver stated that the CSS had not been inspected and that the parents were unable to attend any checkpoints.
