**CALSPAN ON-SITE CERTIFIED ADVANCED 208-COMPLIANT
VEHICLE CRASH INVESTIGATION**

SCI CASE NO: CA03-061

**VEHICLE: 2003 GMC SIERRA PICK-UP TRUCK
LOCATION: MICHIGAN
CRASH DATE: OCTOBER 2003**

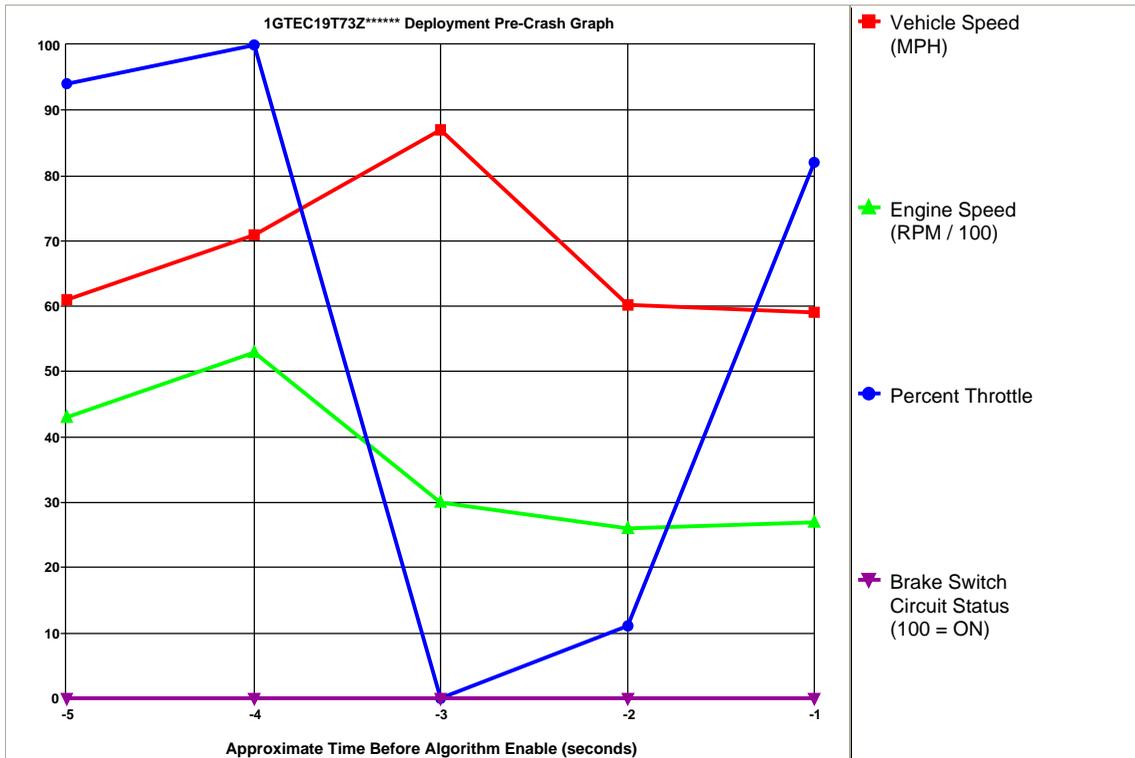
System Status At Deployment

SIR Warning Lamp Status	OFF
Driver's Belt Switch Circuit Status	UNBUCKLED
Passenger Seat Position Switch Circuit Status	Rearward
Ignition Cycles At Deployment	1737
Ignition Cycles At Investigation	1739
Maximum SDM Recorded Velocity Change (MPH)	-32.15
Algorithm Enable to Maximum SDM Recorded Velocity Change (msec)	107.5
Driver First Stage Time Algorithm Enabled to Deployment Command Criteria Met (msec)	12.5
Driver Second Stage Time Algorithm Enabled to Deployment Command Criteria Met (msec)	12.5
Passenger First Stage Time Algorithm Enabled to Deployment Command Criteria Met (msec)	Suppressed
Passenger Second Stage Time Algorithm Enabled to Deployment Command Criteria Met (msec)	Suppressed
Time Between Non-Deployment And Deployment Events (sec)	N/A
Frontal Deployment Level Event Counter	1
Event Recording Complete	Yes
Multiple Events Associated With This Record	No
One Or More Associated Events Not Recorded	No

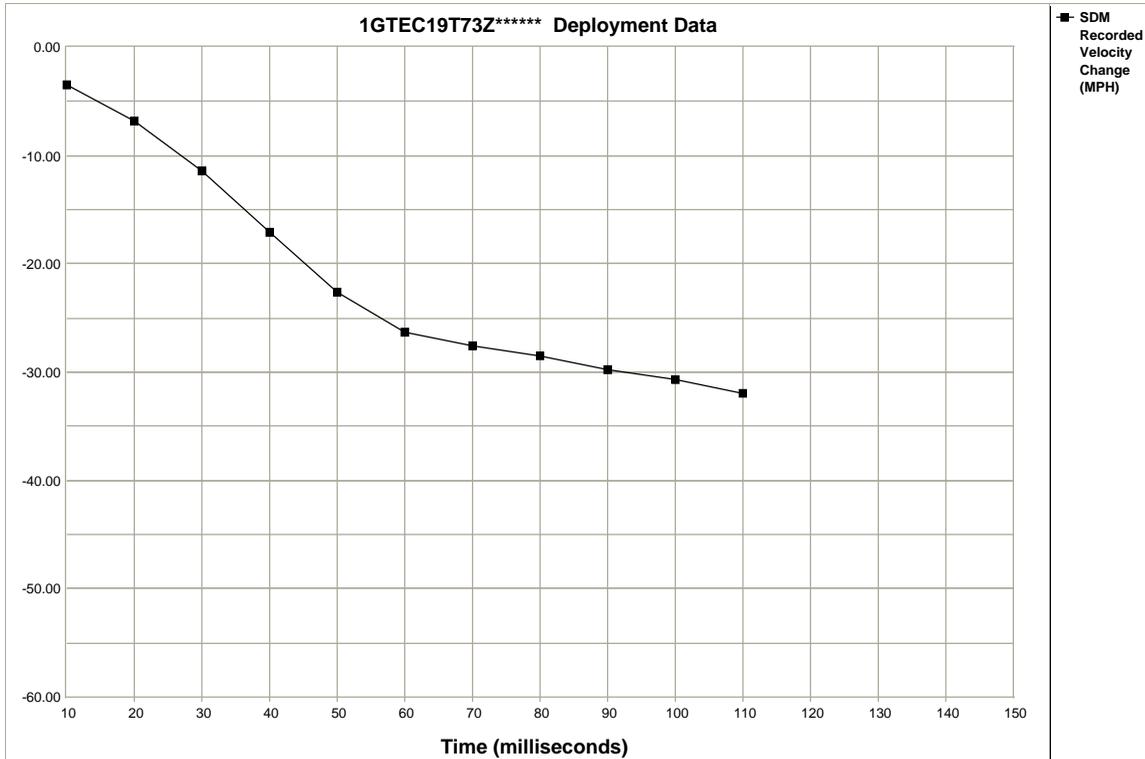
Seconds Before AE	Vehicle Speed (MPH)	Engine Speed (RPM)	Percent Throttle	Brake Switch Circuit Status
-5	61	4288	94	OFF
-4	71	5312	100	OFF
-3	87	3008	0	OFF
-2	60	2560	11	OFF
-1	59	2688	82	OFF

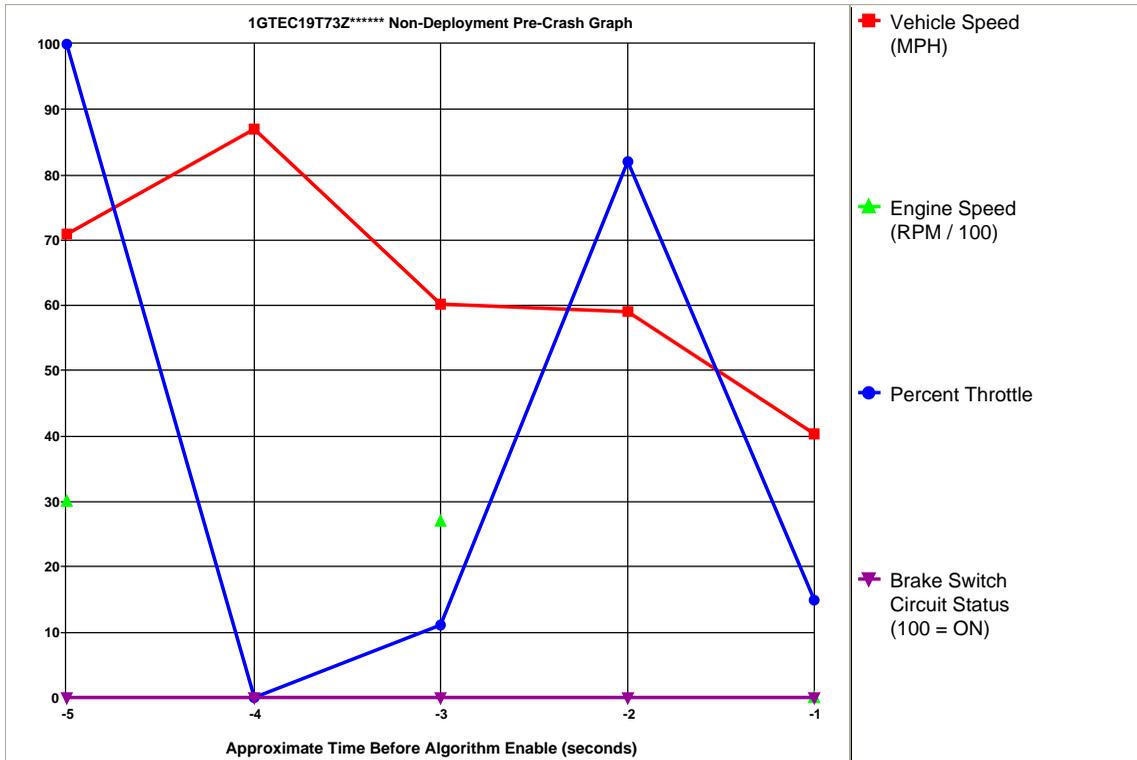
System Status At Non-Deployment

SIR Warning Lamp Status	ON
Driver's Belt Switch Circuit Status	UNBUCKLED
Passenger Seat Position Switch Circuit Status	Rearward
Ignition Cycles At Non-Deployment	1737
Ignition Cycles At Investigation	1739
Maximum SDM Recorded Velocity Change (MPH)	-9.33
Algorithm Enable to Maximum SDM Recorded Velocity Change (msec)	465
Crash Record Locked	No
Event Recording Complete	Yes
Multiple Events Associated With This Record	Yes
One Or More Associated Events Not Recorded	Yes

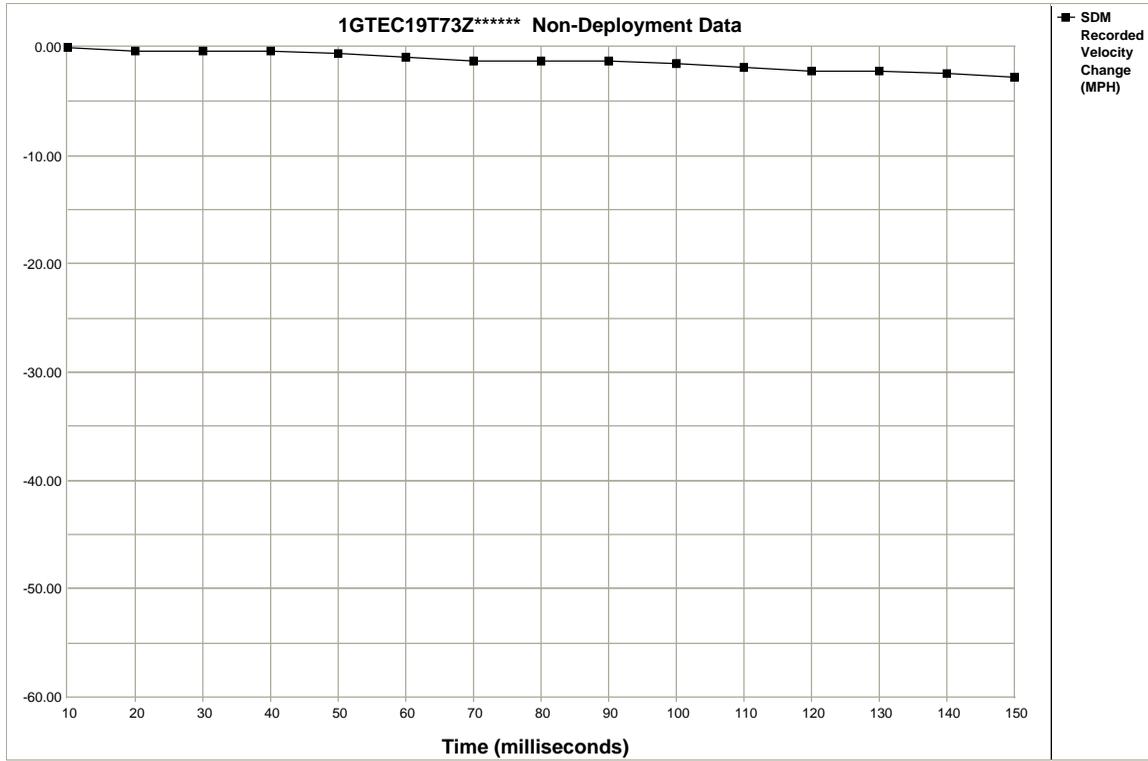
Seconds Before AE	Vehicle Speed (MPH)	Engine Speed (RPM)	Percent Throttle	Brake Switch Circuit Status
-5	71	3008	100	OFF
-4	87	Invalid	0	OFF
-3	60	2688	11	OFF
-2	59	Invalid	82	OFF
-1	40	0	15	OFF
