**GENERAL DYNAMICS ON-SITE CERTIFIED 208-ADVANCED COMPLIANT
VEHICLE CRASH INVESTIGATION**

GENERAL DYNAMICS CASE NO: CA03-065

VEHICLE: 2004 GMC YUKON

CRASH DATE: OCTOBER 2003

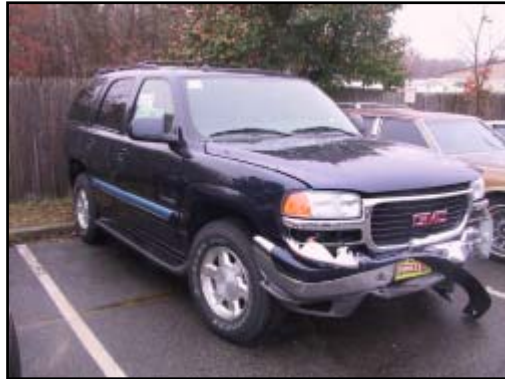
Figure 1. 2004 GMC Yukon.

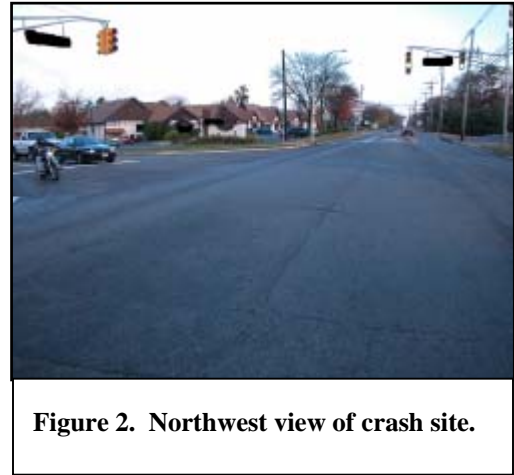
This intersection crash occurred during the nighttime hours of October 2003. At the time of the crash, the weather was clear with no adverse conditions. The crash occurred at a four-leg intersection of two local roadways (**Figure 2**). The north/southbound roadway was configured with one travel in each direction and a center left turn lane. The north leg was divided by a solid double yellow centerline. The south leg was divided by a raised concrete median. Concrete barrier curbs bordered the north/southbound roadway. The east/westbound roadway was configured with one travel lane in each direction with a center left turn lane. Both legs were divided by solid double yellow centerlines and were bordered by concrete barrier curbs.

Figure 2. Northwest view of crash site.

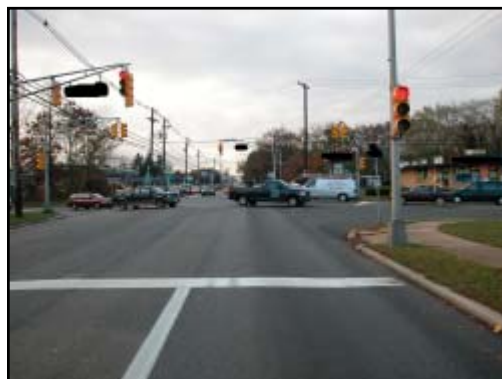
The 51-year-old male driver of the GMC was operating the vehicle on a GM 24-hour test drive and was traveling southbound on the three-lane roadway approaching an intersection (**Figure 3**). The EDR indicated that the GMC was traveling at 64.3 km/h (40.0 mph) five seconds prior the crash. The EDR also indicated that the driver applied the brakes and slowed the vehicle to 45.1 km/h (28.0 mph) one-second prior to the crash. The 17-year-old female driver of the Toyota was operating the vehicle northbound approaching the same intersection where she was intending to turn left. The 31-year-old female driver of the Taurus was stopped on the westbound lane of the intersection at a red light. No pre-impact skid marks were present at the scene.

Figure 3. GMC's approach to intersection.

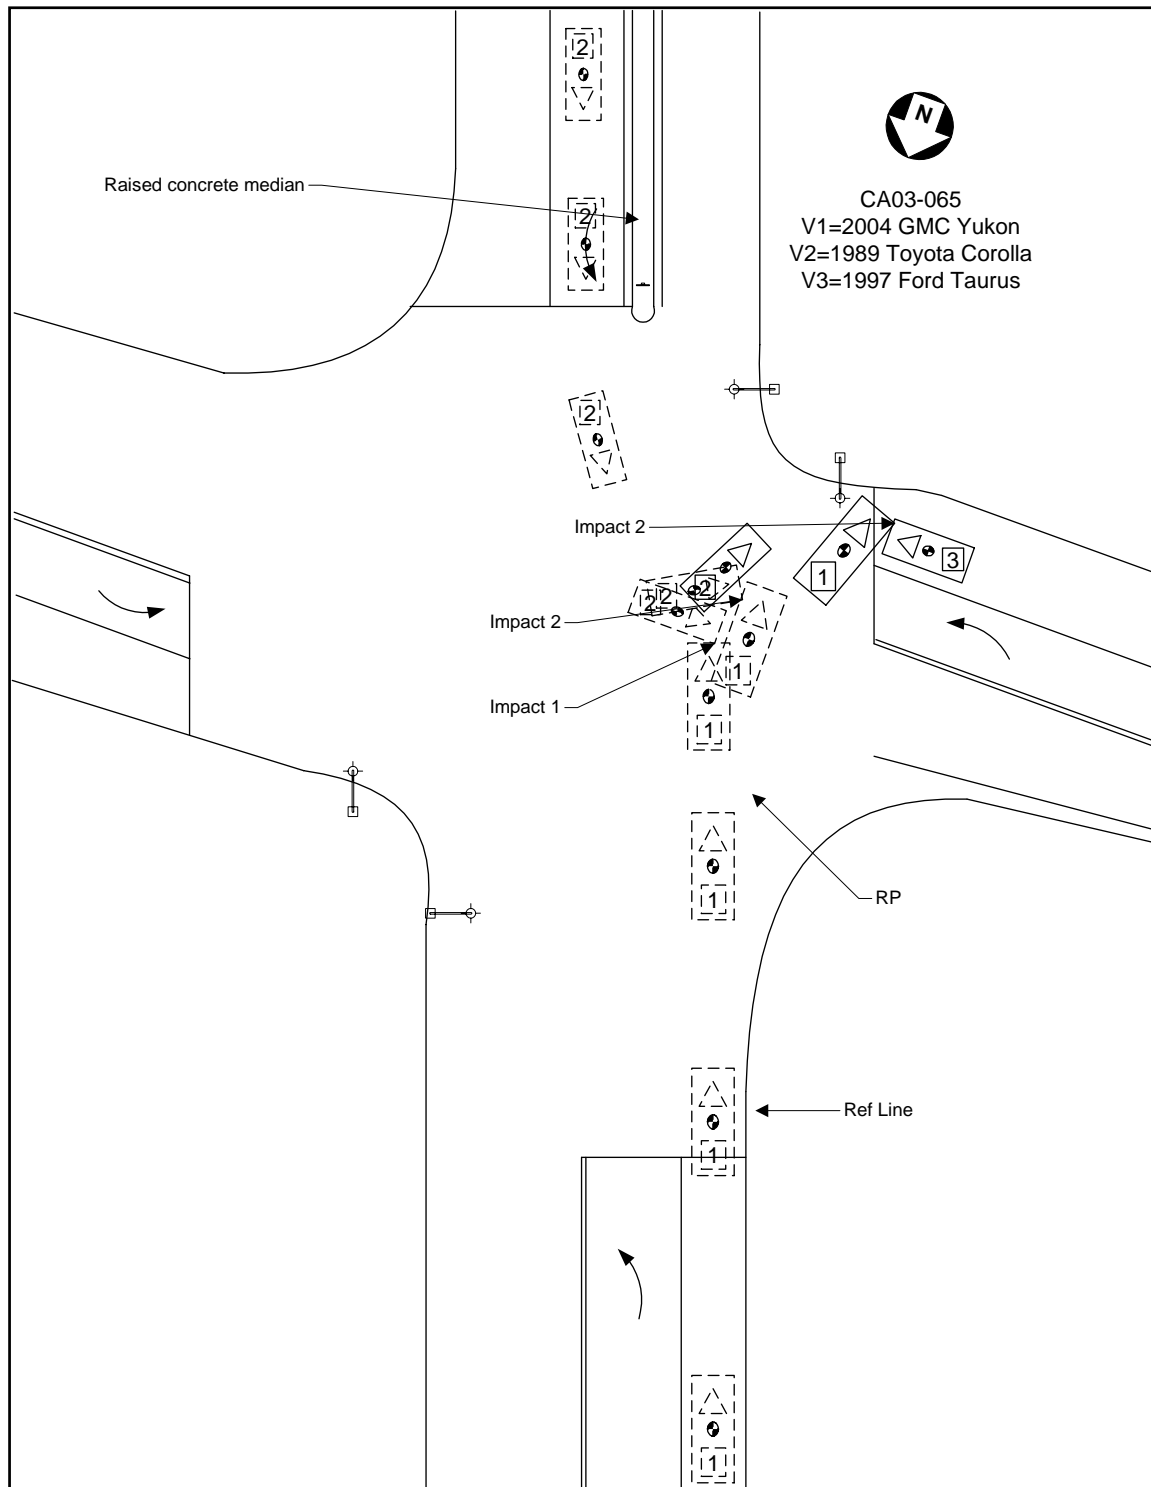
Figure 9. Scene schematic

Traffic through the intersection was controlled by overhead three phase traffic lights. The posted speed limit for both roadways was 64 km/h (40 mph). The scene schematic is included as **Figure 11** of this report.
