**TRANSPORTATION SCIENCES
CRASH DATA RESEARCH CENTER**

SCI TECHNICAL SUMMARY REPORT

NASS/SCI COMBO CASE NO. 2004-47-013C

VEHICLE – 2004 FORD F-150

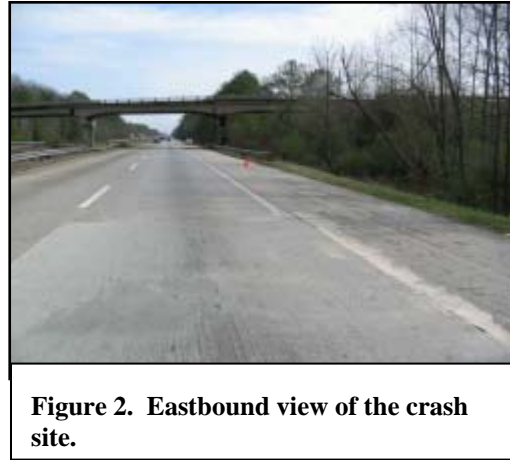
This multiple event crash occurred during the morning hours of February 2004 in the state of Alabama. At the time of the crash, it was raining/snowing and the asphalt road surface was wet. The crash events occurred on the roadside of a local east/west interstate roadway. The east/westbound roadway consisted of two travel lanes in each direction and was delineated by a center grass median. The left roadside (north) was bordered by an asphalt shoulder, a W-beam guardrail and a grass median. The right (south) roadside consisted of an asphalt shoulder, W-beam guardrail, ditch, grass, and several trees. An overpass was located near the crash site. The posted speed limit for the roadway was 97 km/h (60 mph). **Figure 2** is an eastbound view of the crash site. The NASS scene schematic is included as **Figure 15** of this report.
