Child Safety Seat Investigation / Vehicle to Vehicle
Dynamic Science, Inc. / Case Number: DS04001
2003 Toyota Corolla
California
January, 2004

1. Report No. DS04001		2. Government Accession No.		3. Recipient Catalog No.	
4. Title and Subtitle Child Safety Seat Investigation				5. Report Date October 28, 2004

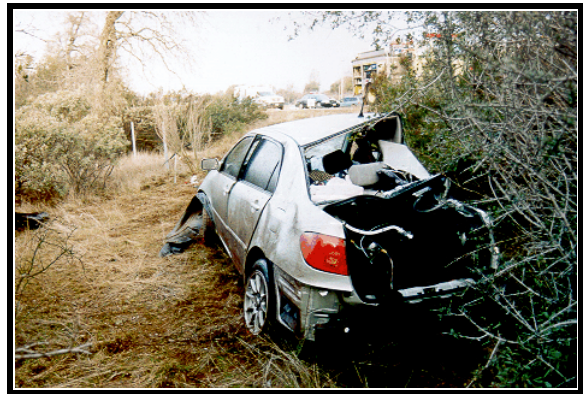
Figure 5. Final rest, Toyota Corolla

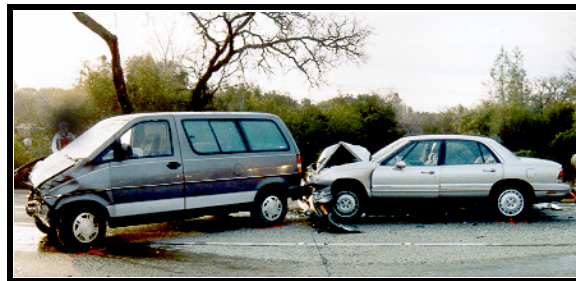
Figure 6. Final rest positions for Buick LeSabre and Ford Aerostar

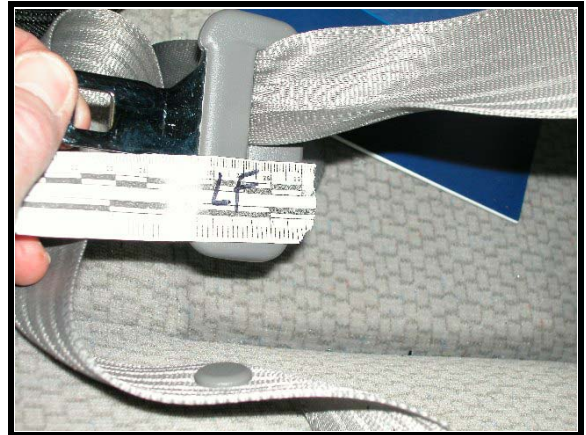
The Toyota Corolla was configured with manual 3-point lap and shoulder belts with sliding latch plates for all five seating locations. The front seat restraints were configured with adjustable shoulder belt anchorages with the driver's side adjusted to the mid position and the front right passenger's adjusted to the full down position. The driver's manual restraint was configured with an emergency locking retractor (ELR). The remaining restraints were configured with switchable retractors that were in the ELR mode. Both front restraints were equipped with seat belt pretensioners that actuated as a result of the impact with the 1997 Buick LeSabre.

Figure 11. Driver's seat belt

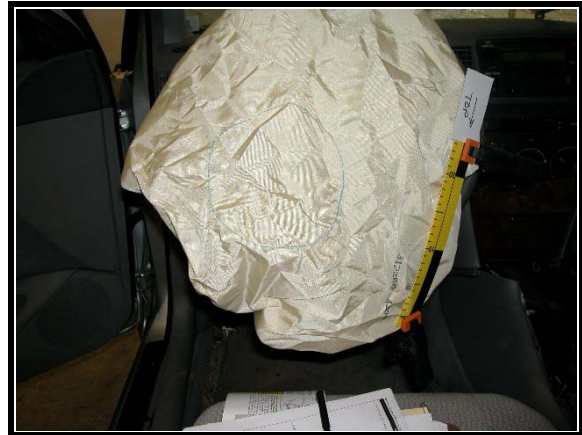
The Toyota Corolla was equipped with dual stage deployment frontal air bags that deployed as a result of the impact with the 1997 Buick LeSabre. The driver's air bag was housed in the steering wheel hub split H configuration cover flaps. The driver's air bag was circular in shape and measured 60.0 cm (23.6 in) in diameter in its deflated state. The air bag was vented by two circular ports located at the 11 and 1 o'clock positions on the rear aspect. The air bag was tethered by a single internal strap. There were no indications of damage or occupant contacts to either the air bag or the cover flaps.

Figure 13. Face of driver's air bag

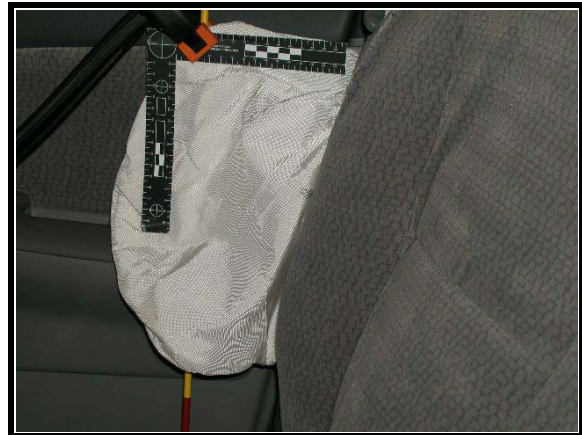
The Toyota Corolla was equipped with seat back mounted side air bags for the front seating positions. The front right passenger's side air bag deployed as a result of the impact with the Ford Aerostar van. This air bag was shaped in a half-circle that measured 31.0 cm (12.2 in) in height and projected forward 21.0 cm (8.3 in) at the apex of the circle. The air bag was not tethered and did not have any vents. There were no indications of damage or occupant contacts to the air bag.

Figure 15. Front right side air bag

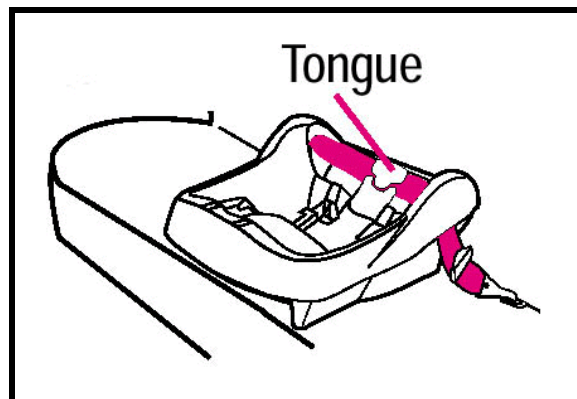
Figure 17. LATCH installation (Graco)

1. The passenger harness straps were folded at the point where they passed through the retaining clip reducing their width.
2. The carrier handle was in the full upright position.
3. There were toys hanging from the carrier handle above the head of the child. .

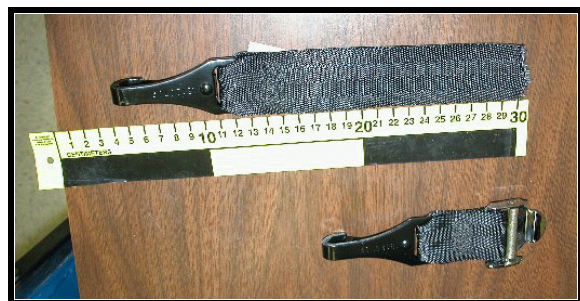
The Graco Quattro Tour child safety seat (Model Number: 7411LV, manufacture date 12/09/02, serial number JJ12090210165) is part of a three-piece set that includes the Quattro Tour stroller, the child car seat, and a stay-in-car base. The stroller was in the trunk at the time of the crash. The manufacturer recommends that the seat be used with children weighing 9 kg (20 lbs) or less and whose height is 66 cm (26 in) or less. The child in this crash weighed 9 kg (19 lbs), putting her in the high range recommended by the manufacturer. The child seat was placed in the right rear seat position in a rear-facing fashion. The seat was attached to the stay-in-car base, the locking handle was in the up position, and the seat was equipped with a 5-point harness which had been threaded through the bottom set of slots. The seat base is designed to allow four different recline positions. The recline position is not known. The seat base was anchored to the vehicle using the available Lower Anchors and Tethers for Children (LATCH) system. According to the police, the seat was being tightly held in place at the time of the crash. It was necessary for the investigating police agency to cut the LATCH tethers to remove the child seat.

Figure 18. LATCH tethers

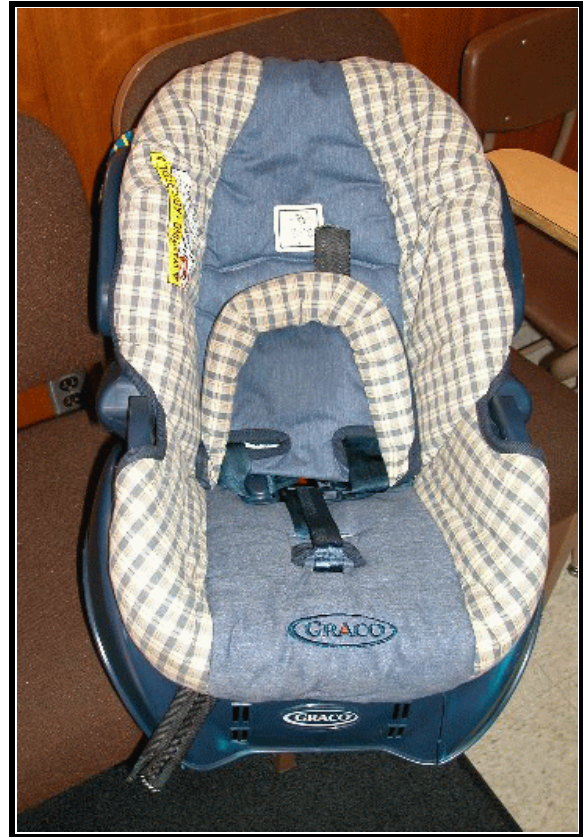
The right and left sides, as well as the front, of the base was cracked and deformed from the impact with the Ford and the resultant interior intrusion. The seat itself did not appear to have sustained any damage. There were no indications of any occupant contact to the inner seat shell.

Figure 19. Front of Graco child seat

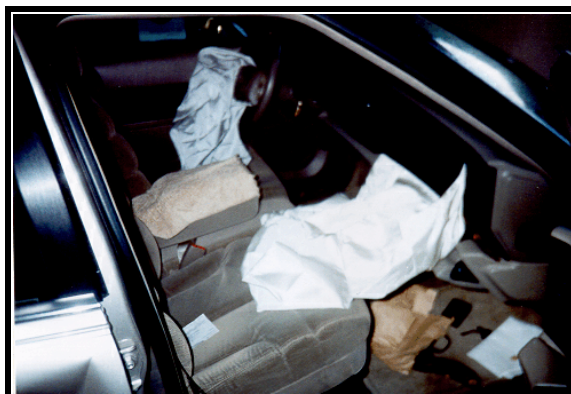
The driver of the Buick LeSabre saw the Toyota and began braking, depositing 29 m (96 ft) of locked wheel skids. He was unable to stop in time. The front of the Buick (12FDEW2) struck the front of the Toyota (01FDEW2). The front bumper and backing bar were both missing from the vehicle at the time of inspection. The total velocity change as calculated by the WinSmash program was 50.3 km/h (31.3 mph). The longitudinal and lateral delta V components were -43.6 km/h (-27.1 mph) and -25.2 km/h (-15.6 mph), respectively. Both front air bags in the Toyota deployed at this time. The driver and front right passenger seat belt pretensioners also both actuated. The front air bags in the Buick LeSabre deployed at this time.

Figure 25. Front air bags, Buick LeSabre

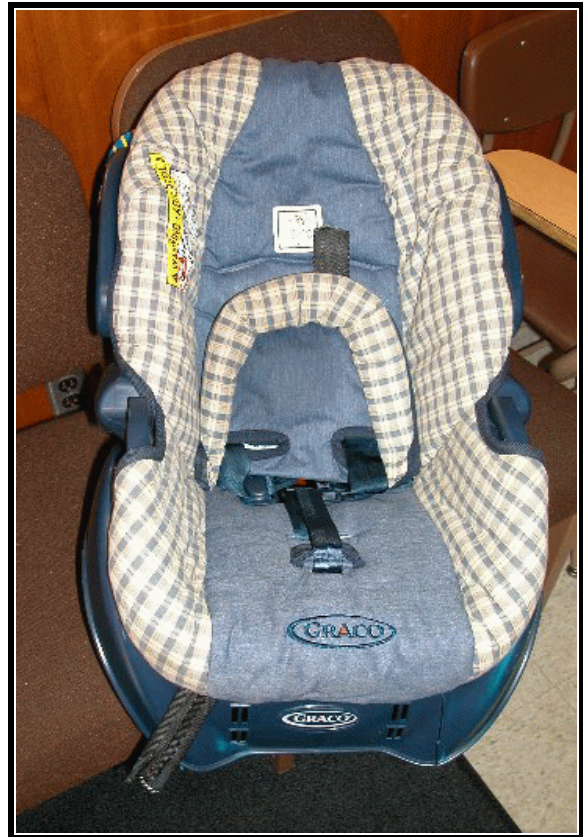
child seat interior with essentially the whole left side of her body. As the impact progressed, the right rear door intruded into and fractured the child seat exacerbating the left side injuries, including the clavicle and skull fractures. This occupant also sustained right side skull and rib fractures and lacerations to the spleen and liver. Given the amount of intrusion and the fact that the restraint remained in place, the injuries were a combination of impact and compression as the child safety seat was intruded on by the right door panel. At impact with the Buick, this occupant would have responded to the 1 o'clock direction of force by moving forward (with her back) and to the right.

Figure 28. Front of Graco child seat
