Advanced Occupant Protection System Investigation/ Vehicle to Vehicle
Dynamic Science, Inc. / Case Number: DS04003
2004 Chevrolet Silverado
Colorado
February 2004

| 4. Title and Subtitle Advanced Occupant Protection System Investigation | | 5. Report Date March 12, 2006 | |
| 16. Abstract This on-site investigation focused on the performance of the advanced occupant protection system that was installed in a 2004 Chevrolet Silverado pickup. The Chevrolet pickup was occupied by a 28-year-old male driver and a 31-year-old male front right passenger. This two vehicle angle/broadside type crash occurred within the confines of a four-leg intersection. The Chevrolet pickup was struck in the front right by a 1995 International 4900 three axle garbage truck. The impact resulted in sufficient longitudinal deceleration of the Chevrolet pickup to command the deployment of the frontal air bag system. The International truck continued forward, departed the roadway and struck a metal light pole. The Chevrolet pickup rotated in counterclockwise rotation and came to rest in the intersection. The driver and front right passenger in the Chevrolet pickup sustained neck strains. The front right passen

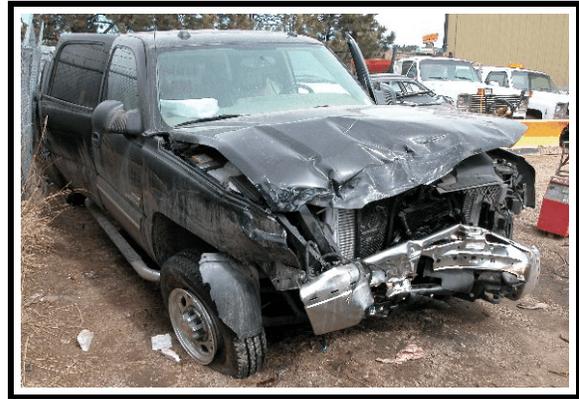
Figure 1. Front, 2004 Chevrolet pickup

Damage Description: The 2004 Chevrolet Silverado sustained moderate front end and right side damage as a result of the two impacts with the garbage truck. For the frontal impact, the direct damage began on the front right bumper corner and extended laterally 160.0 cm (62.9 in). The maximum crush was located at C4 and measured 33.0 cm (12.9 in). There were white and green paint transfers across the entire front end. Six crush measurements were documented at the bumper level as follows: C1 = 0 cm (0 in), C2 = 0 cm (0 in), C3 = 3.0 cm (1.2 in), C4 = 21.0 cm (8.3 in), C5 = 13.0 cm (5.1 in), C6 = 0 cm (0 in). For the side impact, the direct damage began 23.0 cm (9.0 in) forward of the rear axle and extended forward 119.0 cm (46.8 in) along the right side plane. Both right side doors were jammed shut. The right rear door was bowed outward. The front right rim was damaged and the tire was flattened

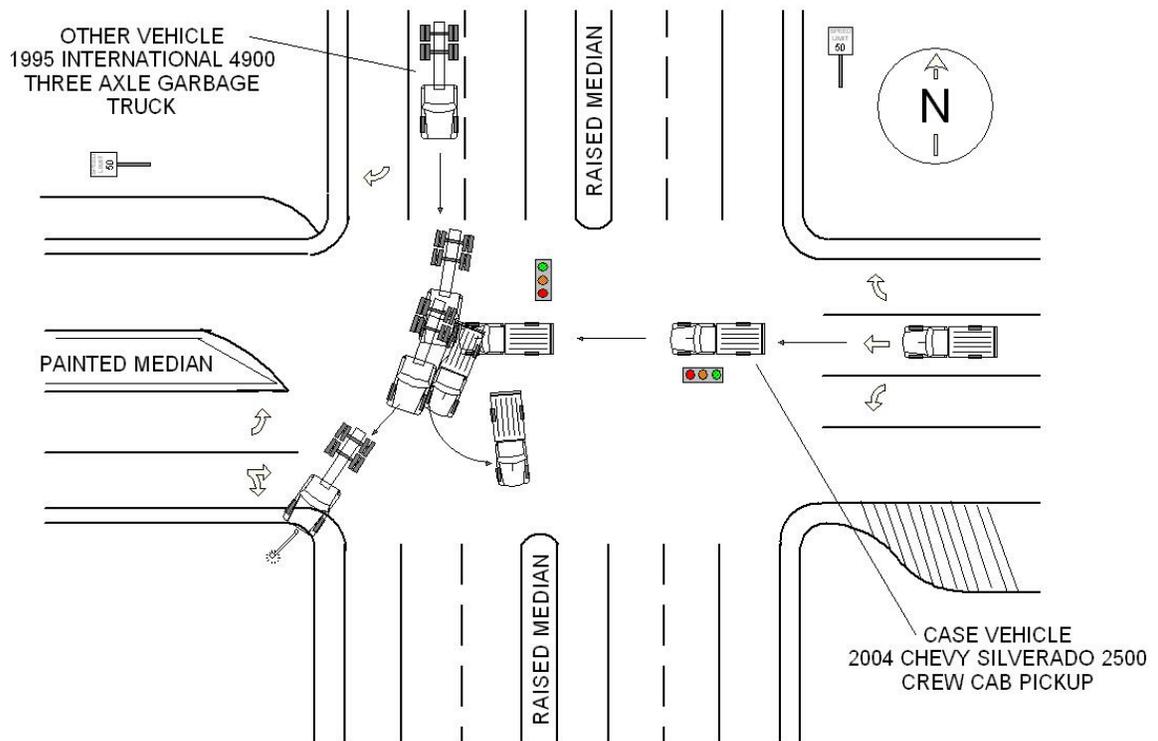
Scene Diagram

The front of the Chevrolet pickup struck (impact 1) the front left side of the International garbage truck. The impact was moderate and resulted in the deployment of the frontal air bag system. The barrier routine of the WinSmash program computed a total delta V of 12.0 km/h (7.5 mph), based on the pickup’s front end crush profile. After the initial impact, the Chevrolet pickup rotated counterclockwise and there was a second impact (side slap) between the right side of the pickup and the left side of the garbage truck. The Chevrolet pickup continued rotating counterclockwise until it had rotated 90 degrees from its original travel path. It came to rest facing west in the middle of the intersection 8.7 meters (28.4 ft) from the initial impact.

The garbage truck traveled 17.2 meters (56.5 ft) after impact, crossing through the intersection in a westbound direction. The garbage truck ran off the right side of the roadway, traveled 1.2 meters (4.0 ft) and struck a light pole on the southwest corner with its front end. The garbage truck came to final rest facing east.
