ON-SITE CERTIFIED ADVANCED 208- COMPLIANT VEHICLE INVESTIGATION

CASE NUMBER - IN-04-011
LOCATION - TEXAS
VEHICLE - 2003 CHEVROLET C1500 SILVERADO
CRASH DATE - April 2004

1. <i>Report No.</i> IN-04-011		2. <i>Government Accession No.</i>		3. <i>Recipient's Catalog No.</i>	
4. <i>Title and Subtitle</i> On-Site Certified Advanced 208-Compliant Vehicle Investigation Vehicle - 2003 Chevrolet C1500 Silverado Location - Texas			5. <i>Report Date:</i> August 16, 2007

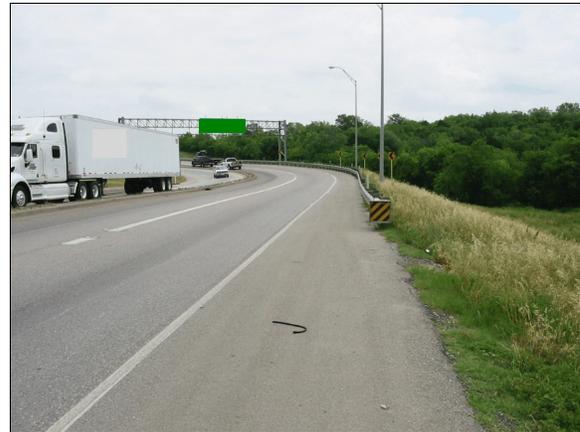
Figure 1: Case vehicle's eastward travel path on a divided State entrance/exit ramp, most likely in outside eastbound lane, approaching a "Y"-shaped split, within a left-hand curve, comprised of two Interstate entrance ramps (case photo #01)

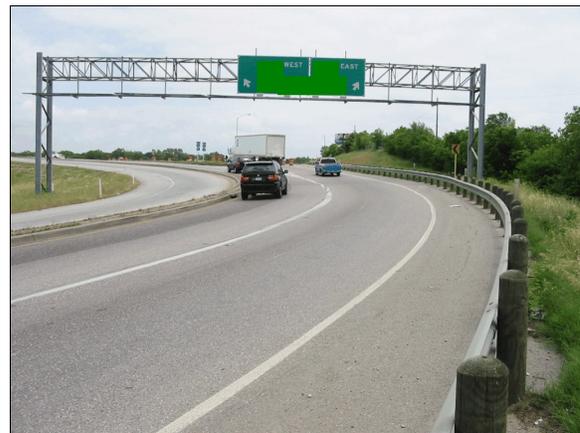
Figure 2: Case vehicle's east-northeasterly travel path, most likely in outside lane, in left-hand curving State entrance/exit ramp approaching a "Y"-shaped split where two Interstate entrance ramps begin (case photo #02)

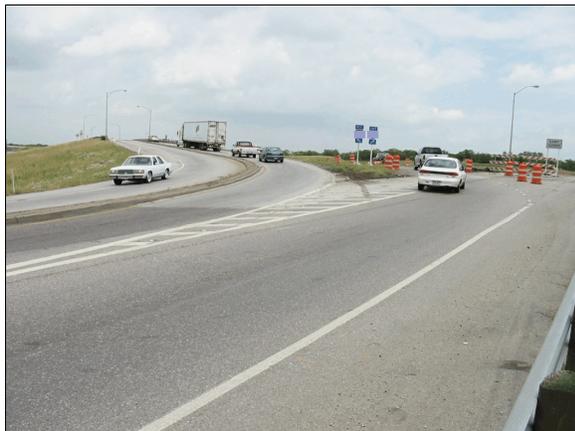
Figure 3: Case vehicle's travel path in left-hand curving "Y"-shaped split ramp showing gore area that separates the beginning of two Interstate entrance ramps; Note: physical evidence indicates that case vehicle traveled into gore area between entrance ramps, indicating that case vehicle was most likely in outside easterly lane of divided State ramp and swerved leftward from the eastern Interstate entrance ramp intending to travel northward on the western Interstate entrance ramp (case photo #03)

The state/interstate highway entrance/exit ramp was curved to the left for east-to-northbound traffic and had a 2.2% grade positive to the northeast (i.e., an upgrade in the case vehicle's direction of travel), near the area of impact (**Figure 3**). The pavement was bituminous, but polished, and the width of the northbound lane (i.e., at the area of impact) was 5.1 meters (16.7 feet) and the southbound lane was 4.4 meters (14.4 feet). The shoulders were improved (i.e., bituminous), with a 1.8 meter (5.9 foot) wide paved shoulder on the east side of the ramp trafficway and 2.8 meter (9.2 foot) wide shoulder on the west side of the trafficway. Both the western side of the northbound roadway and the eastern side of the southbound roadway had an approximate 0.15 to 0.20 meter (6-8 inch) wide shoulder prior to the raised, paved median discussed above. Neither roadway was bordered by curbs. Pavement markings consisted of a single solid yellow centerline and a solid white edge line for both the northern and southern roadways, augmented by yellow and white raised pavement markers placed along the center and

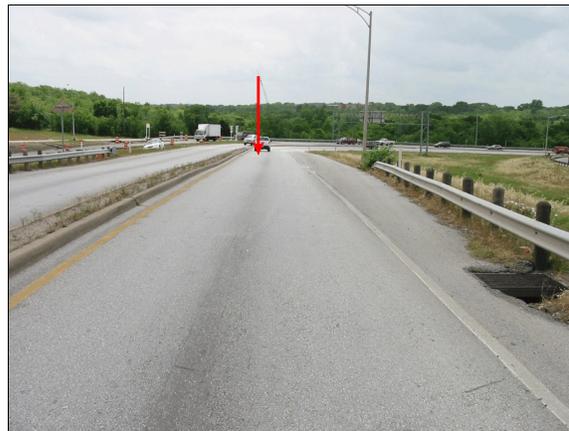
west through a right-hand curve. The median that separated these two roadways was 0.8 meters (2.6 feet) wide and was a raised [i.e., 17 cm (6.7 in)], unprotected, concrete type of median. The southbound roadway of the divided Interstate ramp was a one-lane exit ramp for an Interstate highway (**Figure 4**). This roadway approached a right-hand curve and then traveled westward becoming an entrance ramp for a State highway.

Figure 4: Ford's southward travel path on divided Interstate entrance/exit ramp showing approximate location (arrow) of impact with case vehicle in southbound lane (case photo #11)

Pre-Crash: Based on the available evidence, the case vehicle had been traveling east-to-north in the outside eastbound lane of the east-west entrance/exit ramp and intended to negotiate the left-hand curve and travel northward on the western entrance ramp to the Interstate highway (**Figure 5** above). The Ford was traveling south in the southerly lane of the southbound roadway and was approaching a right-hand curve (**Figure 4** above), intending to negotiate the curve and travel west on the entrance ramp to the State highway (**Figure 1** above). According to the Police Crash Report, the case vehicle's driver lost control while negotiating the left-hand curve. Based on the preponderance of the evidence, this contractor believes that the case vehicle's driver was most likely in the outside eastern lane and realized that he had to change lane to the left to negotiate the left-hand curve and travel on the western entrance ramp (**Figure 3** above). As a result the case vehicle traveled through the gore area and entered the dirt portion of the gore while the driver was steering leftward to re-enter the roadway (**Figure 5** above). As the case vehicle re-entered the roadway it was most likely in a counterclockwise yaw. The case vehicle traveled obliquely across the northbound roadway, mounted and crossed the median, and entered the southbound roadway (**Figure 6**). The case vehicle's driver steered to the right, attempting to avoid the crash. The crash occurred within the interchange area, in the through lane of the southbound roadway (**Figure 4** above). It should be noted that the exact location of the crash could not be determined.

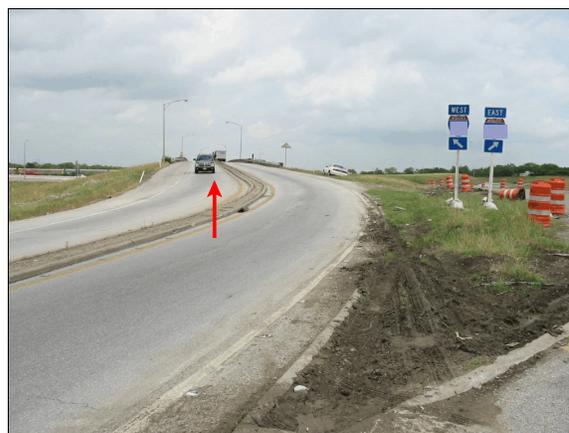
Figure 5: Case vehicle's travel path through gore area separating eastern and western Interstate entrance ramps; Note: case vehicle departs gore area in counterclockwise yaw prior to crossing median that divides western Interstate ramp and travels into ramp's southbound lane where it impacts (arrow) Ford (case photo #04)

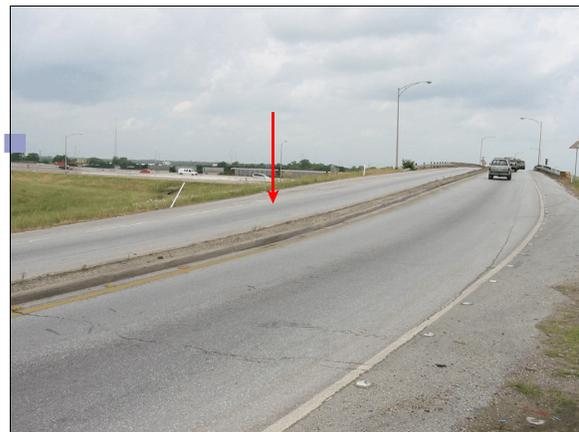
Figure 6: Case vehicle's north-northwesterly travel path from gore area across median into southern lane of divided Interstate entrance/exit ramp; Note: arrow indicates approximate impact area with Ford (case photo #05)

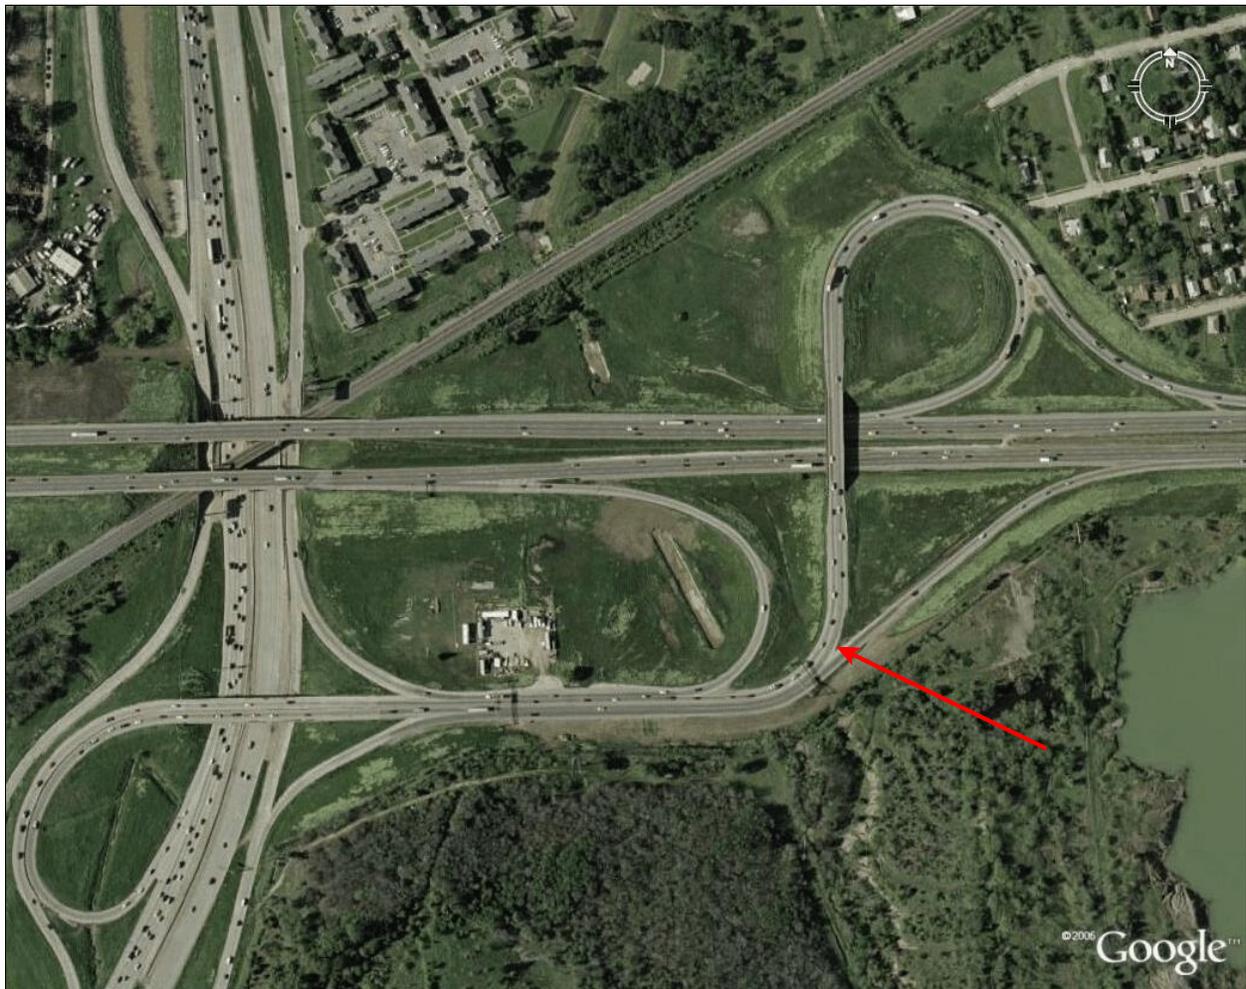
Crash Scene Overview: Red arrow indicates approximate site of crash. Major north-south trafficway is a State highway. Major east-west trafficway is an Interstate highway. Case vehicle entered the ramp complex from the State highway's northbound service road.
