INDIANA UNIVERSITY

ON-SITE CERTIFIED ADVANCED 208- COMPLIANT VEHICLE INVESTIGATION

CASE NUMBER - IN-04-021
LOCATION - TEXAS
VEHICLE - 2003 CHEVROLET C1500 TAHOE
CRASH DATE - May 2004

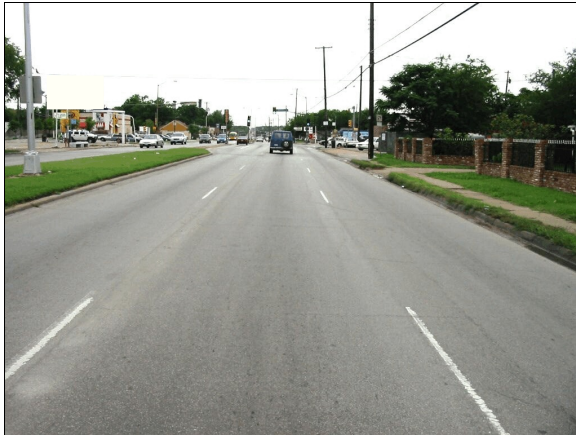
Figure 1: Case vehicle's westbound travel path in center through lane of western roadway of divided city trafficway (case photo #01)

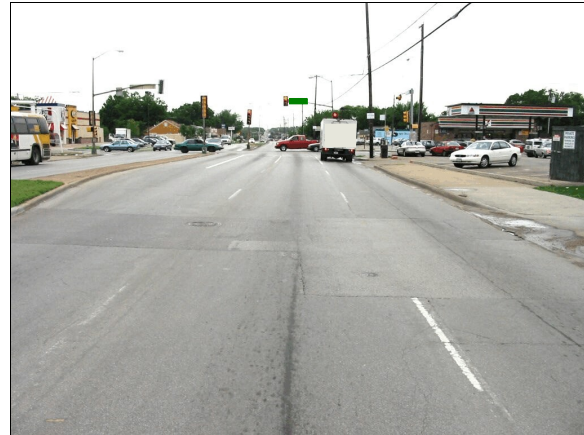
Figure 2: Case vehicle's westbound travel path in center through lane of western roadway near beginning of left-hand turn lane (case photo #01a)

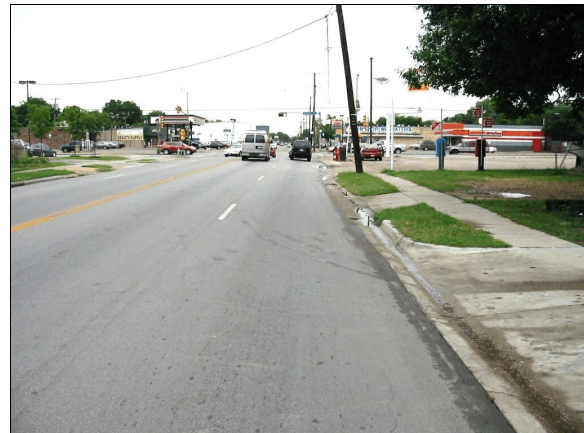
Figure 3: Chrysler's northbound travel path in outside northbound lane approaching four-leg intersection (case photo #11)

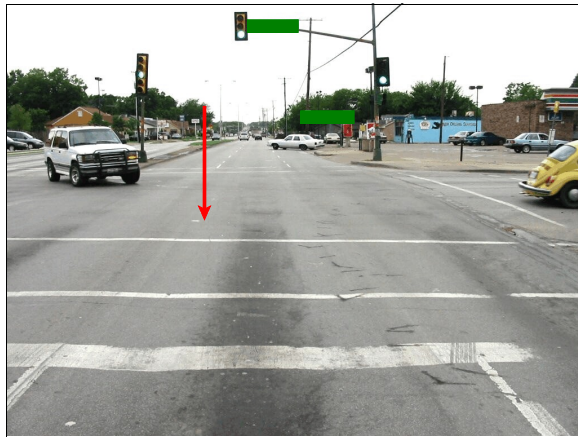
Figure 4: Case vehicle's westbound travel path in center through lane into four-leg intersection; arrow indicates approximate area of impact (case photo #03)

Pre-Crash: The case vehicle was traveling west in the center westbound through lane and intended to continue straight ahead (**Figure 4** above). The Chrysler was traveling north in the outside northbound through lane and intended to continue straight ahead (**Figure 5** above). Based on the available information, the case vehicle's driver braked, attempting to avoid the crash. The crash occurred in the four-leg intersection of the two trafficways.

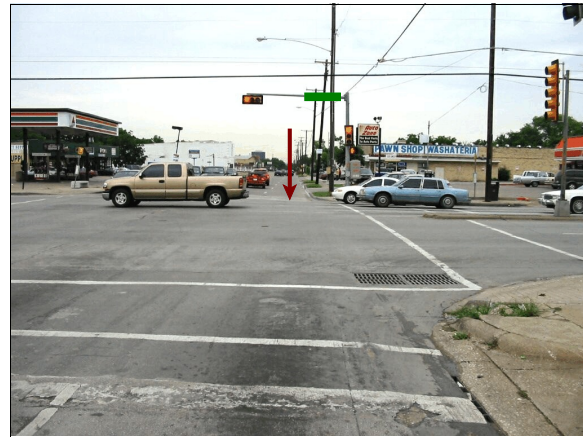
Figure 5: Chrysler's northern travel path in outside northbound lane just prior to four-leg intersection; Note: arrow shows approximate area of impact (case photo #13)

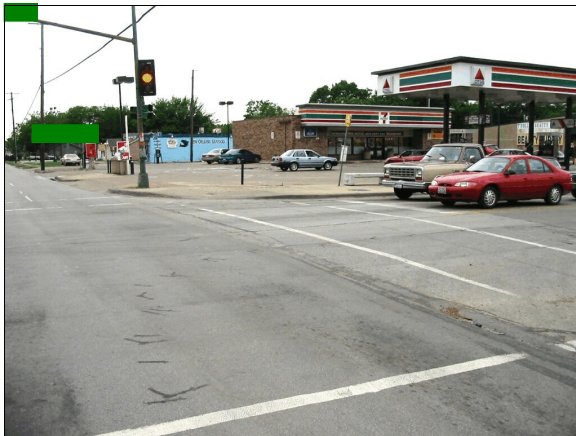
Figure 8: Case vehicle's post-crash travel path toward northwest corner of intersection viewed from center through lane at mouth of intersection (case photo #04)

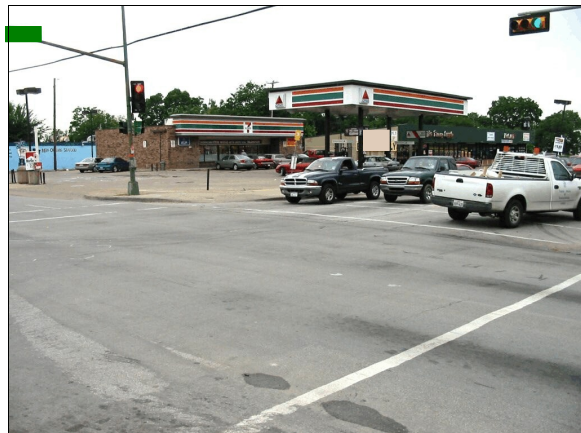
Figure 9: Chrysler's west-northwest travel path toward northwest corner of intersection following initial impact with case vehicle (case photo #14)

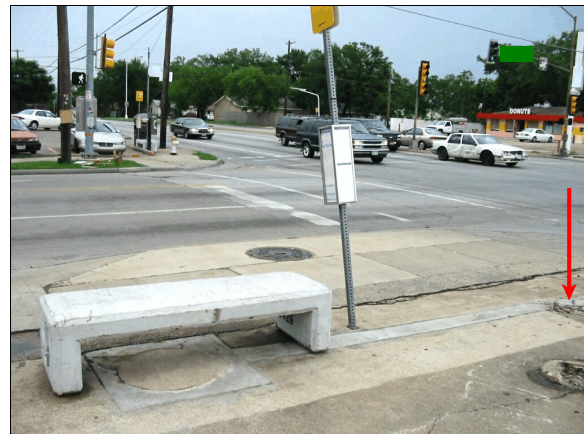
Figure 14: East-southeast view from case vehicle's approximate final rest position; Note: arrow indicates approximate impact with post and this contractor believes southeast corner of bench was on south side of bus stop sign post at time of crash (case photo #08)

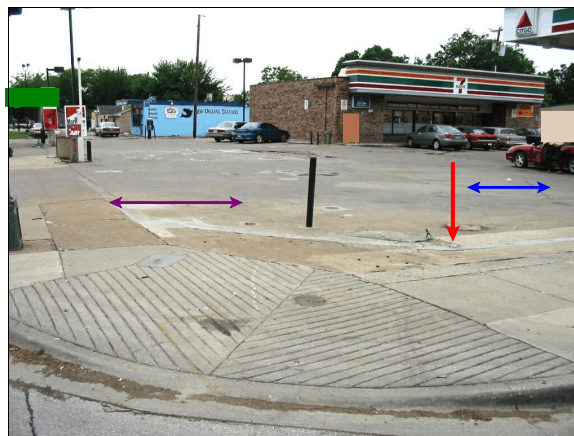
vehicle, the most likely scenario is that after the case vehicle departed the northwest corner of the intersection, the front left impacted a metal protective corner post (Figure 12–4th event–Note: metal post was not present during scene inspection) while at about the same time the front right bumper collided with the southeast corner of a concrete bus bench (Figure 11 and Figure 13 below–5th event). Once again, neither of the case vehicle’s frontal air bags deployed. The case vehicle moved the bench clockwise as it continued along its west-northwest travel path. Furthermore, the bus stop sign post (Figure 14 below–Note: bus stop sign post has most likely been replaced since crash because current post shows no damage) impacted the right rear portion (Figures 15 and 16 below–6th event) of the case vehicle as the case vehicle continued forward. The case vehicle came to rest in the convenience store parking lot, heading northwest (Figure 17 below).

Figure 17: Northwest corner of intersection showing case vehicle's impact with post—red arrow, case vehicle's approximate final rest location—blue arrows, and Chrysler's approximate final rest location—purple arrows (case photo #16)
