CALSPAN ON-SITE CHILD SAFETY SEAT CRASH INVESTIGATION

CASE NO: CA04-054

VEHICLE: 2003 SATURN ION

CRASH DATE: NOVEMBER 2004

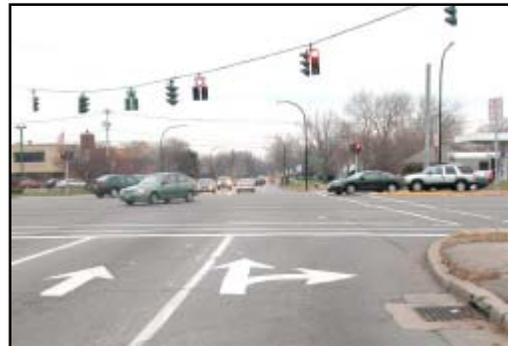
Figure 3. Northbound approach for the 2003 Saturn Ion

The 2003 Saturn Ion was traveling in the outboard northbound lane through the four-leg intersection. The 30-year-old female driver of the Saturn brought the vehicle to a controlled stop at the intersection as the traffic signal for northbound traffic was in the red phase (**Figure 3**). She proceeded into the intersection as the traffic signal cycled to the green phase, evidenced by the steady increase in pre-crash vehicle speed, throttle position, and engine speed that was reported in the EDR summary. The 43-year-old male driver of the Freightliner tank truck was operating the vehicle in the inboard westbound lane (**Figure 4**). The truck's pre-crash speed was unknown. As the Saturn traversed the four eastbound lanes, she may not have seen the approaching truck if traffic was stopped in the westbound left turn lane, or may have seen the truck but anticipated the driver would bring the truck to a controlled stop. For unknown reasons, the driver of the tank truck proceeded into the intersection against the red traffic signal. When the driver of the Saturn detected the approaching truck, she applied the brakes. The EDR-reported speed one second prior to impact was 35 km/h (22 mph). Brake application was based on the EDR pre-crash data, which showed the brake switch circuit status as "on", one second prior to impact. Although police reported that the driver of the tank truck applied the brakes in full-lockup prior to impact, which resulted in approximately 2 m (6') of pre-impact tire marks in the travel lane, there was no evidence present during the SCI scene documentation.

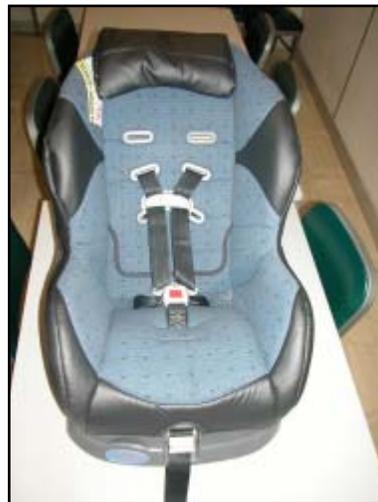
Figure 15. Graco Comfort Sport Convertible CSS

A convertible Graco Comfort Sport CSS (**Figure 15**) was positioned in the rear right seat of the Saturn Ion. The model number was 8432 BLK and the date of manufacture was July 29, 2003. The convertible CSS was configured with a five-point harness system and a two-piece, locking harness retainer clip. The outboard side panels of the CSS extended 14 cm (5.5") forward of the CSS seat back, which provided lateral protection to the child. The CSS was also equipped with a leather pillow that was attached to the top aspect of the CSS seat back by a leather strip that closed with Velcro. The leather strap measured 3 cm (1.0") in width and 13 cm (5.0") in length. The pillow measured 15 cm (6.0") in height, 28 cm (11.0") in width, and 4 cm (1.5") in thickness. The CSS was rated for children who weighed between 2 and 18 kg (5 – 40 lb) and are between 48 and 102 cm (19 – 40") in height. The child's height was 71 cm (28") and his weight was 10 kg (22 lb), which was within the manufacturer's recommended height and weight guidelines. A label on the CSS outlined the recommended use of the CSS as follows:

The CSS sustained minor damage as a result of the crash. The left side plastic circular tray shield housing integrated into the plastic shell (this CSS model not equipped with a tray shield) sustained minor deformation from engagement against the right rear door interior (**Figure 18**). The damaged plastic was located 5 cm (2.0”) forward of the rear aspect of the CSS and 19 cm (7.5”) below the top of the CSS seat back. Two very small and faint stress marks were present on the outboard aspect of the left side of the CSS under the fabric cover. The forward aspects (in relation to the CSS) of the inboard and outboard rear-facing belt path sustained minor deformation of the plastic from loading against the LATCH webbing. The harness straps did not exhibit any deformation from the crash, although historical wear was evident.

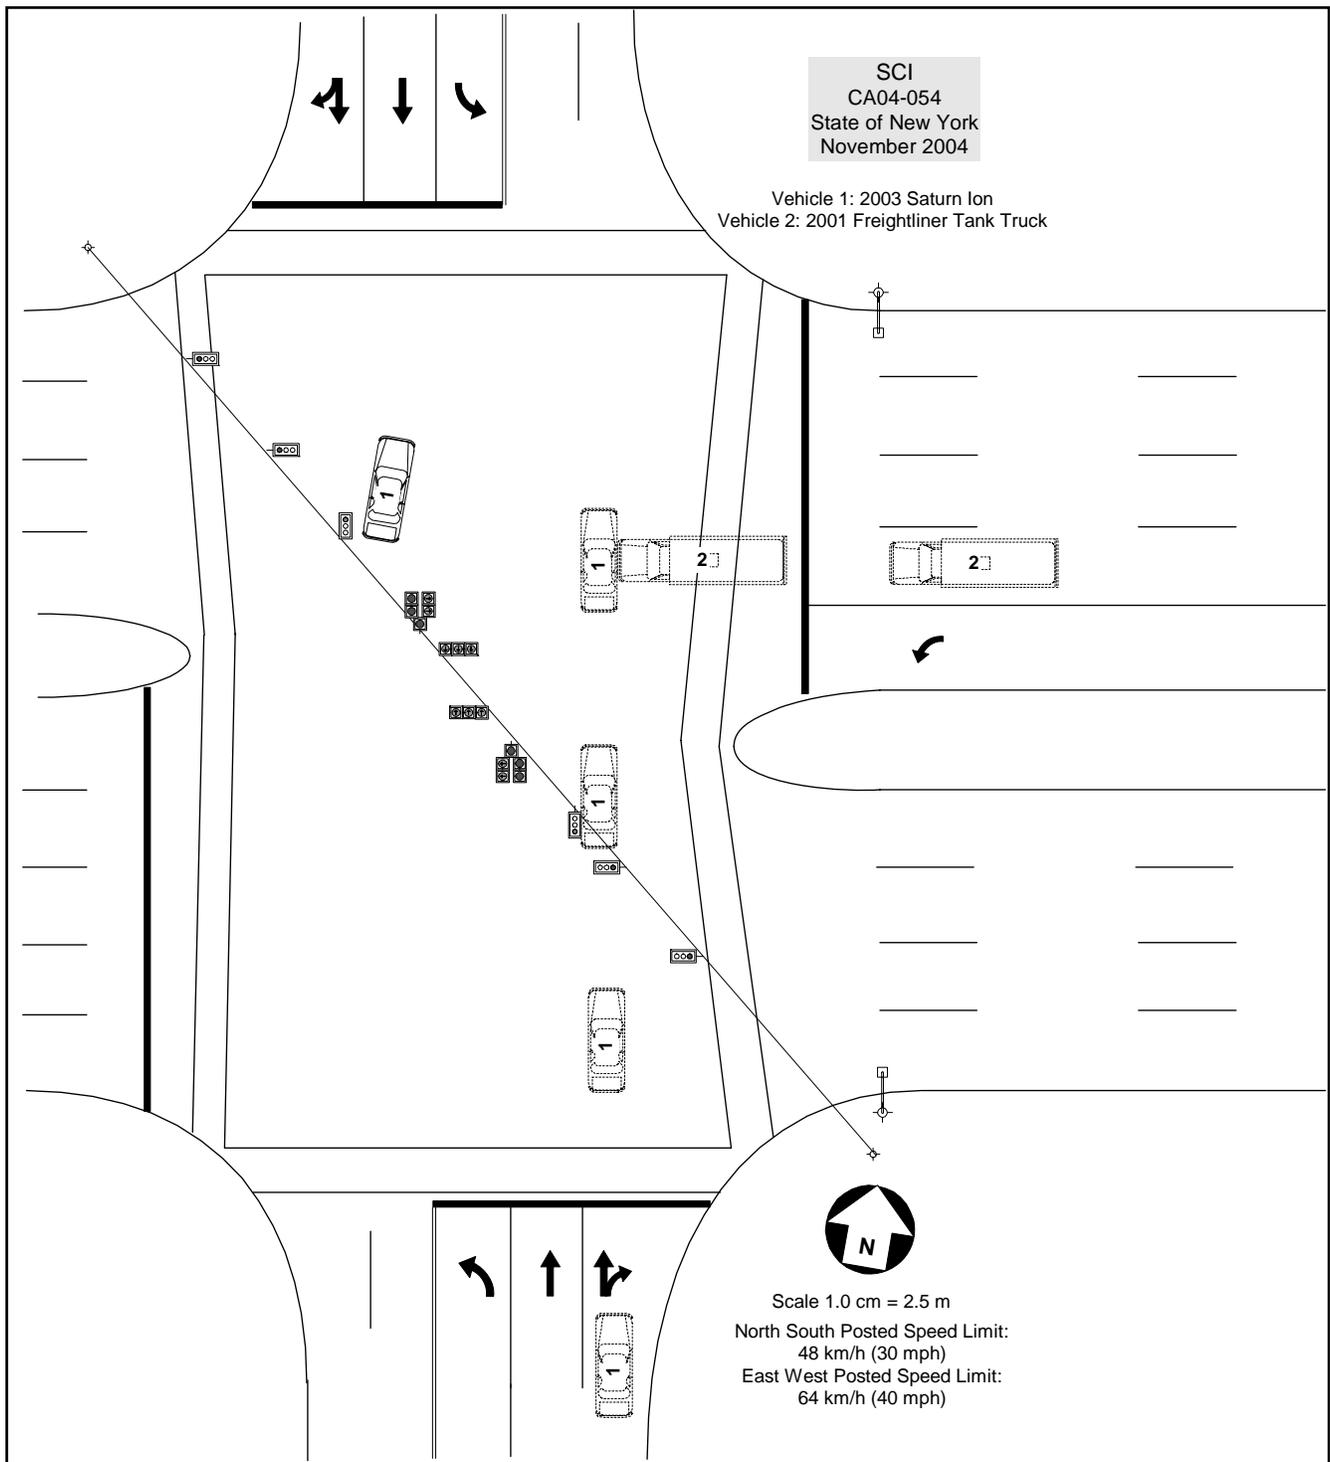
Figure 18. Scene schematic

south legs of the intersection to accommodate center left turn lanes, and painted white arrows identified the left/right turn and through lanes. The east/west roadway was configured with four lanes in each direction that were separated by a raised concrete median. The median narrowed on approach to the intersection to accommodate left turn lanes. Traffic flow through the intersection was controlled by overhead three-phase traffic signals. Each left turn lane (all intersection legs) was also controlled by a separate three-phase left turn signal. The posted speed limit for the north/south roadway was 48 km/h (30 mph) and the posted speed limit for the east/west roadway was 64 km/h (40 mph). The scene schematic is included as **Figure 18** at the end of this narrative report.

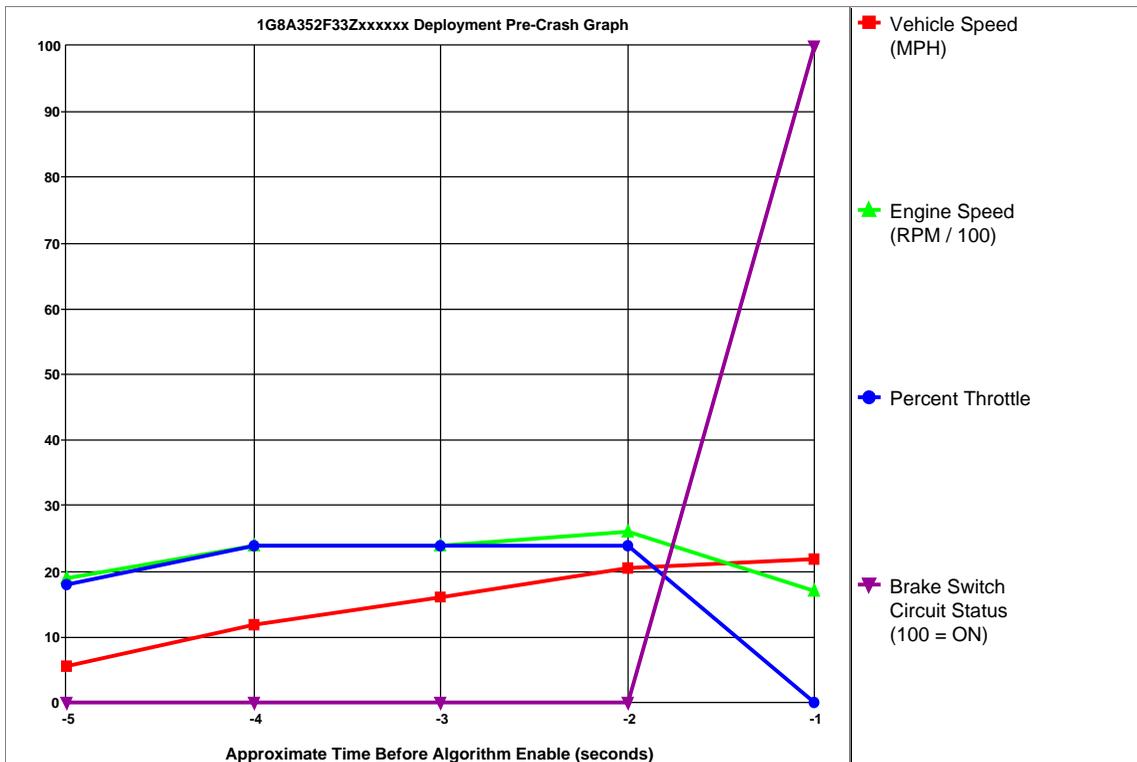
Seconds Before AE	Vehicle Speed (MPH)	Engine Speed (RPM)	Percent Throttle	Brake Switch Circuit Status
-5	6	1856	18	OFF
-4	12	2432	24	OFF
-3	16	2432	24	OFF
-2	21	2560	24	OFF
-1	22	1664	0	ON

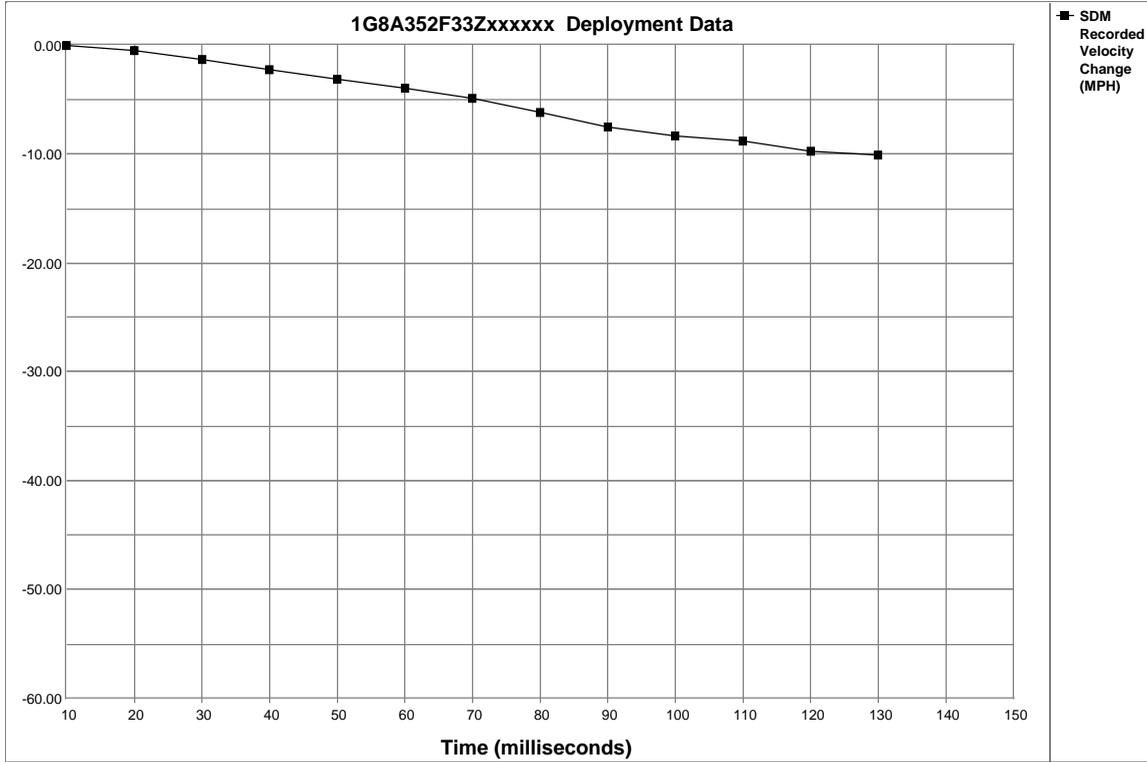
Time (milliseconds)	10	20	30	40	50	60	70	80	90	100	110	120	130	140	150
SDM Recorded Velocity Change	0.00	-0.44	-1.32	-2.19	-3.07	-3.95	-4.83	-6.14	-7.46	-8.34	-8.78	-9.65	-10.09	N/A	N/A
