### SCI/NASS COMBINATION DRIVER AIR BAG- RELATED SERIOUS INJURY INVESTIGATION

CASE NUMBER - 2005-50-175J  
LOCATION - Texas  
VEHICLE - 2004 VOLVO S60  
CRASH DATE - December 2005

Submitted:  
December 6, 2006  
Revised:  
April 21, 2008

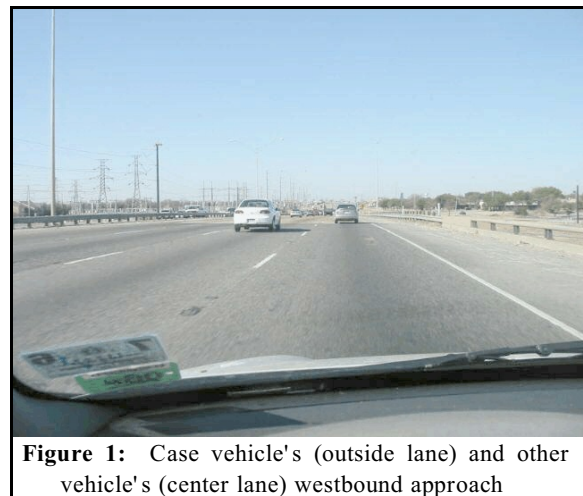
Both vehicles were traveling westward in the westbound lanes of a divided urban expressway (**Figure 1**), with the case vehicle in the outside lane and the tractor-trailer in the adjacent center through lane, abreast of one another. It was daylight, the weather was clear and the road surface was dry and free of defects. The speed limit for both vehicles was 97 km.p.h. [60 m.p.h.]. There is no evidence that either vehicle's driver attempted any avoidance maneuver. The crash sequence began in the outside westbound lane.
