TRANSPORTATION RESEARCH CENTER

ON-SITE CERTIFIED ADVANCED 208- COMPLIANT VEHICLE INVESTIGATION

CASE NUMBER - IN-05-008
LOCATION - OHIO
VEHICLE - 2005 CADILLAC ESCALADE
CRASH DATE - January 2005

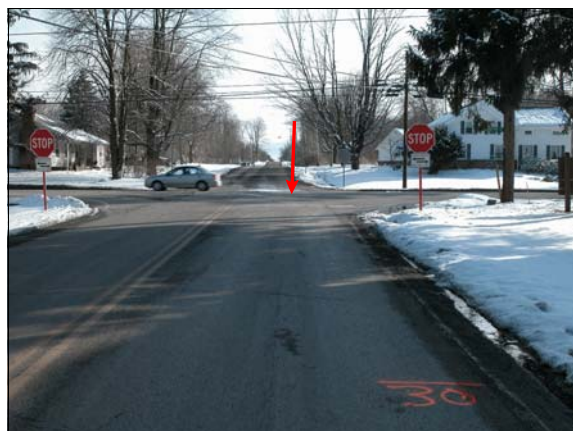
Figure 1: Approach of case vehicle southbound to area of impact, indicated by arrow, number shows meters to impact area

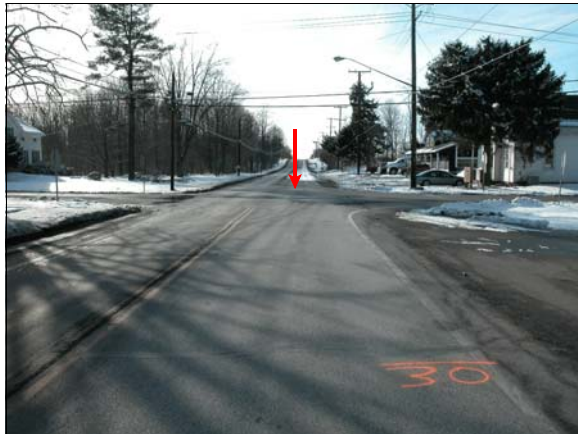
Figure 2: Approach of Jeep westbound to area of impact, indicated by arrow

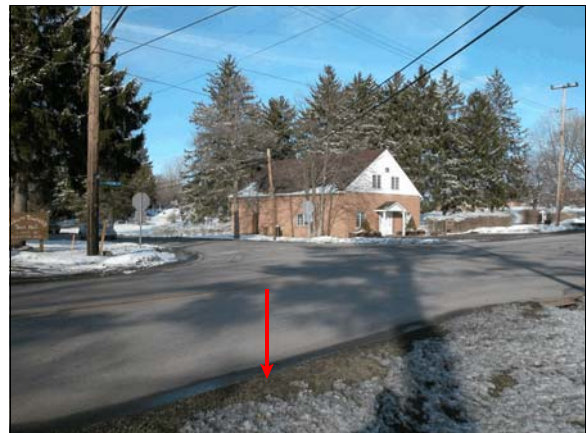
Figure 5: View northeast through case vehicle's area of final rest (arrow) back to area of impact in intersection

Post-Crash: As a result of the impact, the case vehicle rotated counterclockwise about 150 degrees while traveling southwest across the intersection into the west leg of the intersection. The case vehicle continued southwest and came to rest partially off the south side of the roadway (**Figure 5**) facing northeast. The impact with the case vehicle caused the Jeep to rotate counterclockwise. The police crash schematic shows the Jeep at final rest in a parking lot on the northwest corner of the intersection facing northwest (**Figure 6**). This final rest location is not consistent with the crash forces acting on the vehicle. The case vehicle's driver stated the Jeep was in this location immediately after the crash. The Jeep's driver most likely drove the vehicle to this position following the impact.

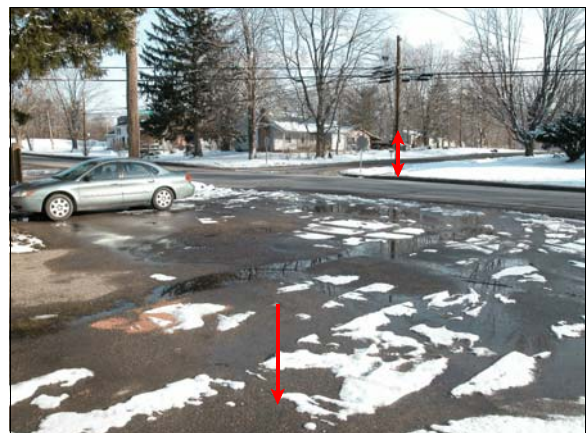
Figure 6: View southeast through area of Jeep's final rest (arrow) back to the intersection, double head arrow shows area of rest of case vehicle

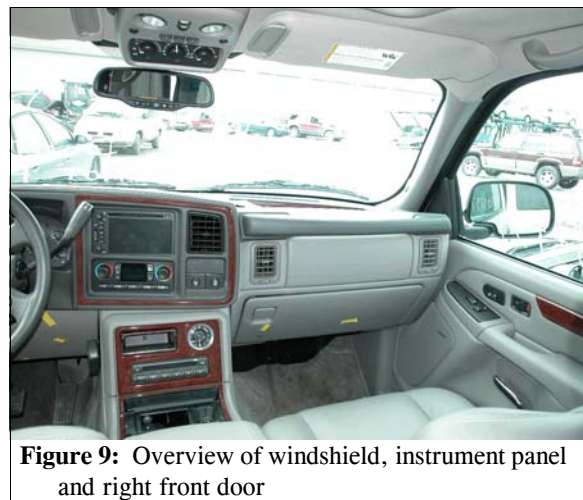
Vehicle Interior: Inspection of the case vehicle’s interior (**Figures 8 and 9**) revealed three small possible occupant contact scuffs on the driver’s right knee bolster. Two small possible occupant contact scuffs were observed on the glove box door, and one small scuff was observed on the right rear door armrest. In addition, there was a scuff on the left front window (**Figure 10** below) that appeared to be due to contact by the deploying seat back-mounted side impact air bag.

Figure 9: Overview of windshield, instrument panel and right front door

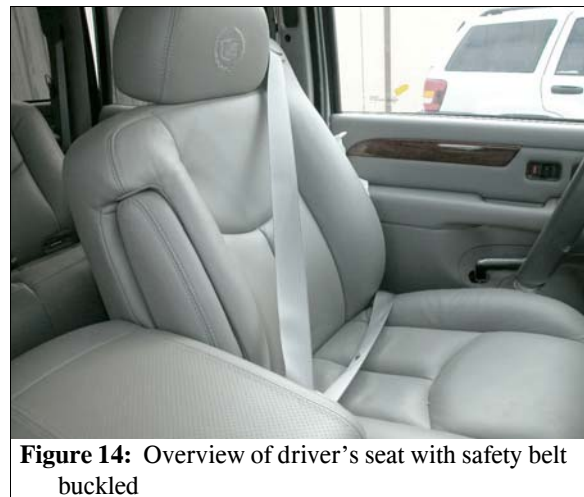
Figure 14: Overview of driver's seat with safety belt buckled

to the middle position and her seat back was slightly reclined (**Figure 14** above). The driver did not know the position of her tilt steering wheel. However, based on the vehicle inspection, the tilt steering wheel was most likely located between its center and full down position. In addition, the position of the power adjustable pedals is not known. The driver was not aware the case vehicle had adjustable pedals. The driver was wearing a heavy winter coat at the time of the crash. Lastly, the driver was not wearing glasses at the time of the crash.

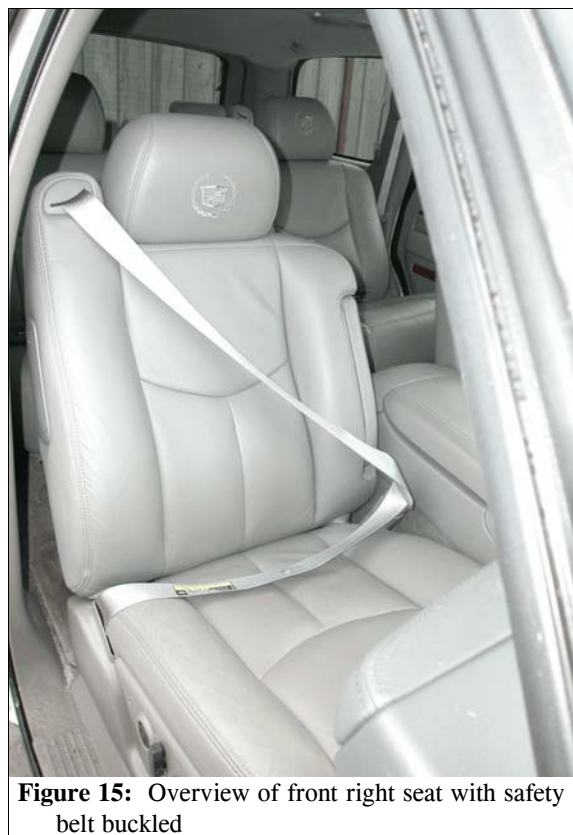
Immediately prior to the crash the case vehicle's front right passenger [13-year-old, White (non-Hispanic) female; 160 centimeters and 36 kilograms (63 inches and 80 pounds)] was seated upright with both feet on the floor and her back against the seat back. The position of her hands is not known. Her seat track was adjusted to the middle position and the seat back was slightly reclined (**Figure 15**). The passenger was wearing a heavy winter coat at the time of the crash.

Figure 15: Overview of front right seat with safety belt buckled

integral, three-point, lap-and-shoulder safety belt system. Inspection of the safety belt assembly revealed some use scratches on the latch plate indicating some prior usage; otherwise, the safety belt system was unremarkable.

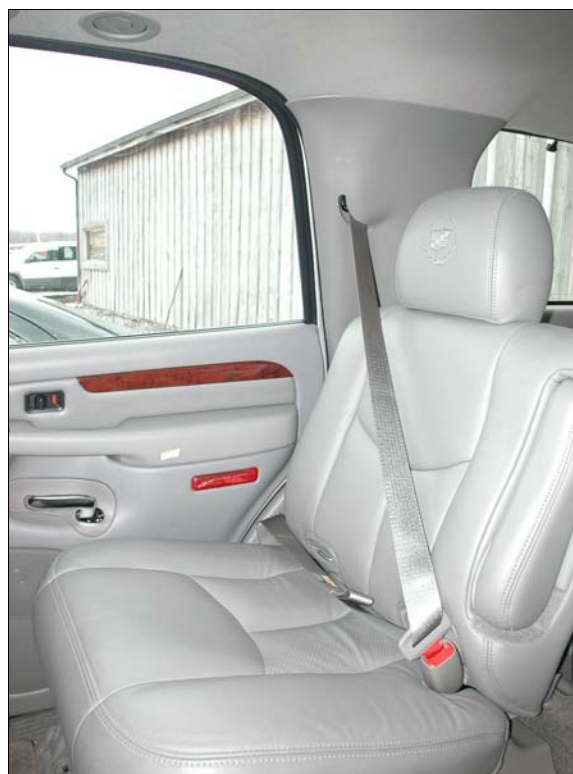
Immediately prior to the crash the case vehicle's second seat row, right passenger [11-year-old, White (non-Hispanic) male; 142 centimeters and 32 kilograms (56 inches and 70 pounds)] was seated upright with both feet on the floor and his back against the seat back. The position of his hands is not known. His seat track was not adjustable, and the seat back was slightly reclined (**Figure 16**). The passenger was wearing a heavy winter coat at the time of the crash.

Figure 16: Overview of case vehicle's second row, right seat with safety belt buckled

direction of principal force as the case vehicle decelerated longitudinally and accelerated latterly. The passenger remained in his seat and moved back to his right as the case vehicle rotated counterclockwise to final rest. A scuff was observed on the right rear door arm rest during the vehicle inspection; however, it was most likely not an occupant contact mark. The passenger was able to exit the case vehicle under his own power through the right rear door.

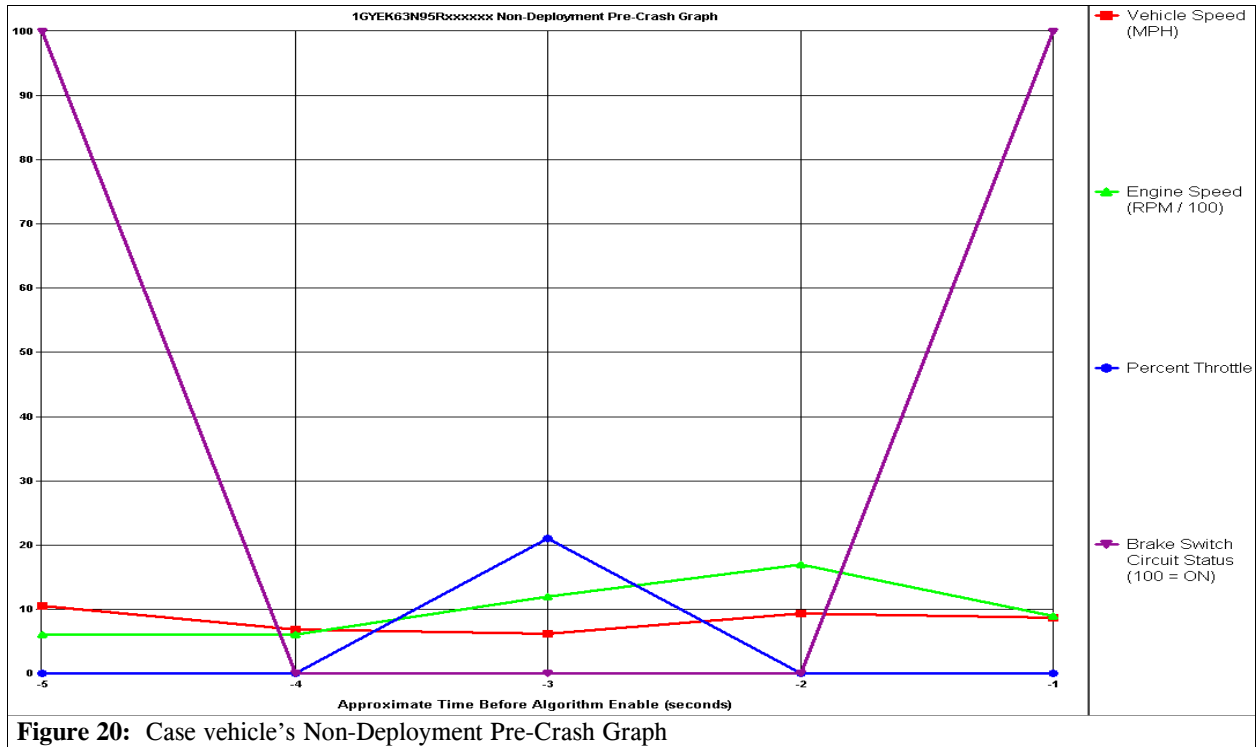
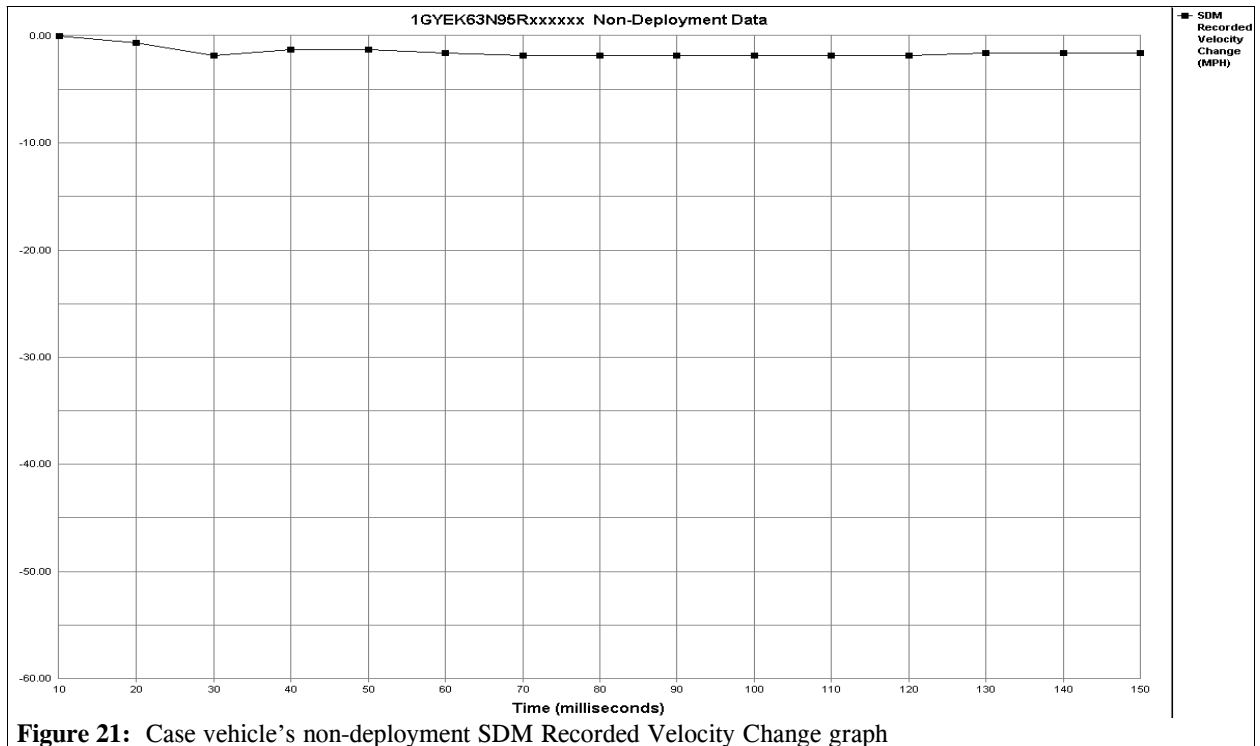
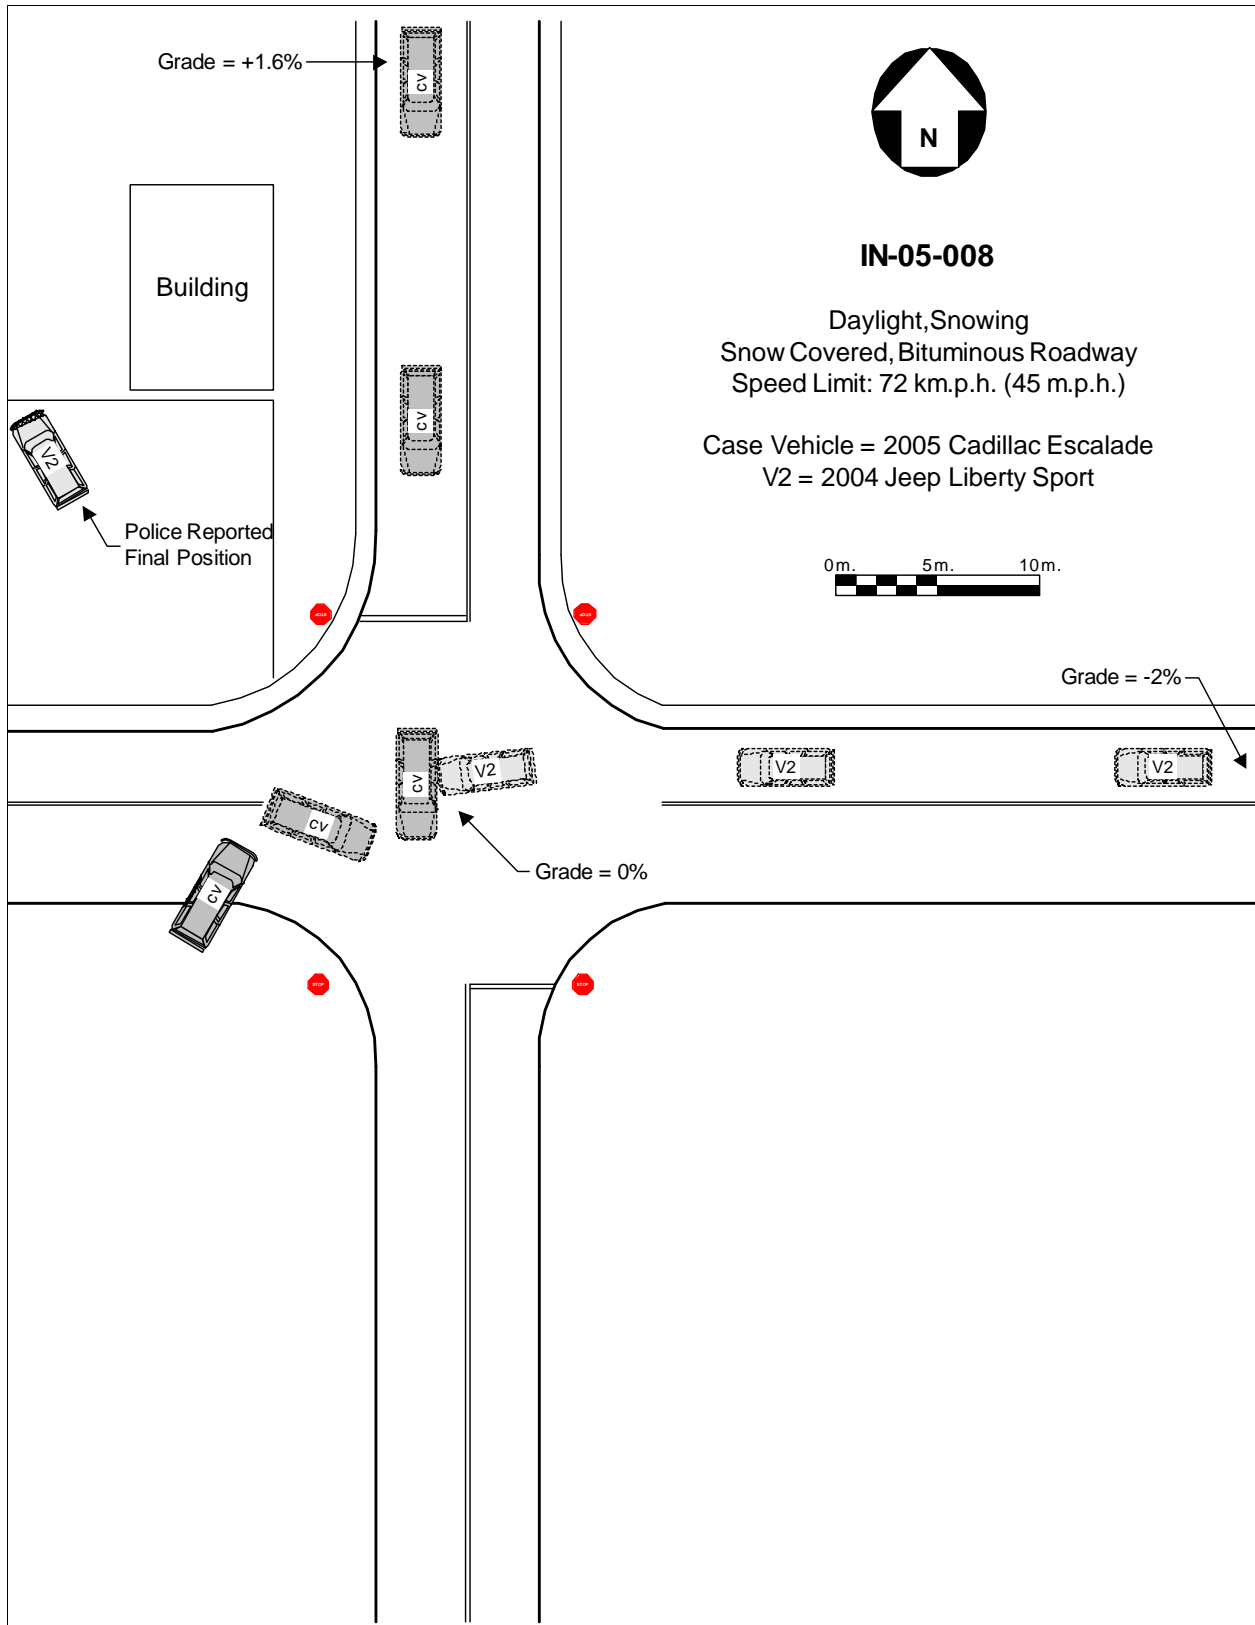
Due to the damaged sheet metal folds in the floor pan under the driver's seat from the side impact, it was necessary to remove the SDM from the case vehicle to accomplish the download. The EDR recorded a non-deployment event. The EDR reports are presented at the end of this report (**Figures 19 - 21**). The system status report indicated the SIR warning lamp was off, and the driver's seat belt switch circuit was recorded as unbuckled. The maximum SDM recorded longitudinal velocity change was recorded as -2.19 km.p.h. (-1.36 m.p.h.) occurring 27.5 milliseconds (0.0275 seconds) after algorithm enable. In addition, the system status report shows that event recording was complete, and there were no multiple events associated with the record. The pre-crash data indicated the brake switch circuit was on five seconds prior to algorithm enable, off for the next three one second sample periods and then on again at one second prior to algorithm enable.
