ON-SITE CHILD SAFETY SEAT INVESTIGATION

CASE NUMBER - IN-05-009

LOCATION - WISCONSIN

VEHICLE - 2004 CHEVROLET VENTURE

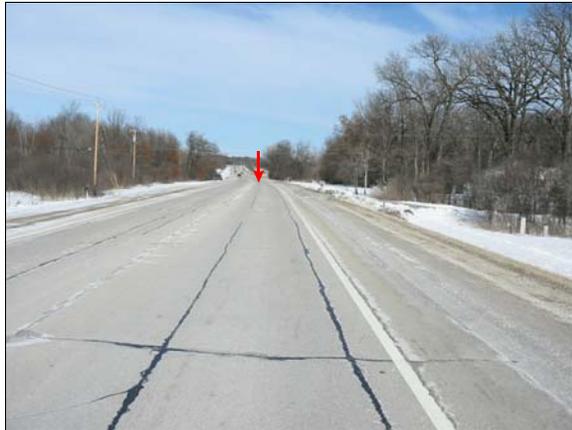
Pre-Crash: The case vehicle was traveling northeast in the northeastbound lane (**Figure 1** below). The case vehicle's driver was intending to continue straight ahead. The Pontiac was traveling

Figure 1: Approach of case vehicle northeastbound to area of impact (arrow) in northeastbound lane

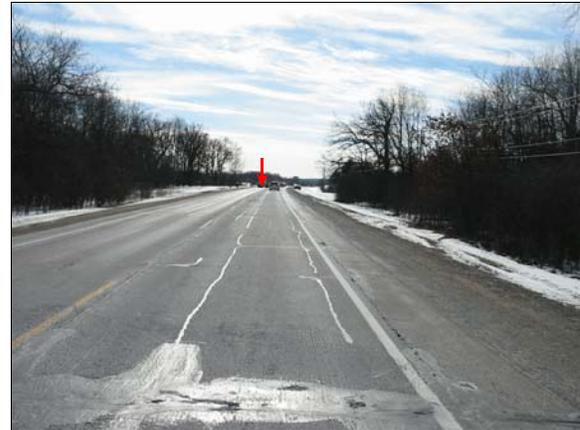
southwest in the southwestbound lane (**Figure 2**). The Pontiac's driver was most likely intending to continue straight ahead. The Pontiac crossed the centerline and entered the case vehicle's travel lane. The case vehicle's driver attempted to avoid the crash by steering right and braking. The crash occurred in the northeastbound lane of the roadway (**Figure 3**).

Figure 2: Approach of Pontiac southwestbound to area of impact (arrow) in northeastbound lane

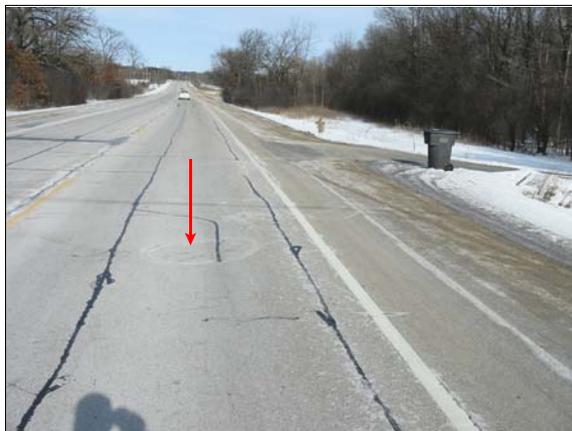
Figure 3: Overview of impact area from case vehicle's approach, arrow shows impact gouges

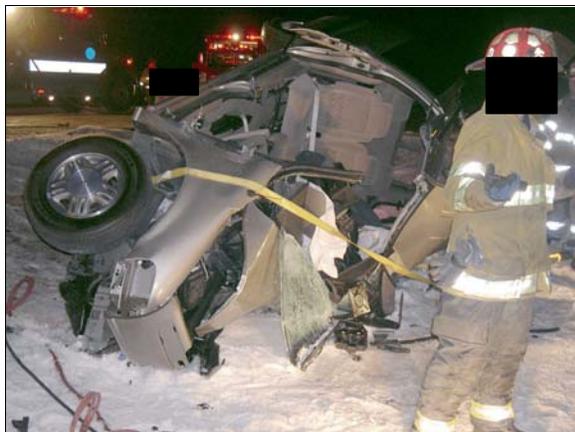
side heading southwest (**Figure 6**). The impact caused the Pontiac to rotate counterclockwise approximately 150 degrees. It came to final rest partially over the centerline heading east (**Figure 7**).

Figure 6: Police on-scene photo showing rest position of case vehicle, view to north

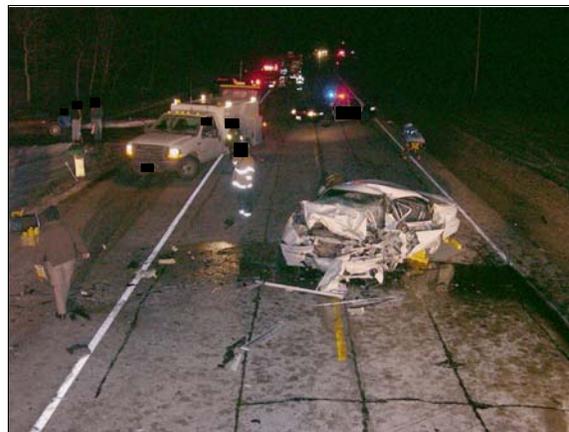
Figure 7: Police on-scene photo showing rest position of Pontiac, view to southwest

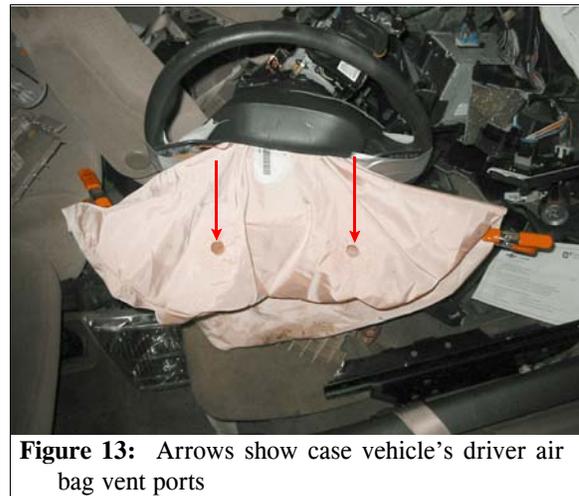
Figure 13: Arrows show case vehicle's driver air bag vent ports

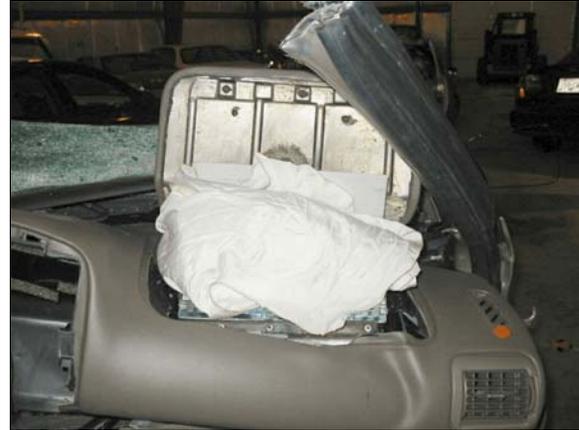
The front right passenger's air bag was located in the top of the instrument panel (**Figure 15** below). An inspection of the front right passenger air bag module cover flaps and the air bag's fabric revealed that the cover flaps opened at the designated tear points. There was no evidence of damage during the deployment to the air bag or the cover flap. The single cover flap was approximately rectangular and constructed of metal with a vinyl cover. The cover flap was 40 centimeters (15.7 inches) in width and 24 centimeters (9.5 inches) in height. The deployed

Figure 15: Location of front right air bag in top of instrument panel

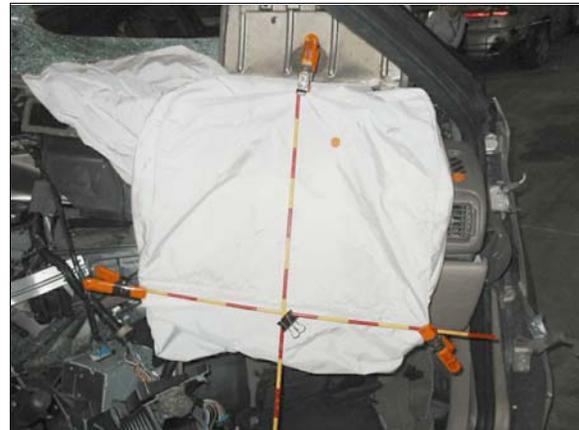
front right air bag (**Figure 16**) was square with a height and width of approximately 52 centimeters (20.5 inches). The air bag was designed with two wide tethers, each approximately 20 centimeters (7.9 inches) in width. The front right passenger's air bag had two vent ports, approximately 3 centimeters (1.2 inches) in diameter, located at the 9:30 and 2:30 clock positions. An inspection of the air bag fabric revealed a 12 centimeter (4.7 inches) scuff on the air bag's lower left side, just below the lower tether stitching. Also noted was a small stress mark (a near puncture) near the center of the air bag and just above the top tether stitching.

Figure 16: Case vehicle's front right passenger air bag

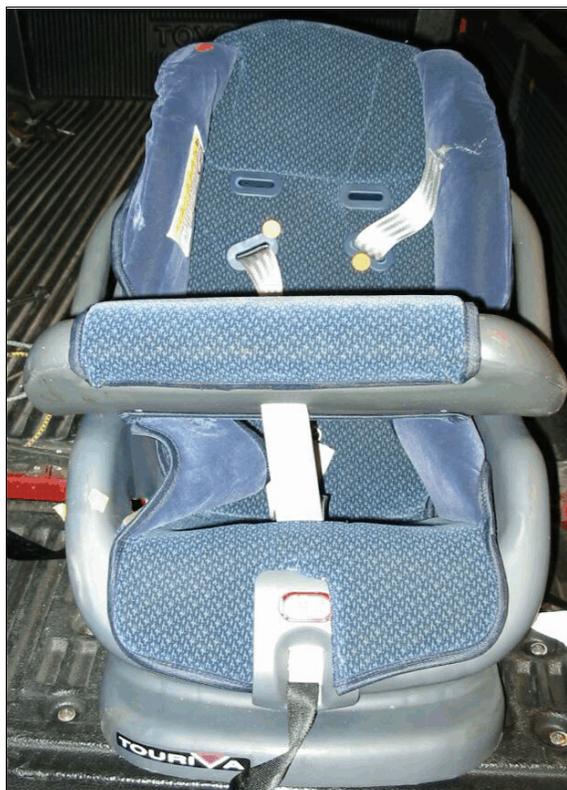
A convertible child safety seat with tray-shield was used to restrain the case vehicle's second seat center passenger [7-month-old, female; 84 centimeters and 10 kilograms (33 inches, 22 pounds)]. It was positioned in the rear facing orientation at the time of the crash. The child seat (**Figure 17**) was manufactured by Dorel Juvenile Group, Inc. on January 1, 2005 and identified by model name "Touriva" and model number 22-130-WAL. The child seat was purchased new about two weeks prior to the crash and was used on a daily basis. It was designed with a three-point, tray-shield harness with harness retainer clip, a recessed buckle and a LATCH system. The child seat was slightly reclined and secured tightly with the child seat's LATCH straps attached to the case vehicle's LATCH system lower anchors. Also, the case vehicle's lap belt was pulled out to switch the retractor to automatic locking mode, routed through the guide below the child seat cushion and retracted to tighten it against pool noodles, which were used to help position the child seat.

Inspection of the child seat revealed evidence it had been compressed between the intruding driver's seat back and the back of the seat in which the child seat was secured. The back, upper right portion of the child seat had extensive stress marks and cracks in the plastic shell (**Figure 18**), and contact marks were observed on the back right portion of the driver's

Figure 17: Case vehicle's second seat center child safety seat

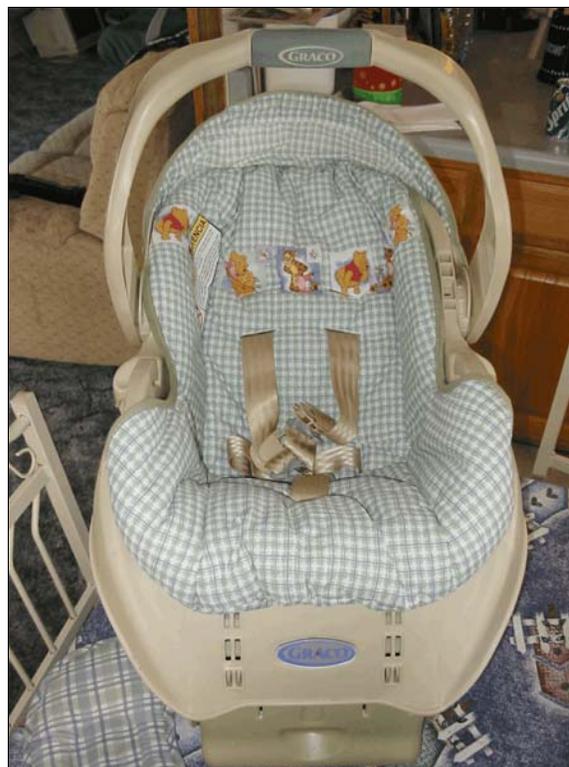
8643DOH. The infant seat (**Figure 24**) was purchased new approximately six weeks prior to the crash and was used on a daily basis. The unit was designed with a five-point harness with harness retainer clip and a non-recessed buckle. There were two sets of harness slots in the back of the infant seat, and the harness straps were located in the bottom slots. The infant seat was designed to snap into a detachable base (**Figure 25**), which was secured to the case vehicle's seat. In addition, there was an indicator on the left side of the infant seat to assure that the seat was installed at the proper angle.

The infant seat consisted of a plastic one-piece shell, which was lined with a "comforter" pad. A close inspection of the infant seat revealed no damage or stress to the shell, base, or harness. Manufacturer's information and warning labels in English and Spanish were affixed to both sides of the infant seat giving height and weight limitations in addition to illustrations depicting the proper installation method. The infant seat's height and weight limitations were given respectively as: 66 centimeters (26 inches) or less and 9 kilograms (20 pounds) or less.

Figure 24: Case vehicle's 2nd seat right infant seat, a Graco "Snugride"

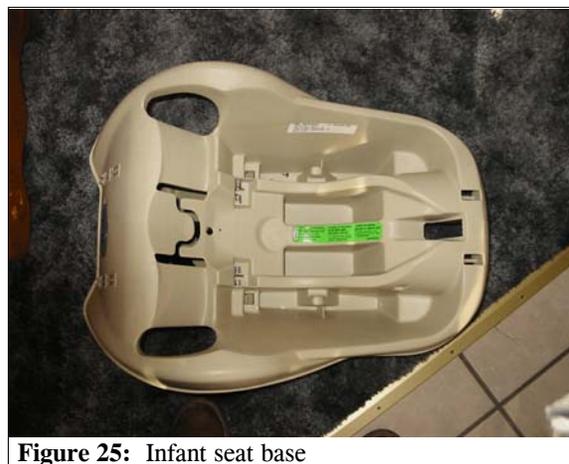
According to the interviewee, the infant seat was attached to its base, which was secured tightly by the case vehicle's lap-and-shoulder belt. Nothing was placed behind the infant seat to position it. The case vehicle's safety belt was pulled out to switch the retractor to automatic locking mode, and the belt was retracted as the infant seat base was pressed down into the seat. The infant seat was then snapped into the base. The interviewee was not sure if the infant seat remained secured to its base following the crash.

Figure 25: Infant seat base

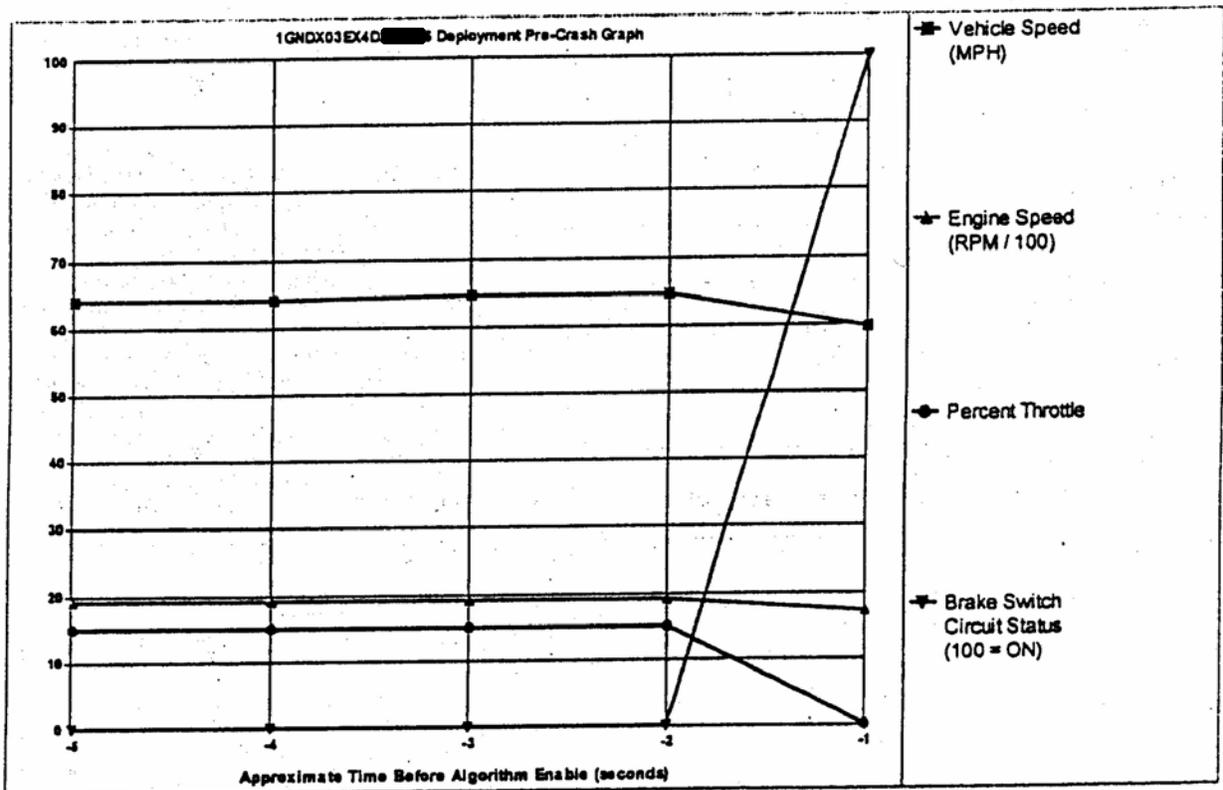
The pre-crash data shows that the case vehicle's speed was recorded as 103 to 105 km.p.h. (64 to 65 m.p.h.) at 15% throttle from five to two seconds prior to AE, and the brake switch circuit was recorded off. At one second prior to AE the vehicle's speed was recorded as 97 km.p.h. (60 m.p.h.) at 0% throttle, and the brake switch circuit is recorded on. The recorded status of the brake switch circuit at this time increment supports the front right passenger's statement that the driver attempted to avoid the crash by applying the brakes just prior to the impact.

SIR Warning Lamp Status	OFF
Driver's Belt Switch Circuit Status	BUCKLED
Ignition Cycles At Deployment	1073
Ignition Cycles At Investigation	1078
Maximum SDM Algorithm Forward Velocity Change (MPH)	-31.66
Algorithm Enable to Maximum SDM Recorded Velocity Change (msec)	107.5
Driver First Stage Time Algorithm Enabled to Deployment Command Criteria Met (msec)	7.5
Driver Second Stage Time Algorithm Enabled to Deployment Command Criteria Met (msec)	10
Passenger First Stage Time Algorithm Enabled to Deployment Command Criteria Met (msec)	7.5
Passenger Second Stage Time Algorithm Enabled to Deployment Command Criteria Met (msec)	10
Time Between Non-Deployment And Deployment Events (sec)	N/A
Event Recording Complete	Yes

Seconds Before AE	Vehicle Speed (MPH)	Engine Speed (RPM)	Percent Throttle	Brake Switch Circuit Status
-5	64	1920	15	OFF
-4	64	1920	15	OFF
-3	65	1920	15	OFF
-2	65	1920	15	OFF
-1	60	1728	0	ON

Figure 32: Case vehicle's System Status as Deployment Report and Deployment Pre-Crash Graph

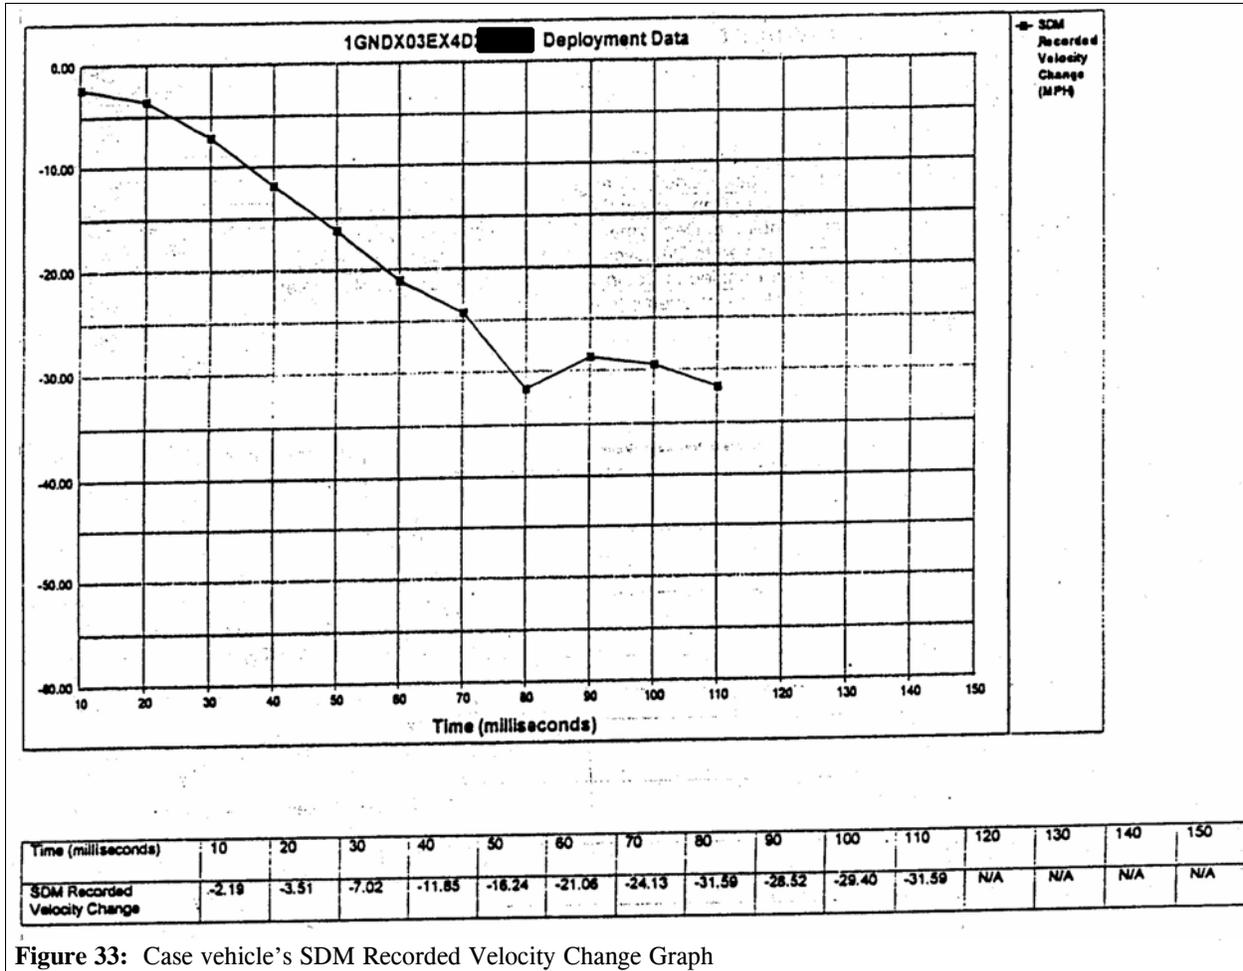
The CDC for the case vehicle's front impact with the Pontiac was determined to be: **12-FDAW-7 (350 degrees)**. The CDC for the case vehicle's subsequent rollover onto its left side was determined to be: **00-LDAO-1**. The WinSMASH reconstruction program, damage only algorithm, calculated the case vehicle's Total, Longitudinal, and Lateral Delta Vs for the front impact respectively as: 84.0 km.p.h. (52.2 m.p.h.), -82.7 km.p.h. (-51.4 m.p.h.), and 14.6 km.p.h. (9.1 m.p.h.). This contractor considers this a borderline reconstruction due to the severity of the crush to both vehicles. The case vehicle's EDR recorded a maximum longitudinal Delta V of 50.95 km.p.h. (-31.66 m.p.h.), which appeared to be low based on the damage to the case vehicle.

Figure 33: Case vehicle's SDM Recorded Velocity Change Graph

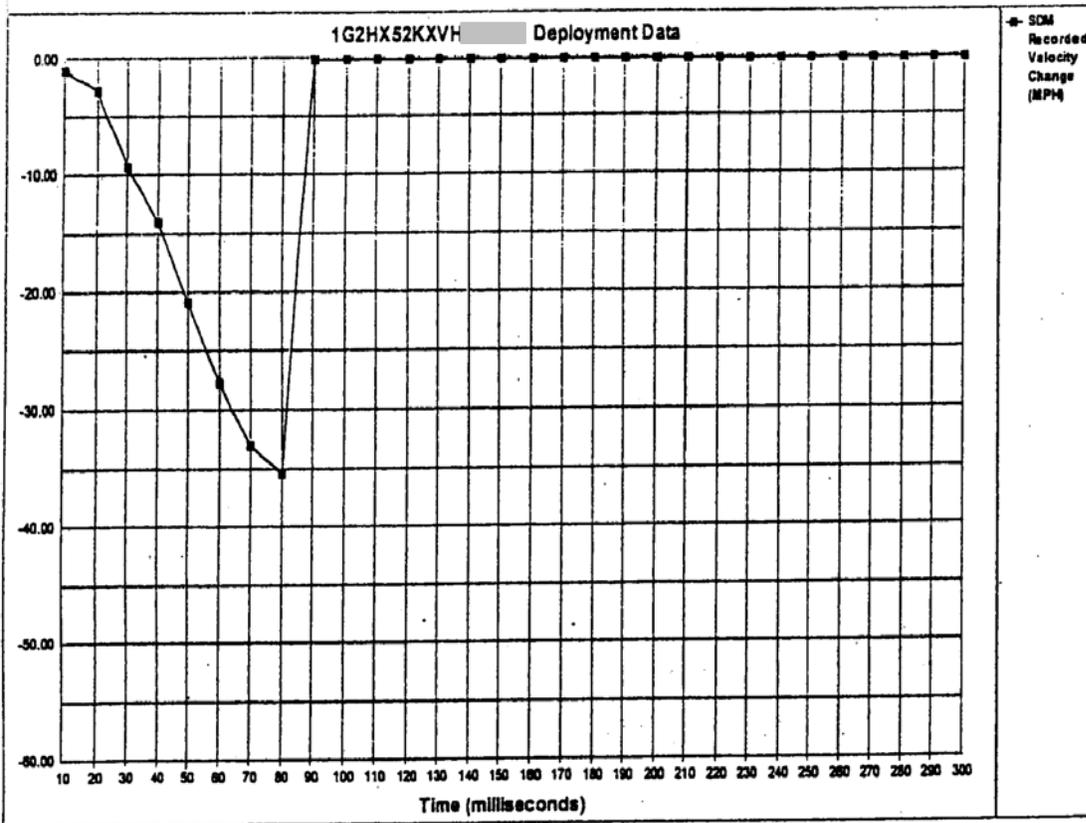
The Pontiac's CDC was determined to be: **12-FDEW-5 (0 degrees)**. The WinSMASH reconstruction program, damage only algorithm, calculated the Pontiac's Total, Longitudinal, and Lateral Delta Vs respectively as: 107.0 km.p.h. (66.5 m.p.h.), -107.0 km.p.h. (-66.5 m.p.h.), and 0.0 km.p.h. (0.0 m.p.h.). This contractor considers this a borderline reconstruction due to the severity of the crush to both vehicles. The Pontiac's EDR data indicated that power was lost during the recording process. As a result, a complete recording of the Delta V history was interrupted and not obtained. The last recorded Delta V value was -56.84 km.p.h. (-35.32 m.p.h.) occurring at 80 milliseconds after AE.

SIR Warning Lamp Status	OFF
Driver's Belt Switch Circuit Status	UNBUCKLED
Passenger Front Air Bag Suppression Switch Circuit Status	Air Bag Not Suppressed
Ignition Cycles At Deployment	0
Ignition Cycles At Investigation	12844
Time From Algorithm Enable To Deployment Command (msec)	7.5
Time Between Non-Deployment And Deployment Events (sec)	N/A

Time (milliseconds)	10	20	30	40	50	60	70	80	90	100	110	120	130	140	150
Recorded Velocity Change (MPH)	-0.88	-2.63	-9.21	-14.04	-20.84	-27.84	-32.91	-35.32	0.00	0.00	0.00	0.00	0.00	0.00	0.00
Time (milliseconds)	160	170	180	190	200	210	220	230	240	250	260	270	280	290	300
Recorded Velocity Change (MPH)	0.00	0.00	0.00	0.00	0.00	0.00	0.00	0.00	0.00	0.00	0.00	0.00	0.00	0.00	0.00

Figure 35: Pontiac's System Status at Deployment report and, SDM recorded velocity change data
