Electronic Stability Control/Vehicle Rollover
Dynamic Science, Inc./Case Number: DS05026
2005 Acura TSX
California
September 2005

1. Report No. DS05026	2. Government Accession No.		3. Recipient Catalog No.	
4. Title and Subtitle Electronic Stability Control System Investigation		5. Report Date June 27, 2006

14. Sponsoring Agency Code		
15. Supplemental Notes				
16. Abstract This on-site investigation focused on the Electronic Stability Control feature in a 2005 Acura TSX. This single vehicle crash occurred in September 2005 at 0103 hours in an urban area of California. The crash occurred at a three-leg intersection controlled by a large traffic circle located in the center of the two intersecting roadways. The case vehicle is a 2005 Acura TSX being driven by a 23-year-old restrained male. There was one additional occupant in the Acura. The Acura was traveling east in the right lane of a two lane, two way, undivided asphalt roadway and was approaching the intersection controlled by the traffic circle. The driver of the Acura reported that he did not see the traffic circle until it was too late to maneuver around it. The case vehicle continued straight ahead and the left side trav

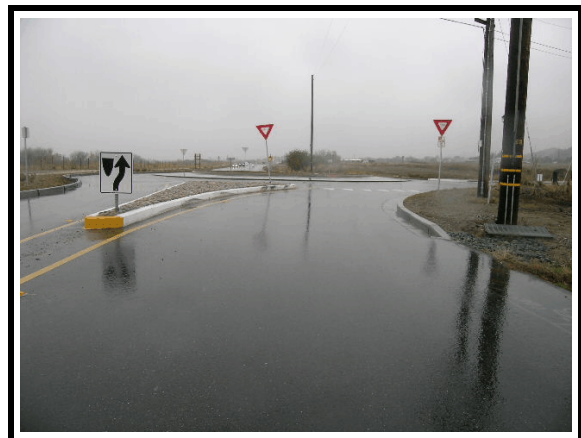
Figure 3. Approach of case vehicle to initial roadway departure area - east

The Acura was traveling east in the right lane of an asphalt roadway consisting of two undivided travel lanes. The one eastbound lane is separated from the one westbound lane by painted, yellow, no passing double lane lines. West of the crash area there are dedicated bike lanes adjacent to both travel lanes, but the solid white lines designating the bike lanes are not present in the precrash area. There are no curbs east or west of the intersection, but curbs are present in the immediate area surrounding the traffic circle and roundabout medians. The traffic circle is large and consists of an outer ring of concrete with an uphill grade. The outermost edge of the traffic circle has a height of 5.0 cm (2.0 in). The concrete ring is 3.2 m (10.4 ft) wide and as the outer concrete ring ends, there is a curb measuring 17.0 cm (6.7 in) high and 14.0 cm (5.5 in) wide. The inner section of the traffic circle is an uneven area of grass and dirt measuring 15.1 m (49.5 ft) in diameter. There are raised medians on the east, west and south sides of the traffic circle that help safely route vehicles around the roundabout. Near the southeast corner of the intersection, there is a concrete drainage culvert located off the roadway, next to the eastbound travel lane. The drain consists of a concrete base that is shaped like an ‘H’ and has steel grating in the center. There was no visible damage to the culvert, but a damaged A-frame traffic barricade was found laying on the ground next to the culvert. It is not known why the barricade was there or if it had been moved post-impact. Southeast of the culvert there is a ditch that is approximately 109.0 cm (43.0 in) deep.

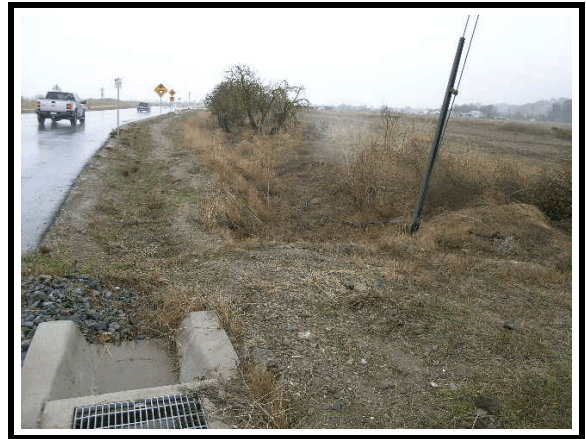
Figure 8. Case vehicle's path to ditch and rollover location

The lamppost fell and sections of the post impacted both the left and right A pillars (00TYDW4). The lamppost had been removed from the crash scene and was not available for inspection. After striking the lamppost, the Acura continued east and sideswiped an A-frame traffic barricade with its right side (12RYES1). The case vehicle traveled a very short distance east of the barricade and went into a ditch. The height differential and sloped sides of the ditch caused the Acura to roll over (00LDAO2) one quarter turn to the left.

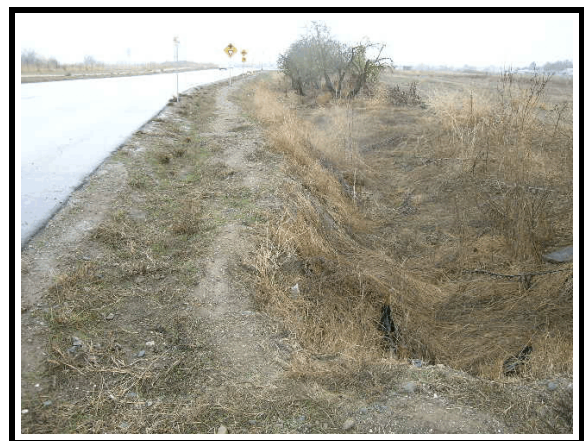
Figure 9. Ditch - Final rest location of case vehicle (east)

The case vehicle came to final rest laying on its left side, off the roadway, facing east.
