ON-SITE CERTIFIED ADVANCED 208-COMPLIANT VEHICLE INVESTIGATION

CASE NUMBER - IN-05-036

VEHICLE - 2005 HONDA ACCORD

CRASH DATE - September 2005

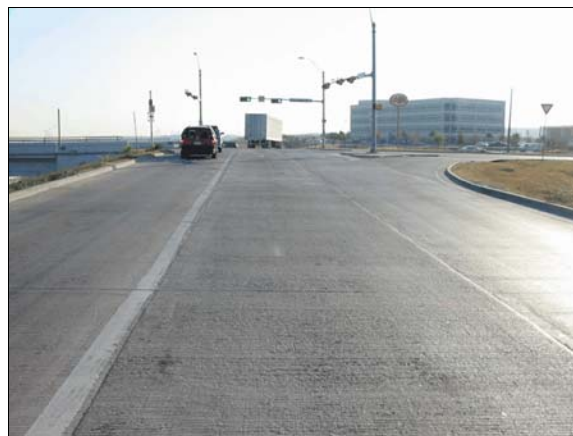
Pre-Crash: The case vehicle was traveling east in the inside through lane (**Figure 1**). The driver was intending to continue straight through the intersection. The other vehicle was traveling north in the inside through lane (**Figure 2**). Its driver was also intending to continue straight through the intersection. It is unknown if the case vehicle's driver made any avoidance maneuvers prior to the crash. The crash occurred in the four-leg intersection of the two trafficways (**Figure 3**).

Figure 1: Approach of case vehicle eastbound to intersection in inside through lane

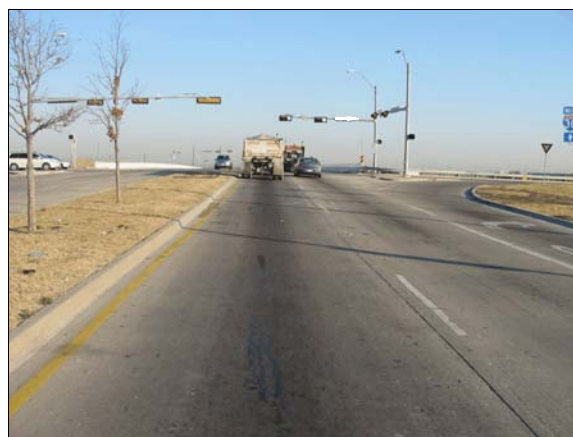
Figure 2: Approach of other vehicle northbound to intersection in inside lane
