**CALSPAN ON-SITE ADAPTIVE CONTROL
VEHICLE CRASH INVESTIGATION**

CASE NO: CA05-037

VEHICLE: 2005 CHEVROLET VENTURE MINIVAN

CRASH DATE: MARCH 2005

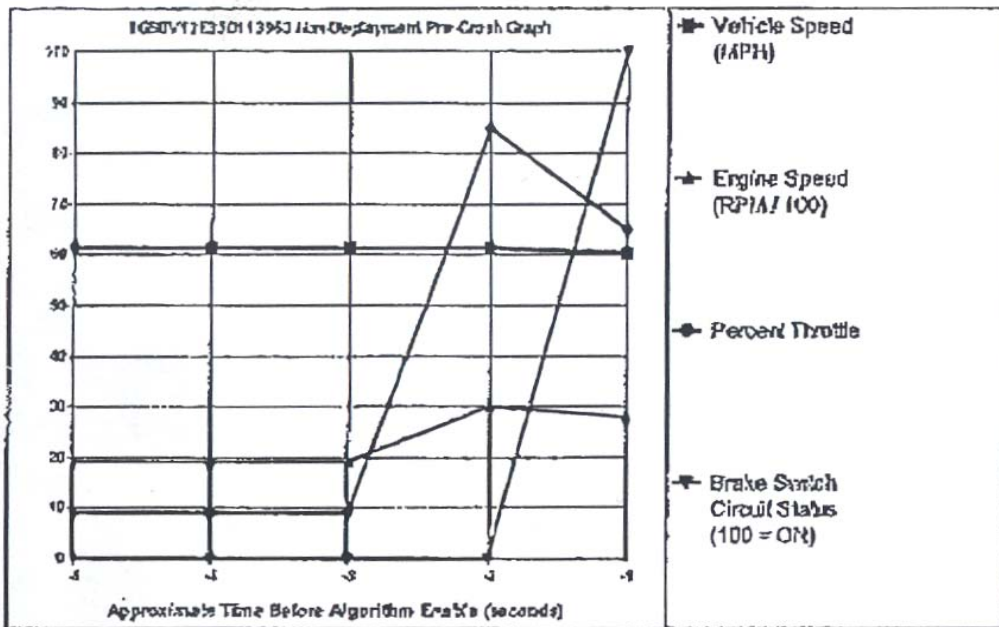
System Status At Non-Deployment

SIR Warning Lamp Status	OFF
Driver's Belt Switch Circuit Status	BUCKLED
Critical Cycles At Non-Deployment	397
Critical Cycles At Investigation	399
Maximum SDM Algorithm Forward Velocity Change (MPH)	0.00
Algorithm Enable to Maximum SDM Recorded Velocity Change (msec)	47.5
A Deployment was Commanded Prior to this Event	No

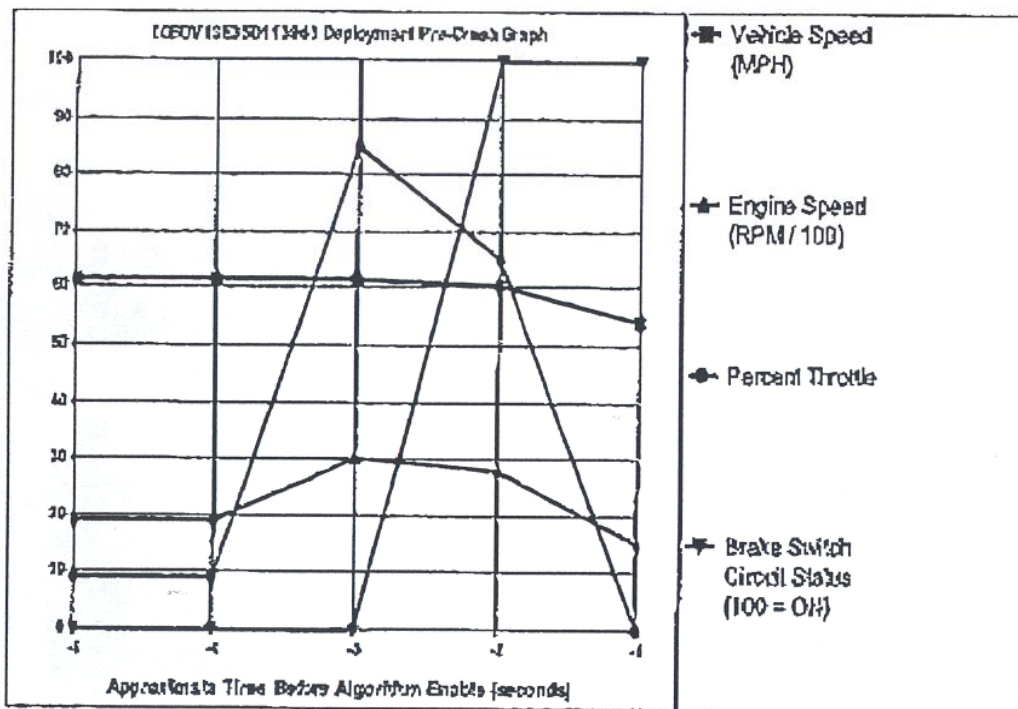
System Status At Deployment

SIR Warning Lamp Status	OFF
Driver's Bell Switch Circuit Status	BUCKLED
Ignition Cycles At Deployment	337
Ignition Cycles At Ignition	339
Maximum SDO1 Algorithm Forward Velocity Change (MPH)	-19.31
Algorithm Enable to Maximum SDO1 Recorded Velocity Change (msec)	32.5
Driver First Stage Time Algorithm Enabled to Deployment Command Criteria Met (msec)	7.5
Driver Second Stage Time Algorithm Enabled to Deployment Command Criteria Met (msec)	7.5
Passenger First Stage Time Algorithm Enabled to Deployment Command Criteria Met (msec)	7.5
Passenger Second Stage Time Algorithm Enabled to Deployment Command Criteria Met (msec)	7.5
Time Between Non-Deployment And Deployment Events (sec)	.5
Event Recording Complete	Yes
