INDIANA UNIVERSITY

TRANSPORTATION RESEARCH CENTER

ON-SITE CERTIFIED ADVANCED 208- COMPLIANT VEHICLE INVESTIGATION

CASE NUMBER - IN-05-037
LOCATION - TEXAS
VEHICLE - 2005 GMC ENVOY XUV
CRASH DATE - August 2005

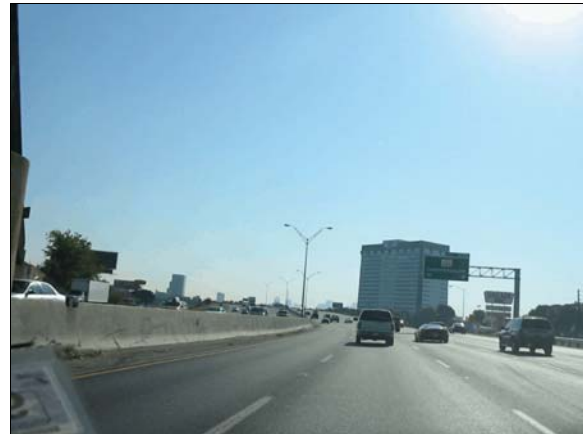
Figure 1: Approach of case vehicle southbound in left center through lane

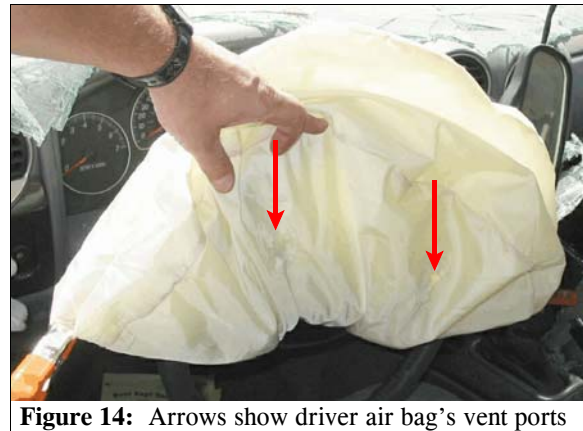
The case vehicle’s driver air bag was located in the steering wheel hub. An inspection of the air bag module cover flaps and the air bag fabric revealed that the cover flaps opened at the designated tear points (Figure 12). There was no evidence of damage during the deployment to the air bag or the cover flaps. The module cover consisted of “I” configuration cover flaps made of pliable vinyl. Each cover flap was 7.3 centimeters (2.9 inches) in width at the top, 5 centimeters (2 inches) in width at the bottom and 12 centimeters in height along the vertical tear seam. The center section of the right cover flap was designed with a circular GMC emblem. Half of the emblem fit into a semi-circular contour on the left cover flap. The driver’s air bag was designed with two tethers, each approximately 11 centimeters (4.3 inches) in width. The deployed driver’s air bag (Figure 13 below) was round with a diameter of approximately 62 centimeters (24.4 inches) and had two vent ports (Figure 14 below), each approximately 3 centimeters (1.2 inches) in diameter, located at approximately the 10:30 and 1:30 o’clock positions. The distance between the mid-center of the driver’s seat back, as positioned at the time of the vehicle inspection (i.e., seat between middle and forward most track

Figure 14: Arrows show driver air bag's vent ports

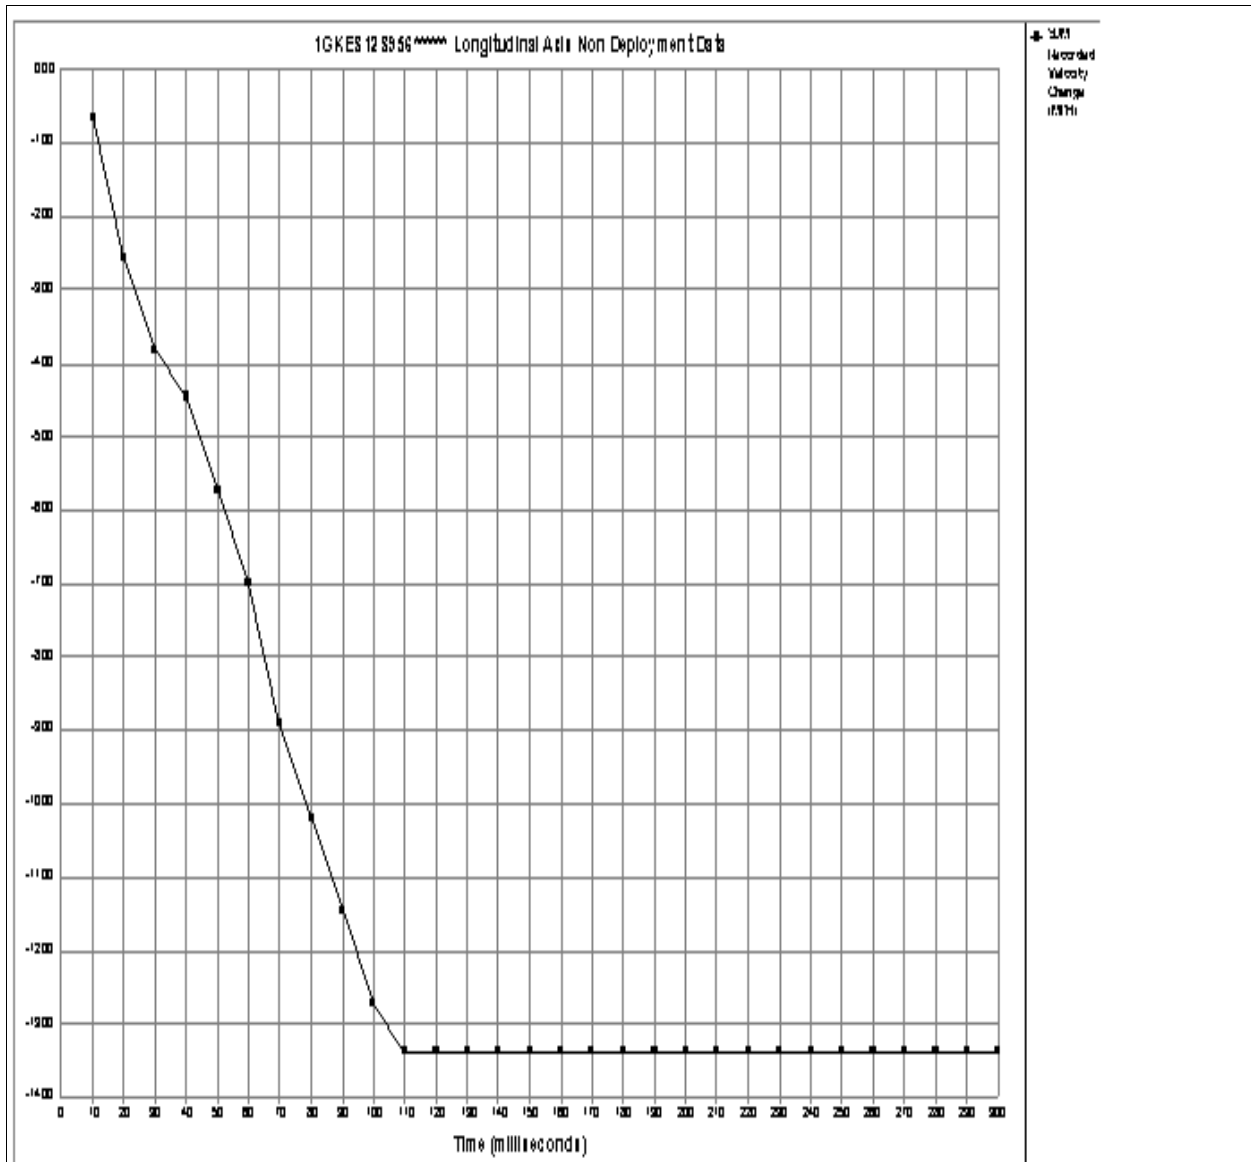
Time (milliseconds)	10	20	30	40	50	60	70	80	90	100	110	120	130	140	150
Longitudinal Axis Recorded Velocity	-0.64	-2.55	-3.82	-4.46	-5.73	-7.00	-8.91	-10.19	-11.46	-12.73	-13.37	-13.37	-13.37	-13.37	-13.37
Time (milliseconds)	160	170	180	190	200	210	220	230	240	250	260	270	280	290	300
Longitudinal Axis Recorded Velocity	-13.37	-13.37	-13.37	-13.37	-13.37	-13.37	-13.37	-13.37	-13.37	-13.37	-13.37	-13.37	-13.37	-13.37	-13.37

Figure 23: Case vehicle's Longitudinal Axis Non-Deployment Data

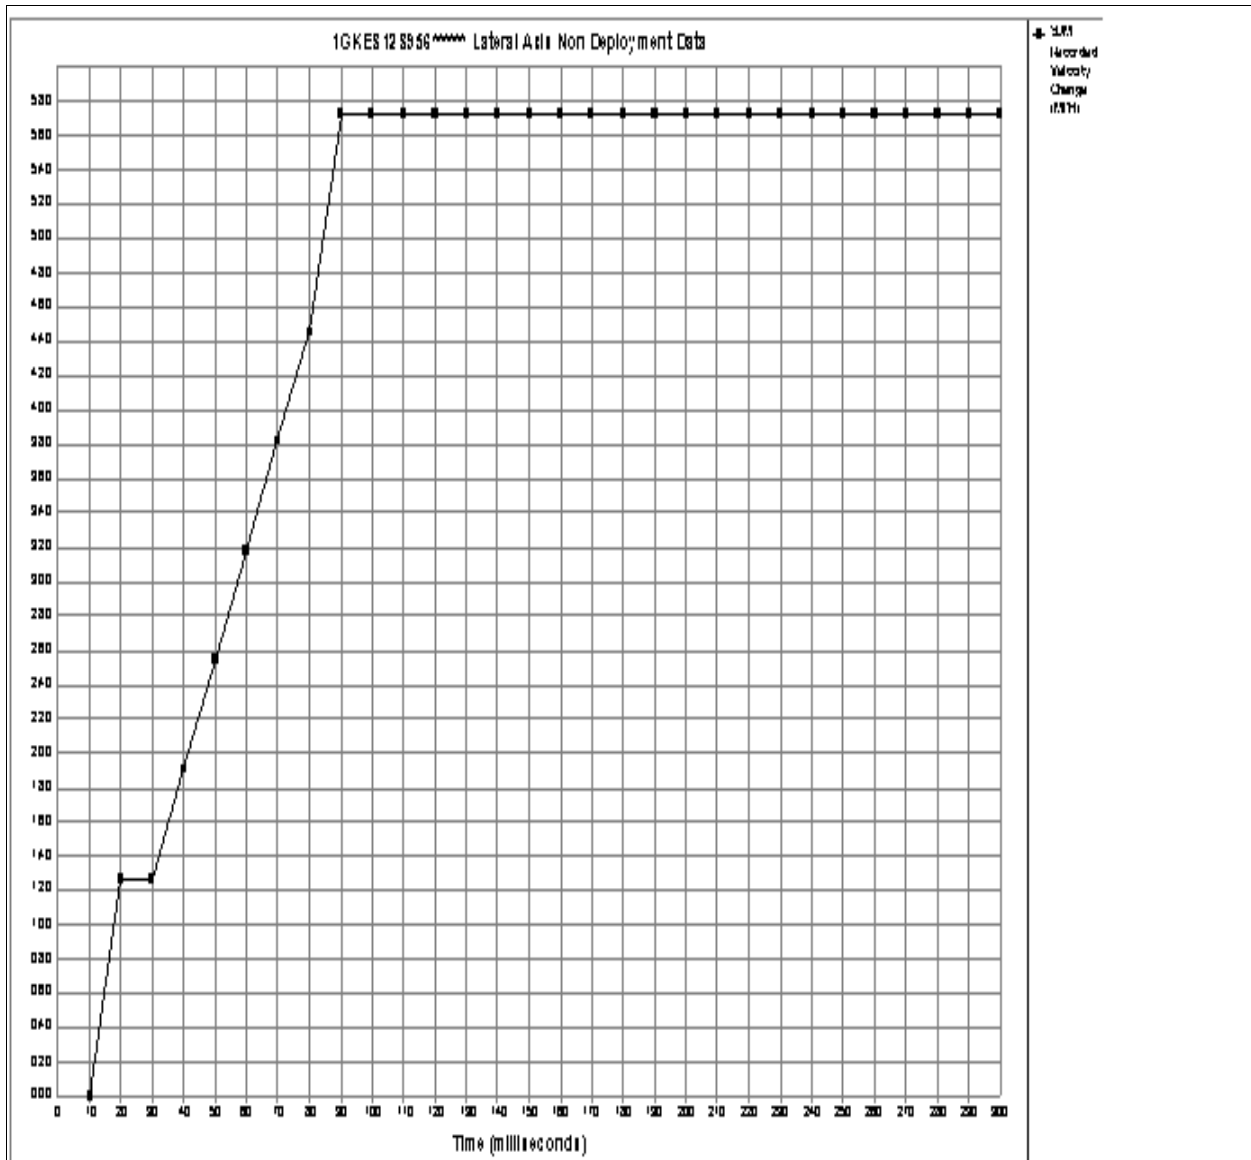
Time (milliseconds)	10	20	30	40	50	60	70	80	90	100	110	120	130	140	150
Lateral Axis Recorded Velocity Change (MPH)	0.00	1.27	1.27	1.91	2.55	3.18	3.82	4.46	5.73	5.73	5.73	5.73	5.73	5.73	5.73
Time (milliseconds)	160	170	180	190	200	210	220	230	240	250	260	270	280	290	300
Lateral Axis Recorded Velocity Change (MPH)	5.73	5.73	5.73	5.73	5.73	5.73	5.73	5.73	5.73	5.73	5.73	5.73	5.73	5.73	5.73

Figure 24: Case vehicle's Lateral Axis Non-deployment Data
