**CALSPAN ON-SITE CHILD SAFETY SEAT CRASH INVESTIGATION
SCI CASE NO: CA05-038**

**VEHICLE: 1998 CHEVROLET CAVALIER
LOCATION: FLORDIA
CRASH DATE: JUNE, 2005**

<p><i>14. Sponsoring Agency Code</i></p>	
<p><i>15. Supplementary Note</i> An investigation of a side impact crash involving a 1998 Chevrolet Cavalier.</p>			
<p><i>16. Abstract</i></p> <p>This investigation focused on the crash dynamics and fatal injury mechanisms of a 20 month old female seated in a Cosco Touriva convertible Child Safety Seat (CSS) restrained in the rear left position of a 1998 Chevrolet Cavalier. The Chevrolet was involved in a left side impact crash with a 2005 Suzuki GSX 1300 R Hayabusa motorcycle. The 26 year old female driver of the Chevrolet pulled out from a parking lot directly into the path of the motorcycle precipitating the crash. The impact of the motorcycle into the left rear door area of the Chevrolet resulted in a 47 cm (18.5 in) of door panel intrusion. The child was seated at the point of impact and sustained fatal head injuries. She was life-flighted to a trauma center and pronounced deceased. The driver of the Chevrolet was not injured. The motorcyclist sustained unidentified minor injur

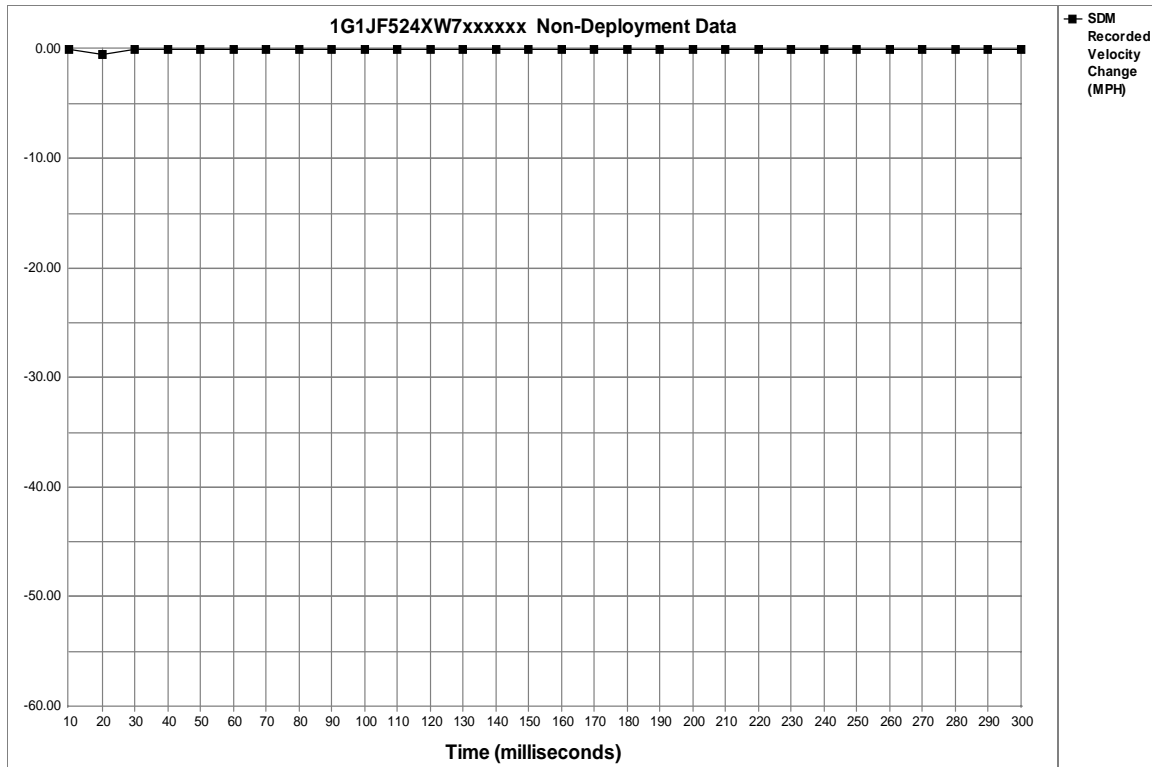
System Status At Non-Deployment

SIR Warning Lamp Status	OFF
Driver's Belt Switch Circuit Status	UNBUCKLED
Passenger Front Air Bag Suppression Switch Circuit Status	Air Bag Not Suppressed
Ignition Cycles At Non-Deployment	25014
Ignition Cycles At Investigation	25022
Algorithm Enable to Maximum SDM Recorded Velocity Change (msec)	22.5
Maximum SDM Recorded Velocity Change (MPH)	-0.66
A Deployment was Commanded Prior to this Event	No

Time (milliseconds)	10	20	30	40	50	60	70	80	90	100	110	120	130	140	150
Recorded Velocity Change (MPH)	0.00	-0.44	0.00	0.00	0.00	0.00	0.00	0.00	0.00	0.00	0.00	0.00	0.00	0.00	0.00
Time (milliseconds)	160	170	180	190	200	210	220	230	240	250	260	270	280	290	300
Recorded Velocity Change (MPH)	0.00	0.00	0.00	0.00	0.00	0.00	0.00	0.00	0.00	0.00	0.00	0.00	0.00	0.00	0.00
