**CALSPAN ON-SITE ALTERNATIVE FUEL VEHICLE CRASH  
INVESTIGATION**

**CALSPAN CASE NO: CA05-041**

**VEHICLE: 2004 TOYOTA PRIUS**

**CRASH DATE: MAY 2005**

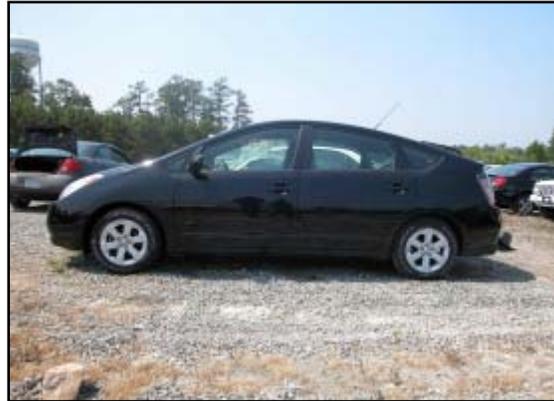
**Figure 1. Subject vehicle 2004 Toyota Prius.**

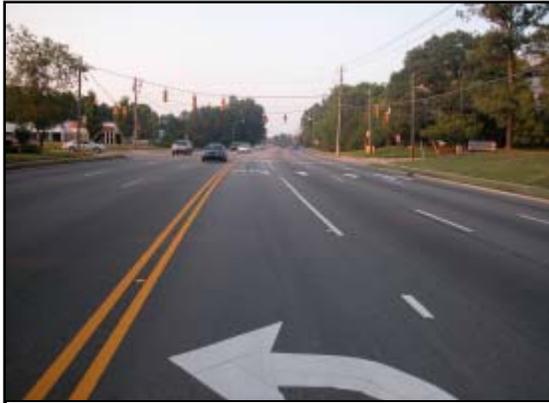
The restrained 32-year-old male driver of the 2004 Toyota Prius was operating the vehicle northbound on the four-lane roadway approaching the four-leg intersection where he intended to turn left (**Figure 2**). A 35-year-old female driver was operating the 2000 Nissan Altima southbound approaching the same intersection (**Figure 3**). The driver of the Prius failed to detect the southbound Nissan and turned left at the intersection, crossing the path of the Altima.

**Figure 2. Pre-crash travel for the Toyota.**

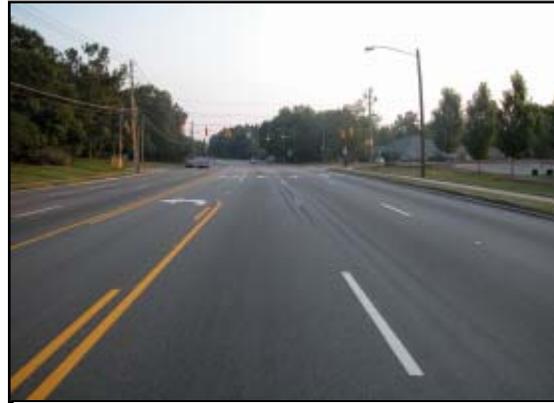
**Figure 3. Southbound travel of the Nissan.**

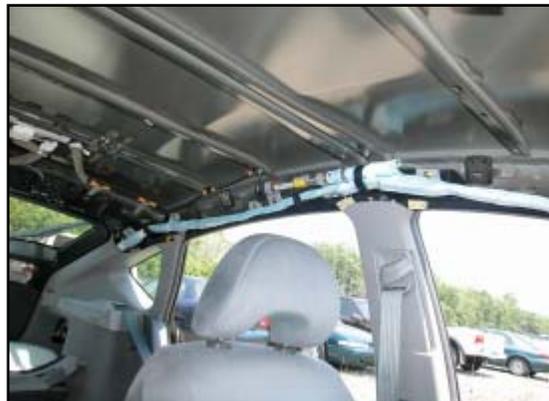
The repair facility removed the headliner and roof side rail trim panels, which allowed access to the non-deployed left IC (**Figure 11**). The following nomenclature was identified on the left IC:

**Figure 11. Non-deployed left IC.**

The side impact air bag system was designed to deploy based solely on impact. There was no occupant presence sensor in this vehicle. The right side impact air bag and right IC deployed into unoccupied positions during the crash.

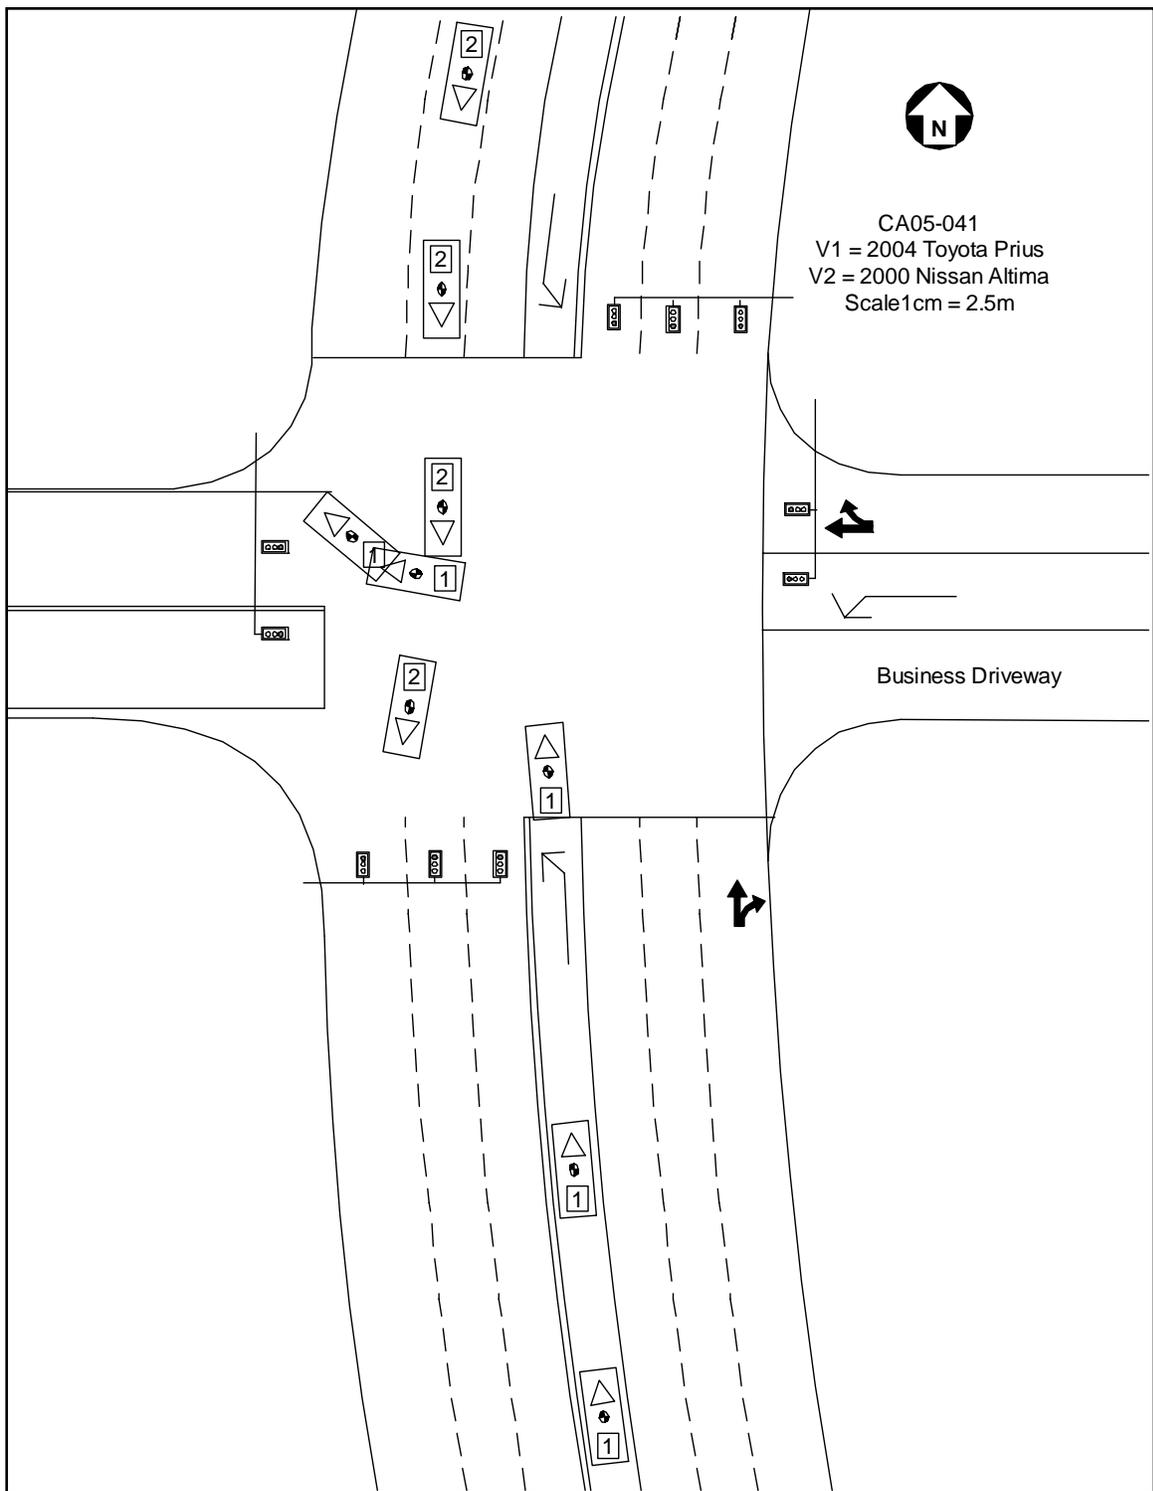
Figure 12. Scene schematic

east leg were separated by double yellow centerlines. The roadways were surfaced with asphalt and were bordered by concrete barrier curbs. Traffic through the intersection was controlled by overhead three-phase traffic lights. The posted speed limit for the north/south roadway was 72 km/h (45 mph). The scene schematic is included as **Figure 12** of this report.
