Side Curtain and Side Air Bag Investigation/Vehicle to Objects
Dynamic Science, Inc./Case Number: DS06006
2003 Volkswagen Golf
Washington
February 2006

1. Report No. DS06006	2. Government Accession No.	3. Recipient Catalog No.	
4. Title and Subtitle Side Curtain and Side Air Bag Investigation		5. Report Date August 18, 2006

This on-site investigation focused on the side curtain and side air bag systems in a 2003 Volkswagen Golf.

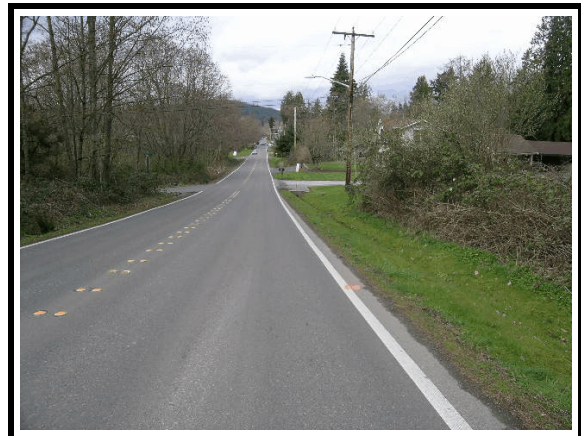
Figure 3. Approach of case vehicle to roadway departure area - north

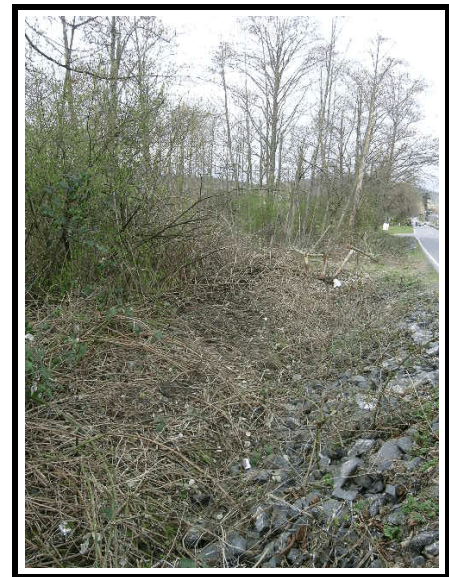
Figure 4. Ditch on west side of roadway; disturbed blackberry vines and damaged trees in background

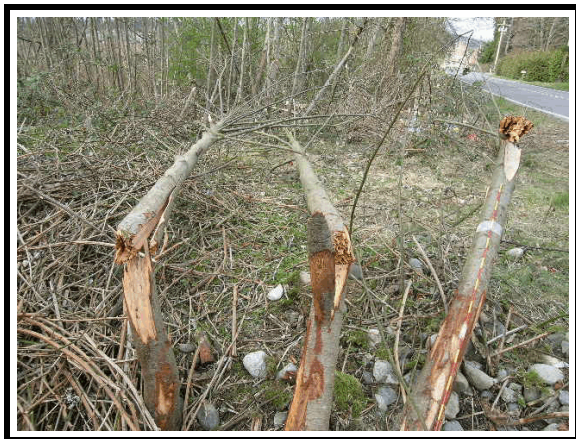
Figure 5. First set of impacted trees; tops of trees found north of case vehicle's final rest location

The 2003 Volkswagen Golf sustained moderate right side damage as a result of the impact with the first set of three trees. Due to the amount of sporadic vehicle damage, the location of the direct damage from this specific event could not be determined. The CDC for this event was 03RZAW3. The area of maximum crush was to the right C pillar. The right rear tire and axle were severely damaged during this event. The fuel tank filler neck was deformed and out of position, but no evidence of fuel leakage was found.

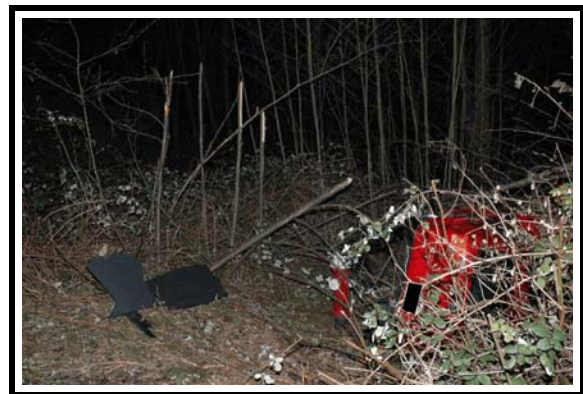
Figure 6. Damaged cluster of trees and case vehicle's final rest (police photo)

The case vehicle sustained moderate top damage due to the impact between the hood and the second cluster of trees. It is possible that the front right fender hit the cluster of trees first and the hood impacted them as the vehicle continued to rollover mid-air. There is right fender damage that is similar and somewhat consistent to the hood damage. Only one CDC was coded because the impact configuration could not be verified. The vehicle was airborne and rolling over at the time of the impact, resulting in sporadic damage to the vehicle's hood. The CDC for this event was 40TFDW6. Both frame rails sustained downward vertical frame rail shift that was greater than 10 cm (4.0 in).

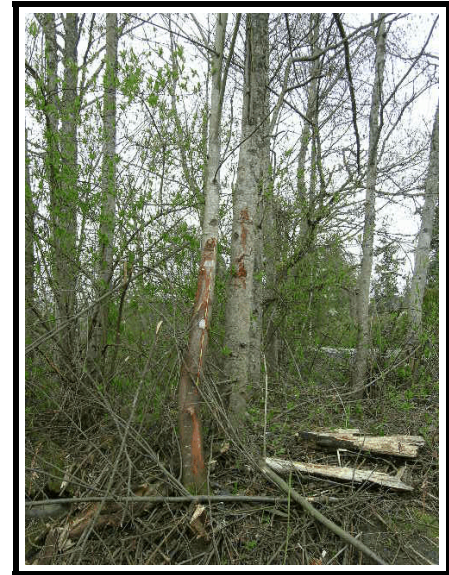
Figure 7. Last set of trees impacted by case vehicle

The Volkswagen sustained moderate top damage as a result of the impact between the case vehicle and the last set of two trees. This damage occurred while the vehicle was airborne and still rolling over. The distance between the larger cluster of trees and the last two trees is not far and it is possible that the vehicle was still in its second quarter turn, just beginning its third quarter turn when this impact occurred. The CDC for this event was 00TPYW4. The area of maximum crush was located 86.0 cm (33.9 in) behind the left front axle. There was 44.0 cm (17.3 in) of vertical crush, which is the maximum crush documented for the rollover event. The area of maximum lateral crush was in the same location and measured 7.0 cm (2.8 in).

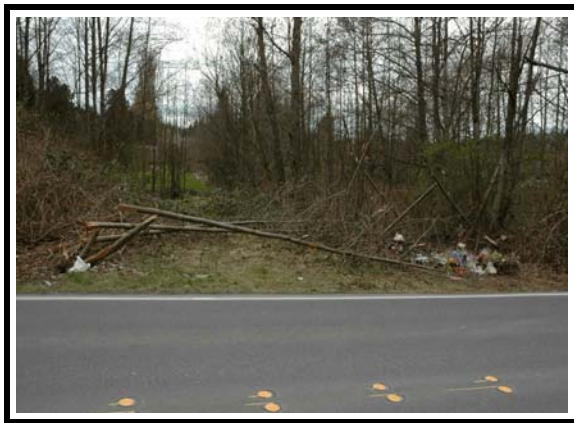
Figure 8. Distance between initial tree impacts/final rest location

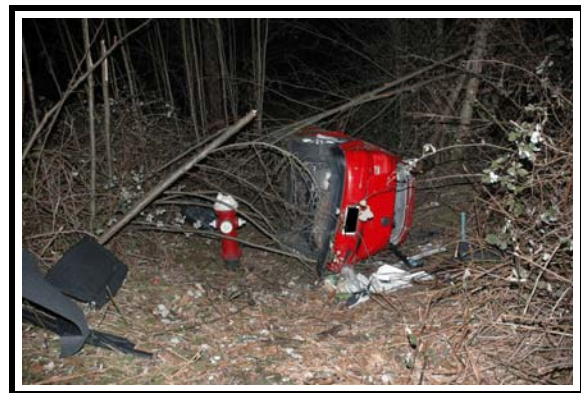
Figure 9. Final rest of case vehicle (police photo)

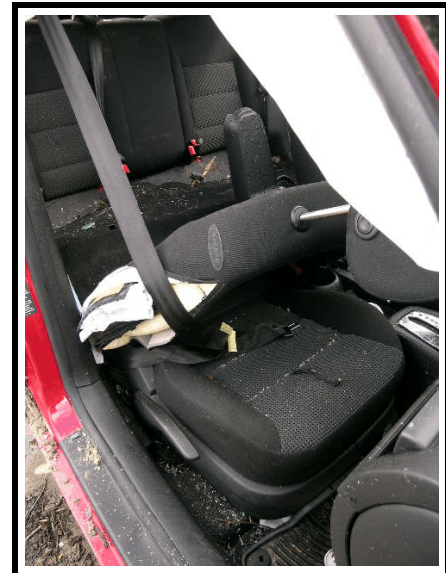
There were scuffs to the shoulder portion of the driver and front right passenger's seat belts due to the actuation of the B pillar pretensioners. There were friction marks on the front right passenger's seat belt latch plate from this occupant loading the belt. Both belts were found to be locked in place post crash due to the actuation of the retractor pretensioners. The left front door armrest was deformed due to contact from the driver. There was a scuff to the left front roof side rail, near the top of the A pillar, possibly due to occupant contact from the driver's nose and/or head. There was a black mark near the sunroof in the driver's area, which may have had nothing to do with the crash and could have been a slight burn from a lit cigarette. There was blood found on the right instrument panel, likely due to contact from the front right occupant's head and/or face. The front right seatback was deformed and locked in place, likely due to occupant contact from the backseat passengers. This seatback was found folded forward, with the head restraint nearly on top of the instrument panel. There were scuffs to the back of the front left seatback, likely due to occupant contact. There were scuffs to the back of the front right seatback, likely due to occupant contact from the hands and/or legs of the second row right seat passenger. The right rear door armrest was deformed, likely due to occupant contact from the

Figure 17. Right front seat belt

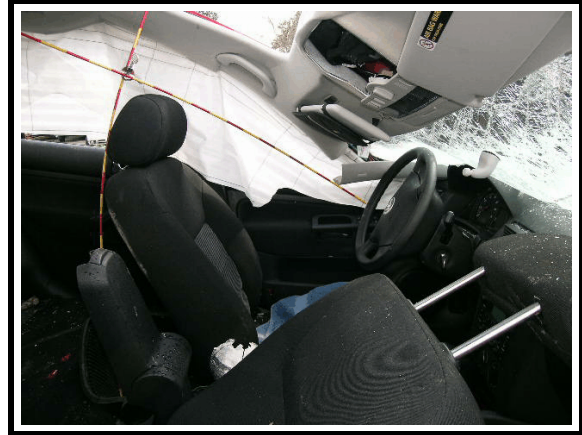
The left curtain showed no visible signs of occupant contact. The right curtain was dirty toward the front of the bag and the back section had multiple bloodstains from the second row right seat passenger. The material on the outer side of both curtains was dirty from the rollover event.

Figure 20. Front section of the left side curtain

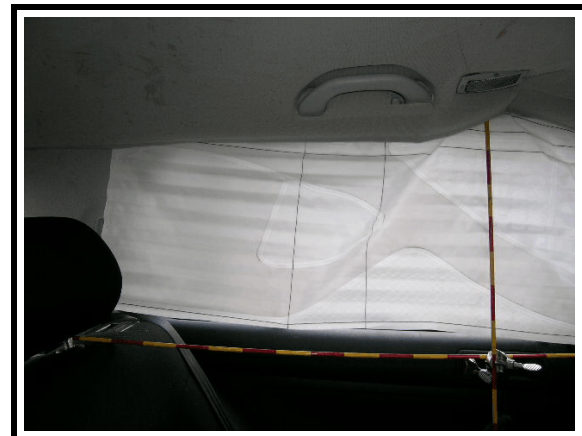
Figure 21. Back section of the left side curtain

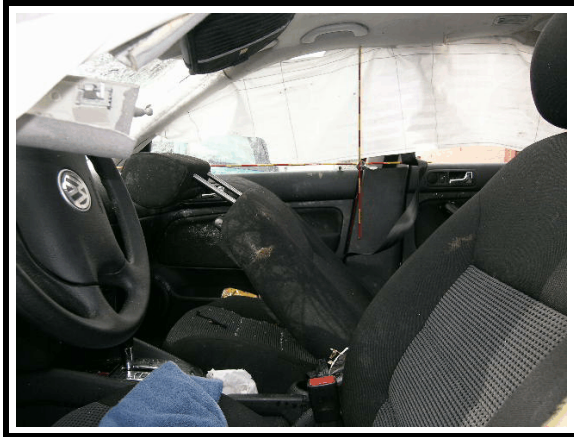
The deployed left and right side curtain air bags extended from the A pillars to the C pillars. There was a small coverage gap present at both A pillars, but the gap was eliminated on the left side due to the A pillar intrusion. The gap on the right side measured 46.0 cm (18.1 in) wide by 14.0 cm (5.5 in) high. The side curtains were rectangular in shape and in their deflated state, measured 186.0 cm (73.2 in) in length. The height of both side curtains was 28 cm (11.0 in). The curtains did not have tethers or vent ports. The side curtains deployed from the roof side rails.

Figure 22. Front section of passenger side curtain
