Advanced Occupant Protection System Investigation / Vehicle to Object
Dynamic Science, Inc. / Case Number: DS06007
2005 Chevrolet Malibu
California
February 2006

Figure 1. 2005 Chevrolet Malibu

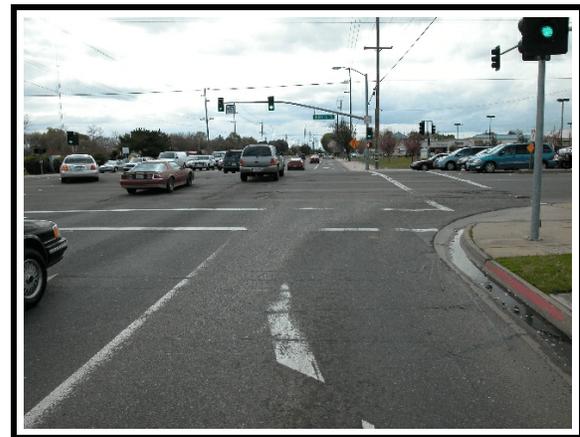
Figure 2. Approach to area of impact (west)

This single vehicle crash occurred just outside of a four-leg intersection in February 2006. At the time of the crash, there were no adverse weather conditions and the asphalt roadway surface was dry. The outside temperature was 28 C (50 F) degrees according to the electronic data recorder. The westbound roadway was configured with three westbound travel lanes, two left turn lanes, and two eastbound travel lanes. The roadway was curved to the right. The northwest corner of the intersection was configured with a concrete sidewalk and 15.2 cm (6.0 in) concrete partition that parallels the roadway curb returns. There were two poles present in the corner, a metal traffic signal pole and a wooden power pole. The wooden pole was 7.9 m

(26 ft) west of the road edge. Traffic flow through the intersection was controlled by three-phase traffic signals. The posted speed limit for westbound travel was 72 km/h (45 mph).

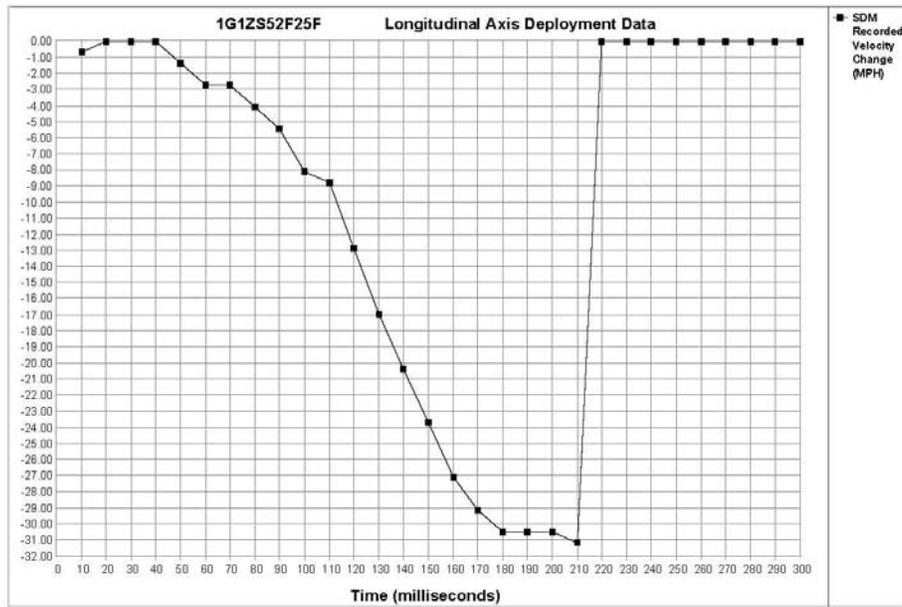
Time (milliseconds)	10	20	30	40	50	60	70	80	90	100	110	120	130	140	150
Longitudinal Axis Recorded Velocity	-0.68	0.00	0.00	0.00	-1.36	-2.71	-2.71	-4.07	-5.42	-6.78	-8.13	-9.48	-10.84	-12.19	-13.55
Time (milliseconds)	160	170	180	190	200	210	220	230	240	250	260	270	280	290	300
Longitudinal Axis Recorded Velocity	-14.90	-16.26	-17.61	-18.97	-20.32	-21.68	-23.03	-24.39	-25.74	-27.10	-28.45	-29.81	-31.16	-31.18	-31.18

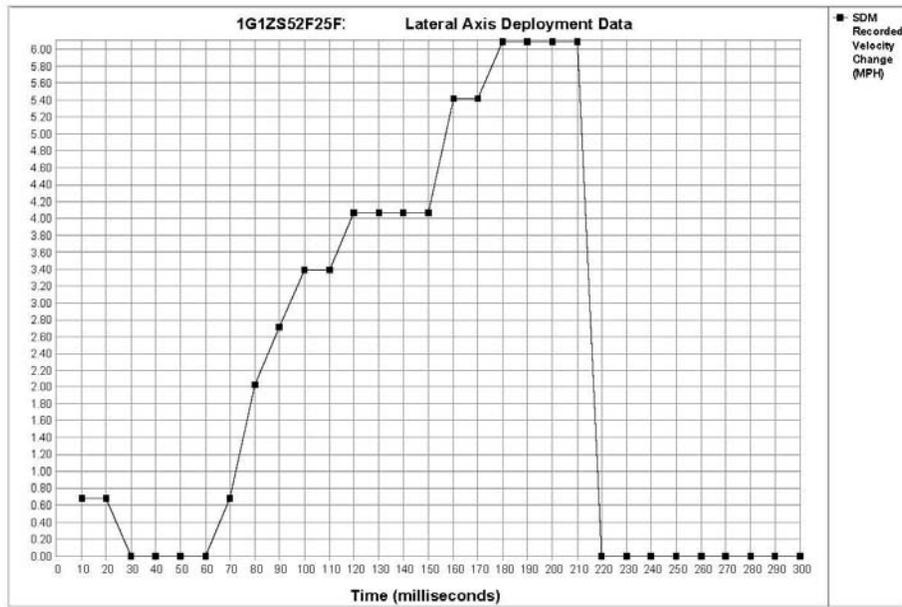
Time (milliseconds)	10	20	30	40	50	60	70	80	90	100	110	120	130	140	150
Lateral Axis Recorded Velocity Change (MPH)	0.68	0.68	0.00	0.00	0.00	0.00	0.68	2.03	2.71	3.39	3.39	4.07	4.07	4.07	4.07
Time (milliseconds)	160	170	180	190	200	210	220	230	240	250	260	270	280	290	300
Lateral Axis Recorded Velocity Change (MPH)	5.42	5.42	6.10	6.10	6.10	6.10	0.00	0.00	0.00	0.00	0.00	0.00	0.00	0.00	0.00
