15 Passenger Van Rollover Investigation / Vehicle Rollover
Dynamic Science, Inc. / Case Number: DS06012
2004 Ford E350 Van
Utah
May 2006

1. Report No. DS06012	2. Government Accession No.		3. Recipient Catalog No.	
4. Title and Subtitle 15 Passenger Van Rollover Investigation			5. Report Date August 25, 2006

This on-site investigation focused on a 2004 Ford E350 van involved in a rollover. This is a single vehicle crash that occurred in May 2006 in a rural area of Utah. The crash occurred on a US highway. The case vehicle is a 2004 Ford 15-passenger van. At the time of the crash, the van was being driven by a 32-year-old American driver who was transporting 13 international passengers. The passengers ranged in age from 20 to 33. The van was traveling northbound. As the vehicle attempted to pass another vehicle, the driver lost control of the vehicle due to a reported tire malfunction. The driver swerved left, then right, then departed the roadway and rolled several times. Seven passengers were ejected from the vehicle. One occupant, a 21-year-old male, sustained head injuries and died in the crash. The injured were taken to three separate hospitals.

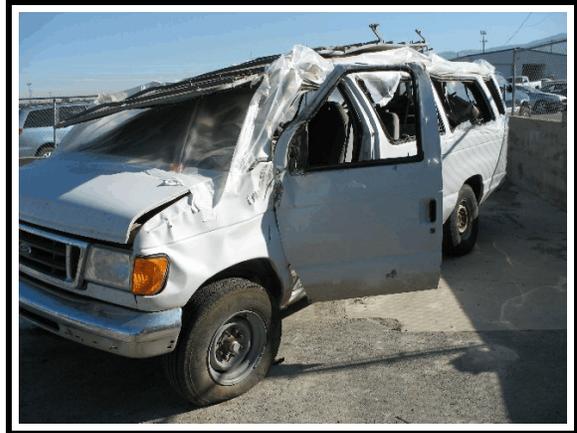
Figure 1. Left side, 2004 Ford E350

The 2004 Ford E350 van sustained moderate rollover damage to the roof and both sides of the vehicle. A Collision Deformation Classification (CDC) was assigned as 00TDDO3.

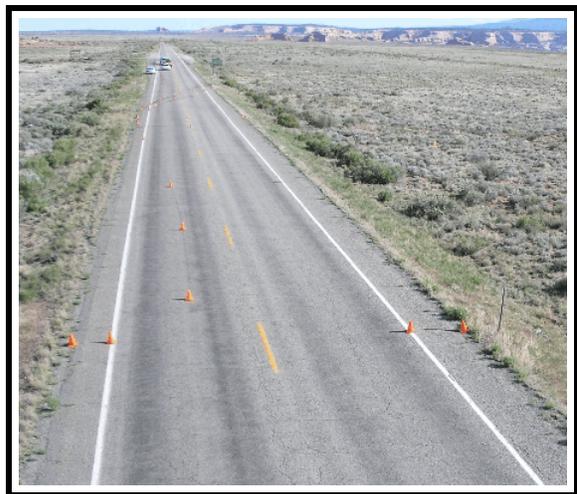
Figure 2. Overhead view of initial loss of control area and path to roadway departure

This single vehicle crash took place on an undivided state highway in May 2006 at 1759 hours. At the time of the crash, there were no adverse weather conditions and the asphalt roadway surface was dry. The north/south roadway was configured with one lane in each direction that were separated by a dashed yellow painted centerline. There are paved shoulders adjacent to the roadway that are delineated by solid painted white lines. Just beyond the shoulders, there is a grass covered embankment with a slight downward grade. The posted speed limit is 105 km/h (65 mph).

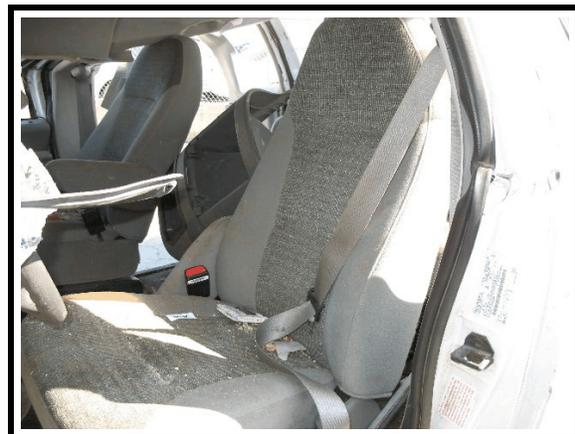
Figure 17. Driver/front right passenger seating area

Driver	Occupant 2
Age/Sex:	32/Male	28/Female
Seated Position:	Front left	Front right
Seat Type:	Bucket	Bucket
Height:	173 cm (68 in)	Unknown
Weight:	82 kg (180 lbs)	59 kg (130 lbs)
Occupation:	Driver	Unknown
Pre-existing Medical Condition:	None	None noted
Alcohol/Drug Involvement:	None	NA
Driving Experience:	Unknown	NA
Body Posture:	Presumed upright	Presumed upright
Hand Position:	Hands on steering wheel, actively steering	Unknown
Foot Position:	Right foot presumed to be on brake	Unknown
Restraint Usage:	Lap and shoulder belt available, used	Lap and shoulder belt available, used

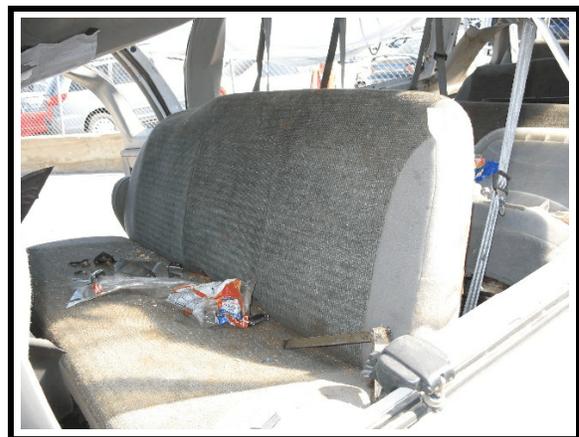
Figure 18. Second row

Occupant 3	Occupant 4	Occupant 5
Age/Sex:	24/Male	23/Female	20/Male
Seated Position:	Second row, left	Second row, middle	Second row, right
Seat Type:	Bench	Bench	Bench
Height:	Unknown	Unknown	Unknown
Weight:	Unknown	Unknown	Unknown
Occupation:	NA	NA	NA
Pre-existing Medical Condition:	Asthma	None noted	None noted
Alcohol/Drug Involvement:	NA	NA	NA
Driving Experience:	NA	NA	NA
Body Posture:	Presumed upright	Presumed upright	Presumed upright
Hand Position:	Unknown	Unknown	Unknown
Foot Position:	Unknown	Unknown	Unknown
Restraint Usage:	Lap and shoulder belt available, used	Lap belt available, not used	Lap and shoulder belt available, not use

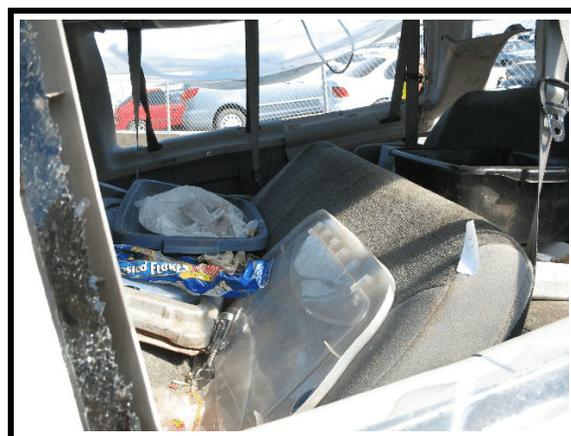
Figure 19. Third row

Occupant 6	Occupant 7	Occupant 8
Age/Sex:	20/Female	21/Female	21/Male
Seated Position:	Third row, left	Third row, middle	Third row, right
Seat Type:	Bench	Bench	Bench
Height:	Unknown	Unknown	Unknown
Weight:	Unknown	54 kg (120 lbs)	Unknown
Occupation:	NA	NA	NA
Pre-existing Medical Condition:	None noted	None noted	None noted
Alcohol/Drug Involvement:	NA	NA	NA
Driving Experience:	NA	NA	NA
Body Posture:	Presumed upright	Presumed upright	Presumed upright
Hand Position:	Unknown	Unknown	Unknown
Foot Position:	Unknown	Unknown	Unknown
Restraint Usage:	Lap and shoulder belt available, not used	Lap belt available, not used	Lap and shoulder belt available, not used

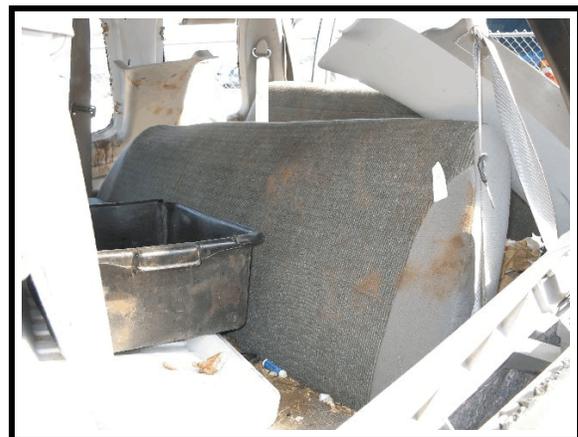
Figure 20. Fourth row

Occupant 9	Occupant 10	Occupant 11
Age/Sex:	22/Female	33/Male	23/Female
Seated Position:	Fourth row, left	Fourth row, middle	Fourth row, right
Seat Type:	Bench	Bench	Bench
Height:	Unknown	Unknown	Unknown
Weight:	Unknown	90 kg (180 lbs)	145 lbs
Occupation:	NA	NA	NA
Pre-existing Medical Condition:	None noted	None noted	None noted
Alcohol/Drug Involvement:	NA	NA	NA
Driving Experience:	NA	NA	NA
Body Posture:	Presumed upright	Presumed upright	Presumed upright
Hand Position:	Unknown	Unknown	Unknown
Foot Position:	Unknown	Unknown	Unknown
Restraint Usage:	Lap and shoulder belt available, not used	Lap belt available, not used	Lap and shoulder belt available, not used

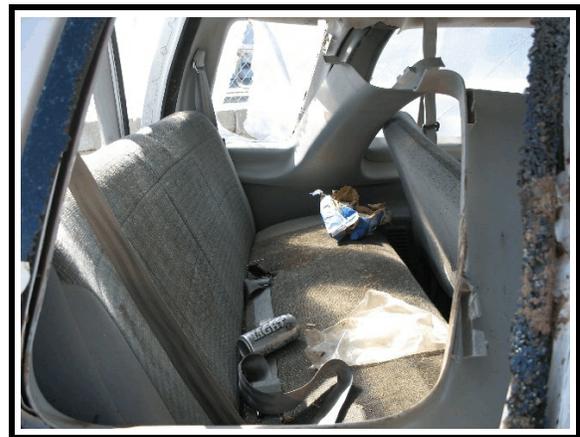
Figure 21. Fifth row

Occupant 12	Occupant 13	Occupant 14
Age/Sex:	21/Male	21/Female	22/Male
Seated Position:	Fifth row, unknown	Fifth row, unknown	Fifth row, unknown
Seat Type:	Bench	Bench	Bench
Height:	Unknown	Unknown	Unknown
Weight:	Unknown	Unknown	Unknown
Occupation:	NA	NA	NA
Pre-existing Medical Condition:	None noted	None noted	None noted
Alcohol/Drug Involvement:	NA	NA	NA
Driving Experience:	NA	NA	NA
Body Posture:	Presumed upright	Presumed upright	Presumed upright
Hand Position:	Unknown	Unknown	Unknown
Foot Position:	Unknown	Unknown	Unknown
Restraint Usage:	None, ejected	Unknown	Unknown

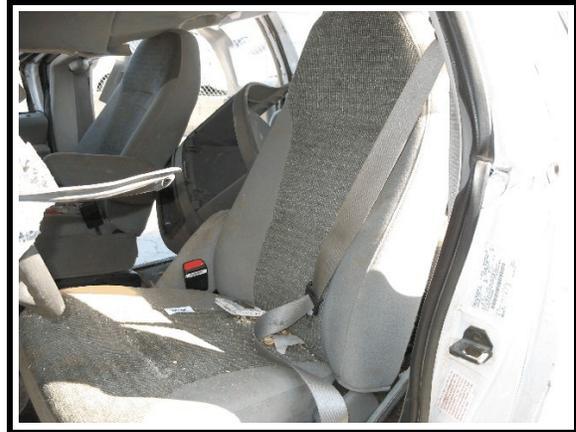
Figure 22. Driver's seated position

The 32-year-old male driver was seated in an upright posture and was restrained by the 3-point manual lap and shoulder belt. The driver had changed lanes to the left to pass a slower moving vehicle. As the vehicle began the passing maneuver, the right rear tire malfunctioned. The driver lost control of the vehicle. The vehicle began a clockwise rotation. The driver was actively steering to the right. He was likely leaning to the left in response to the rotational forces. As the vehicle's left side tires gouged the roadway, the vehicle tripped and began a left side leading rollover. The driver pitched sharply to the left. As the roll continued, the driver pitched back and forth. The driver sustained a minor contusion to his right arm that likely came as a result of contacting the center console. He was able to exit the vehicle under his own power.

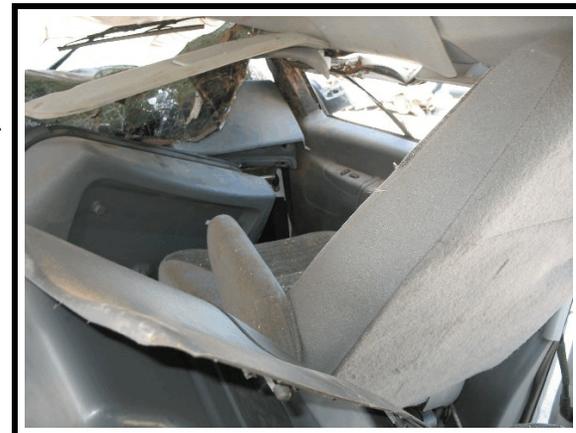
Figure 23. Front row right occupant position

The 28-year-old female front right occupant was seated in an upright posture and was restrained by the 3-point manual lap and shoulder belt. The driver had changed lanes to the left to pass a slower moving vehicle. As the vehicle began the passing maneuver, the right rear tire malfunctioned. The driver lost control of the vehicle. The vehicle began a clockwise rotation. The driver was actively steering to the right. This occupant was likely leaning to the left, against the center console. As the vehicle's left side tires gouged the roadway, the vehicle tripped and began a left side leading rollover. This occupant pitched sharply to the left, possibly contacting the center console with her left shoulder. She remained restrained but during the rollover her head and face likely contacted the intruding roof rail. She sustained a concussion, a contusion to the right orbital area, and an abrasion to the forehead. The front right door was jammed shut, but it appears that she was able to exit the vehicle on her own. She was transported to an area hospital where she was admitted and hospitalized for two days.

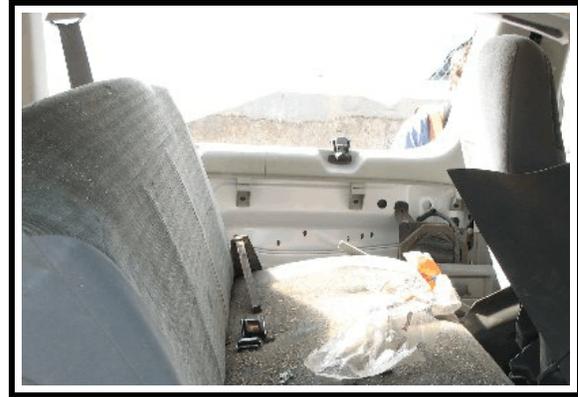
Figure 24. Second row, left and middle seat positions

The 24-year-old second row left occupant was seated in an upright posture on the bench seat. He was using the manual lap and shoulder belt. The driver lost control of the vehicle. The vehicle began a clockwise rotation. The driver was actively steering to the right. This occupant was likely leaning to the left, against the side of the vehicle. As the vehicle's left side tires gouged the roadway, the vehicle tripped and began a left side leading rollover. This occupant pitched sharply to the left, possibly contacting left side interior of the vehicle—causing an abrasion to the left posterior ribs. As the vehicle rolled, this occupant appears to have loaded the lap and shoulder belt—causing a liver laceration. He was transported to an area hospital where he was treated and released. He returned to the hospital the following morning for a follow up x-ray that proved to be negative.

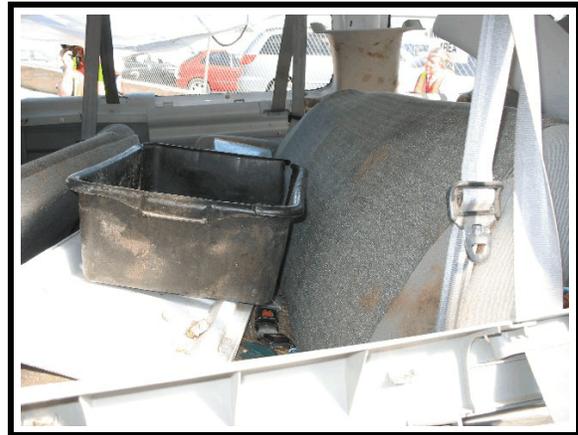
Figure 25. Third row seating

The 20-year-old female third row left occupant was seated in an upright posture on the bench seat. She was not using the available safety belt. The driver had changed lanes to the left to pass a slower moving vehicle. As the vehicle began the passing maneuver, the right rear tire malfunctioned. The driver lost control of the vehicle. The vehicle began a clockwise rotation. The driver was actively steering to the right. This occupant was likely leaning to the left. As the vehicle rolled, this occupant pitched over to the right. The seat base separated from the vehicle. It appears that this occupant was fully ejected from the vehicle through the right side window. She sustained pelvic fractures, a left humerus fracture, a C2 spinal fracture, a laceration to the nerve root, and multiple contusions and lacerations. She was transported to an area hospital. She was transferred later that day to an area Level I trauma center where she was hospitalized for an unknown number of days.

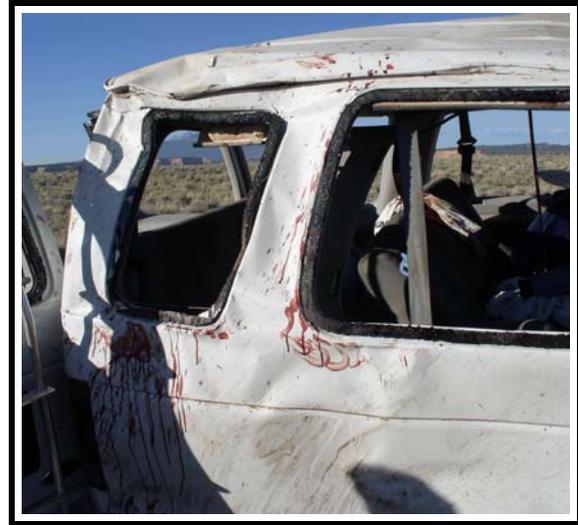
It appears that the double rear doors came open during the rollover. The right front door was jammed shut. There was blood found along the upper right side window frame adjacent to the third, fourth and fifth rows. The blood extended down the exterior right rear of the vehicle. The fifth row seat back was deformed. There was blood forward of the right D pillar. Brown scuff marks were located along the left interior roof, as well as above the third row seat. The third row seat was separated from its base. The seat is designed to be removable. A lever at the base is rotated rearward to unlock the seat from the floor attachment. At the time of the vehicle inspection, the seat was no longer locked in place and was rotated rearward at approximately a 45 degree angle.

Figure 29. Close up of blood/hair at right rear window

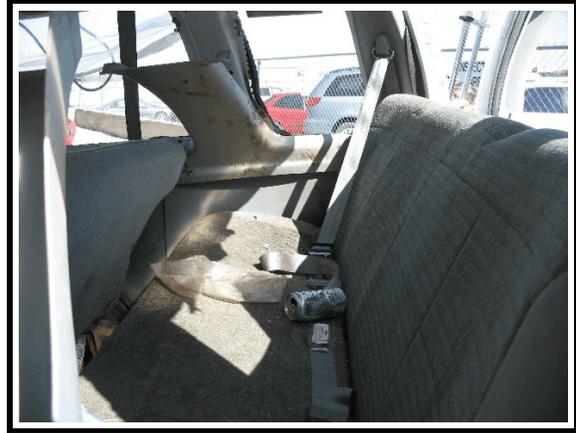
Figure 30. Overview of fifth row

The 20-year-old male in the fifth row was seated in an unknown position on the bench seat. He was not wearing the available safety belt. As the vehicle began a passing maneuver, the right rear tire malfunctioned. The driver lost control of the vehicle. The vehicle began a clockwise rotation. The driver was actively steering to the right. This occupant was likely leaning to the left. As the vehicle rolled, this occupant pitched over to the right and appears to have struck the right side D pillar with his face, causing the nasal fracture, orbit fractures, and incisor fractures. As the vehicle continued to roll, this occupant was fully ejected from the vehicle. The ejection path is not known. He was transported to an area hospital. He was hospitalized for three days before being transferred to an area trauma center.
