Child Safety Seat Serious Injury Investigation / Vehicle to Vehicle
Dynamic Science, Inc. / Case Number: DS06029
1986 Honda Accord
Oregon
December 2006

1. Report No. DS06029	2. Government Accession No.	3. Recipient Catalog No.	
4. Title and Subtitle Child Safety Seat Serious Injury Investigation		5. Report Date April 23, 2007

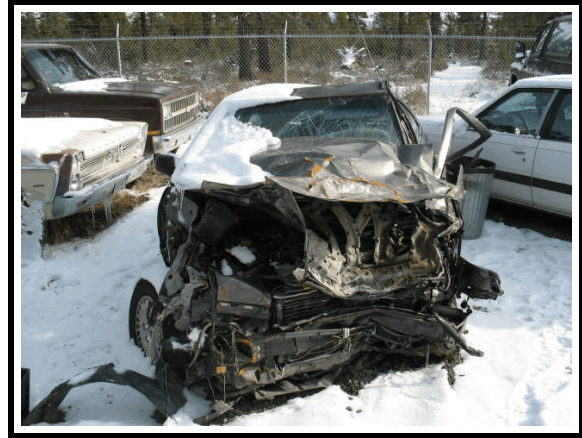
Figure 1. Front - 1986 Honda Accord

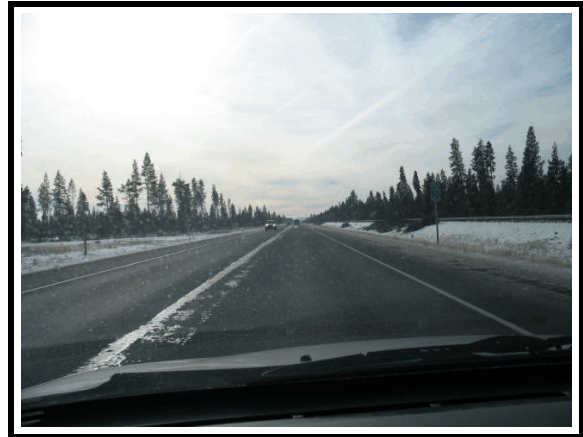
Figure 4. Approach of case vehicle to crash location (south)

The case vehicle was traveling south (see Figure 4) and the Dodge Ram was traveling north (see Figure 5). According to police and the driver's mother, the driver of the Accord may have fallen asleep, causing the Accord to drift into the northbound traffic lane.

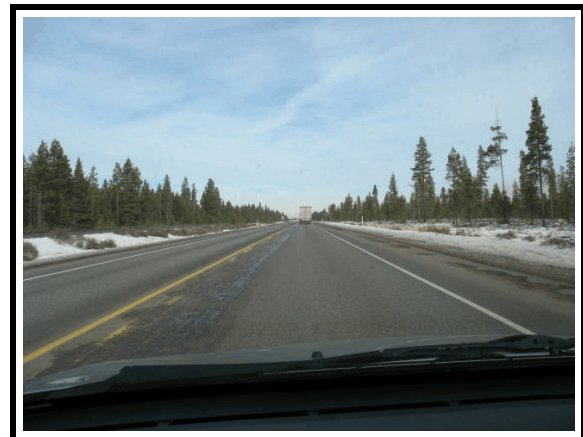
Figure 5. Approach of Dodge Ram to crash location (north)

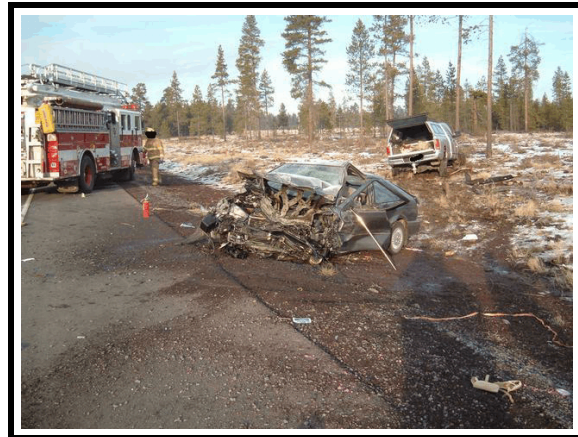
Figure 6. Vehicles at final rest (police photo)

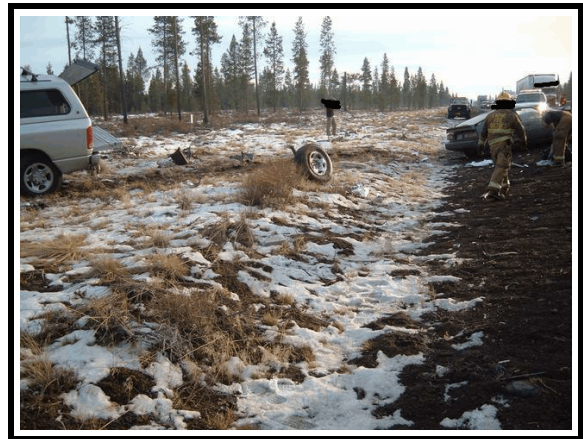
The front of the Honda Accord (52FDEW4) struck the front left of the Dodge Ram. The impact severity to the case vehicle was severe. The barrier routine of the WinSmash program computed a total delta V of 65.0 km/h (40.4 mph) for the case vehicle. The longitudinal and lateral components were -64.0 km/h (-39.8 mph) and 11.3 km/h (7.0 mph), respectively. The Accord rotated counterclockwise as it was pushed north by the Dodge Ram. The vehicle rotated nearly 360 degrees before coming to final rest facing southwest on the dirt and gravel area adjacent to the east shoulder. After the initial impact, the Dodge Ram continued north and departed the roadway to the right. The pickup came to final rest in a field, a fair distance from the roadway, facing northeast (see Figure 6). The Dodge Ram's left front tire and driveline were ripped off the vehicle and both came to rest in the field behind the pickup (see Figure 7).

Figure 7. Vehicles & Dodge Ram's LF tire at final rest (police photo)

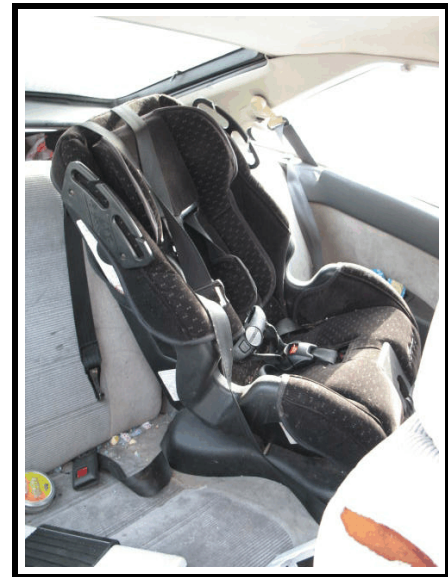
A Dorel Juvenile Group Alpha Omega child safety seat was positioned in the second row left seat of the Honda Accord (see Figure 22). The model number was 22-150-BNP and the date of manufacture was August 31, 2004. The seat was configured with a five-point harness system. This CSS may be used forward or rearward facing. When used forward facing, it can be used as a convertible safety seat to be used with the available harness, but it may also be used as a belt positioning booster seat to be used without the harness.

At the time of this crash, the driver had secured the CSS forward facing as a belt positioning booster seat, with the manual 3-point lap and shoulder belt routed across the child.

The manufacturer recommends that the seat be used as a belt positioning booster only with children who weigh between 14-36 kg (30-80 lbs), whose height is between 73-132 cm (29-52 in), and who are greater than 1 year of age without harness. The manufacturer recommends to remove the harness and/or shield when using it as a belt-positioning booster seat, in order to avoid strangling young children. See Figure 23 for more information on the manufacturer's instructions on how to use the seat as a belt positioning booster. The child's reported weight on her official medical records was 13.5 kg (29.8 lb) which is just under the lowest recommended weight for this seat when it is used as a belt positioning booster seat. The child's height, 76 cm (30 in) was just above the lowest acceptable height to use this seat as a belt positioning booster. The harness straps had not been removed from the CSS, as recommended by the manufacturer when using the seat as a booster seat.

Figure 22. Dorel Alpha Omega child safety seat as found in vehicle

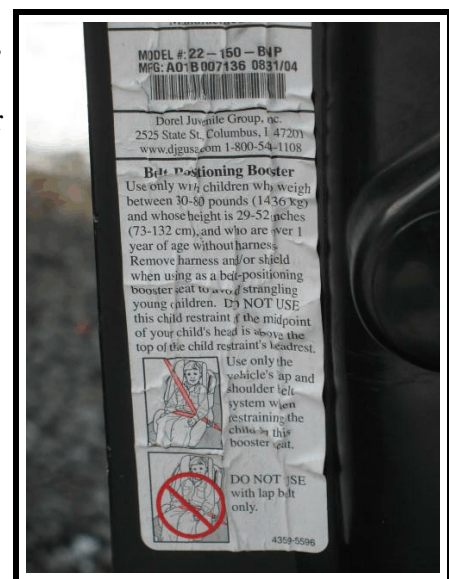
Figure 23. CSS label information

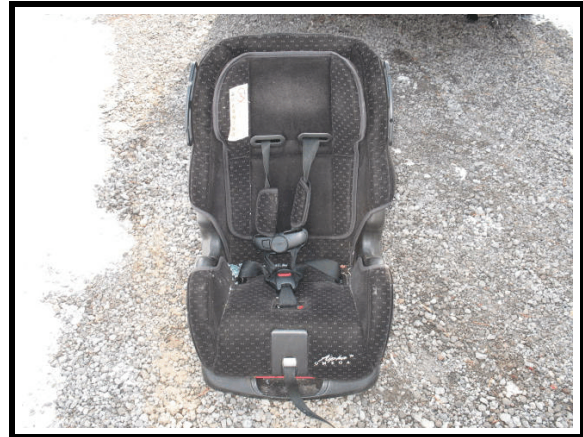
The 2-1/2 year female second row left passenger was seated with a generally upright posture in a forward facing Dorel Juvenile Group Alpha Omega belt positioning booster seat (see Figure 32). According to police, the child was “properly buckled into a car seat”. At the time of the inspection, the child seat was not anchored to the vehicle, the harness straps were buckled together while twisted and the retainer clip was found in the latched position.

Figure 32. Dorel Juvenile Group Alpha Omega CSS
