ON-SITE CHILD AIR BAG-RELATED FATALITY INVESTIGATION

CASE NUMBER - IN-07-001

VEHICLE - 1995 FORD MUSTANG

CRASH DATE - April 2006

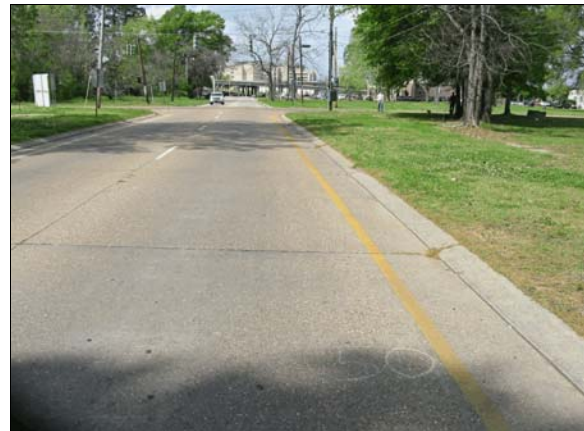
Pre-Crash: The case vehicle was traveling northbound in the right lane of the one-way southbound street (**Figure 1**) approaching the intersection. The case vehicle's driver had just turned left (i.e., the wrong way) onto the one-way street from an intersecting city street (**Figure 2** below). The case vehicle's driver stated she was a little "bewildered" and wondering where she was, but was intending to continue northbound through the approaching intersection. The Five Hundred was traveling eastbound in the eastbound lane, also approaching the intersection (**Figure 3** below). The police crash report indicated that the case vehicle's driver applied the brakes in an attempt to avoid the crash. The driver also stated that she applied hard braking in an attempt to avoid the crash with the approaching Five Hundred. The crash occurred in the intersection of the two trafficways (**Figures 3 and 6** below).

Figure 1: Approach of case vehicle to intersection, northbound on southbound one-way street, number on pavement shows meters to intersection

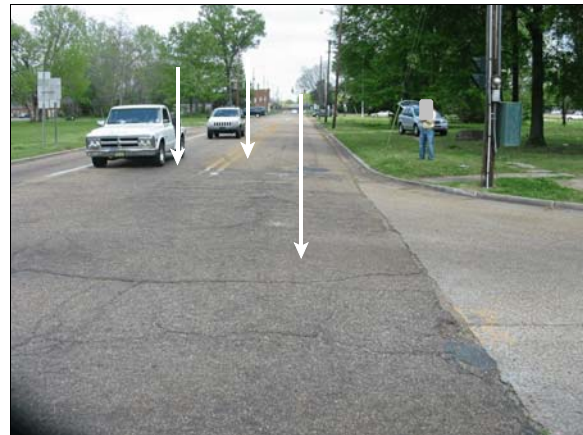
Post-Crash: As a result of the impact, the case vehicle rotated clockwise and came to rest in the mouth of the east leg of the intersection heading northeast (**Figure 6** below). The Five Hundred rotated clockwise approximately 145 degrees, traveled into the east leg of the intersection and came to rest heading southwest (**Figure 6** below).

Figure 6: View eastbound to area of impact (right arrow) and final rest of case vehicle (left arrow) and Five Hundred (middle arrow)
