Rollover Investigation / Vehicle to Object
Dynamic Science, Inc. / Case Number: DS07005
2006 Chevrolet Colorado
California
December 2006

1. Report No. DS07005	2. Government Accession No.		3. Recipient Catalog No.	
4. Title and Subtitle Rollover Investigation		5. Report Date May 22, 2007

14. Sponsoring Agency Code		
15. Supplemental Notes				
16. Abstract This on-site investigation focused on the rollover event and the Certified Advanced 208-Compliant air bag system in a 2006 Chevrolet Colorado pickup. The manufacture of this vehicle certified that it met the requirements of Federal Motor Vehicle Safety Standard No. 208. This single vehicle crash occurred in December 2006 at 0030 hours. The crash occurred in northbound lanes of a four-lane divided interstate highway. The case vehicle was being driven by a 25-year-old male. The driver of a non-contact vehicle apparently changed lanes to the right. The driver of the case vehicle steered to the right, crossed a narrow shoulder, and struck a concrete barrier on the right side of the roadway. The vehicle then rolled onto its left side. The vehicle came to rest blocking the second and third lanes of traffic. There were no reported injur

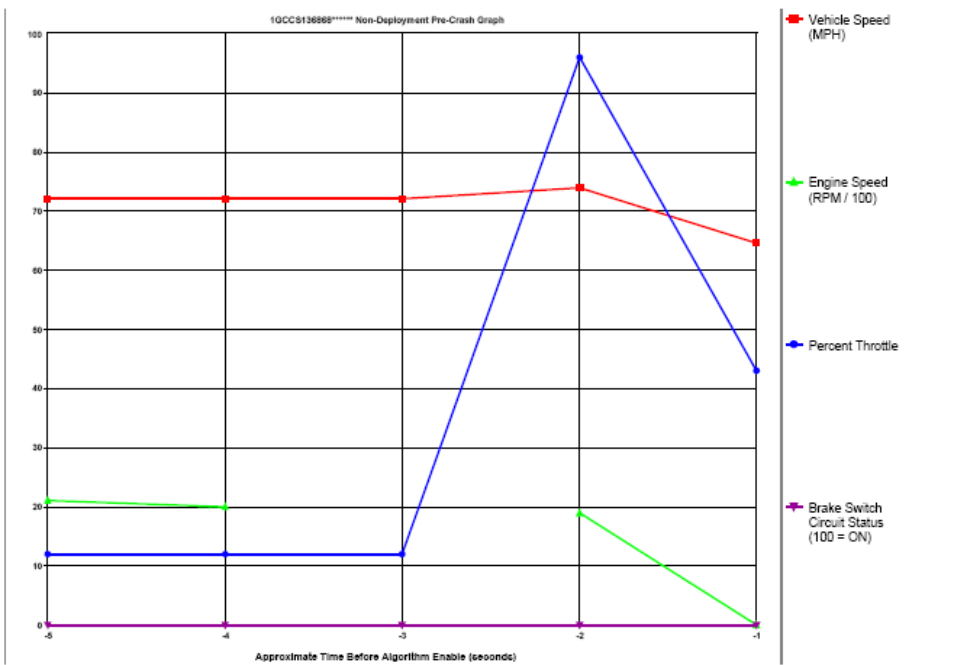
System Status At Non-Deployment

SIR Warning Lamp Status	OFF
Driver's Belt Switch Circuit Status	UNBUCKLED
Passenger's Belt Switch Circuit Status	UNBUCKLED
Passenger Seat Position Switch Circuit Status	Rearward
Ignition Cycles At Non-Deployment	1880
Ignition Cycles At Investigation	1894
Maximum SDM Recorded Velocity Change (MPH)	-0.68
Algorithm Enable to Maximum SDM Recorded Velocity Change (msec)	45
Crash Record Locked	No
Event Recording Complete	Yes
Multiple Events Associated With This Record	Yes
One Or More Associated Events Not Recorded	Yes

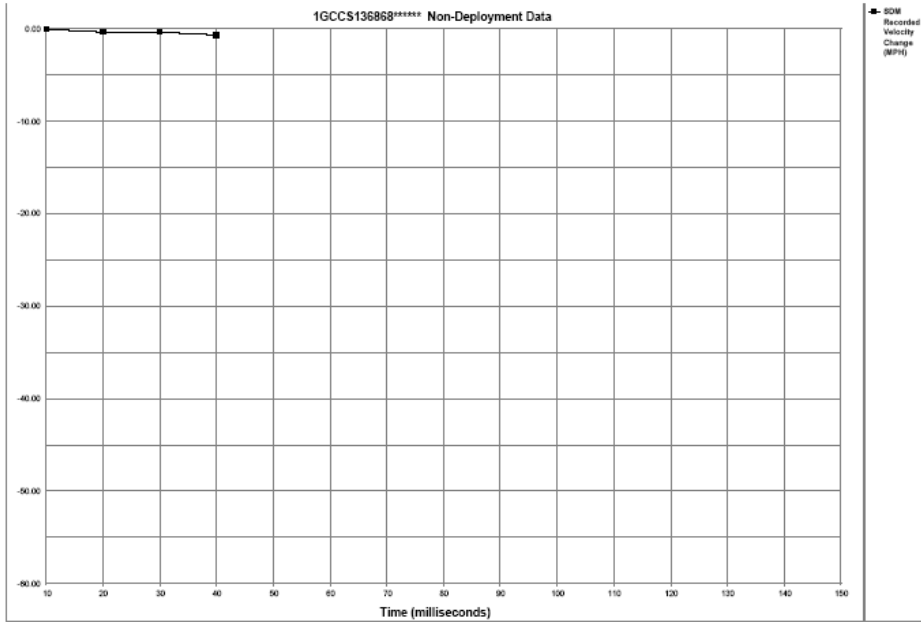
Seconds Before AE	Vehicle Speed (MPH)	Engine Speed (RPM)	Percent Throttle	Brake Switch Circuit Status
-5	72	2112	12	OFF
-4	72	2048	12	OFF
-3	72	Invalid	12	OFF
-2	74	1856	96	OFF
-1	65	0	43	OFF
