**NOT-IN-TRAFFIC SURVEILLIANCE
CALSPAN REMOTE POWER WINDOW FATALITY INVESTIGATION**

SCI CASE NO.: CA07-010

**VEHICLE: 2007 PONTIAC VIBE
LOCATION: MICHIGAN
DATE: DECEMBER 2006**

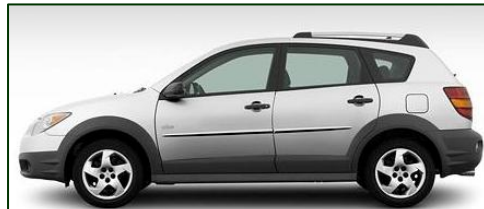
Figure 1. Exemplar Pontiac Vibe.

This remote investigation focused on the cause of death for a 3-year old female rear left passenger of a 2007 Pontiac Vibe (**Figure 1**). The child was killed when her neck became captured in the power window of the Pontiac. The Vibe was equipped with power door windows and toggle switches that were mounted vertically on the forward aspects of the rear door panels. While traveling on a city street, a motorist traveling in the lane adjacent to the Pontiac observed the child's head captured between the left rear door window and the top of the door window frame. This witness alerted the driver of the Vibe of the child's position and the Pontiac driver stopped near an intersection. She exited the vehicle and observed the child trapped in the power window. Another witness at the intersection observed the Pontiac as it stopped and noted the position of the child. This witness reached in the vehicle, lowered the window and removed the child. It could not be determined which window controls were used to lower the window. A third witness to the events initiated CPR activities as the 9-1-1 system was called. Following the arrival of paramedics and police, the child was transported by ambulance to a local pediatric hospital where she was pronounced deceased on arrival. The Pontiac was towed from the scene and impounded. The child's death was police reported as a crime and not as a traffic fatality.
