CALSPAN ON-SITE BACK OVER INCIDENT INVESTIGATION

SCI CASE NO.: CA07-025

VEHICLE: 2002 CHEVROLET YUKON XL

CRASH DATE: JULY 2007

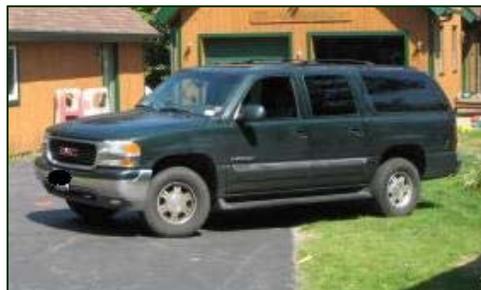
Figure 4. Overall view of the 2002 GMC Yukon.

The Yukon was equipped with step bars that extended the full length of the sill. A class III receiver hitch was mounted to the rear frame of the vehicle. Although the ball-mount sleeve was not installed in the hitch at the time of the SCI investigation, the driver did state that this unit was in-place at the time of this incident. The ball-mount was a drop-style that lowered the height of the ball in relation to the vehicle. The Yukon was not equipped with the Rear Ultrasonic Parking Assist (URPA) system.

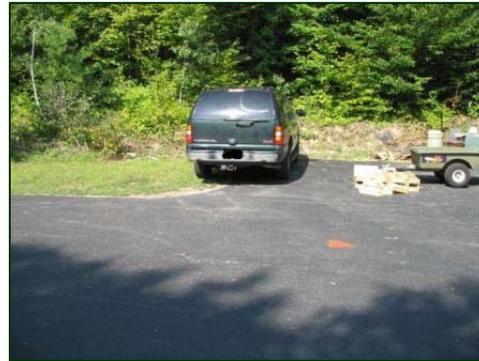
His 19-month old son proceeded up the driveway (**Figure 7**), heading in a westerly directly toward the Yukon that was parked straddling the west edge of the driveway turnaround (**Figure 8**). The vehicle was parked facing in as northerly directly with the right side exposed to the path of travel of the pedestrian non-motorist.

Figure 8. Parked position of the GMC Yukon.
