ON-SITE CHILD SAFETY SEAT INVESTIGATION

CASE NUMBER - IN07033
LOCATION - ILLINOIS
VEHICLE - 1999 PONTIAC GRAND AM SE
CRASH DATE - October 2007

14. <i>Sponsoring Agency Code</i>		
15. <i>Supplementary Notes</i> On-site child safety seat investigation involving a 1999 Pontiac Grand Am SE, four-door sedan, with manual safety belts and dual front air bags, that ran-off-road and rolled over

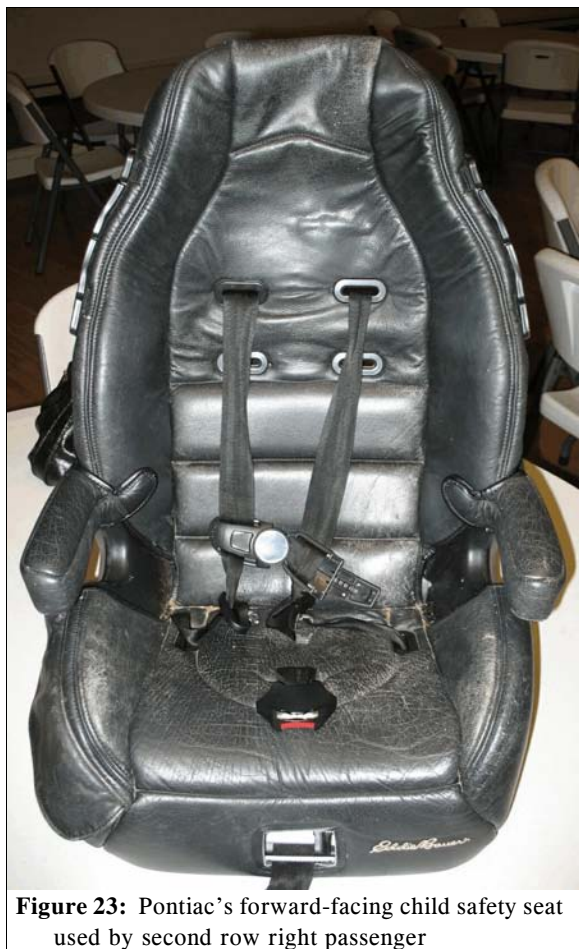
The second row right passenger was seated in a booster/forward-facing child safety seat (BSS/FSS) that was used in its forward-facing configuration (**Figure 23**). The FSS was manufactured by Cosco/Dorel on December 20, 2002. The child seat was identified by model name Eddie Bauer High Back Booster and model number **22 870 BLT**. The FSS was designed with a five-point harness which attached between the child’s legs into a buckle which was sewn to a piece of webbing at the bottom of the seat. The FSS was equipped with a top tether (**Figure 24**), and there were two slots to thread the harness through. At the time of the crash, the harness belts were threaded through the top slots. The FSS was in the upright position.

Figure 23: Pontiac's forward-facing child safety seat used by second row right passenger

Based on the vehicle inspection, the Pontiac's second row right passenger (son) was restrained by his child seat's five-point harness (**Figures 23**) and the child seat was secured through the seat's forward-facing slots by the lap-and-shoulder, safety belt system. There was no
