On-Site Child Safety Seat Investigation  
Dynamic Science, Inc. (DSI), Case Number DS08002  
1989 GMC Jimmy S-15  
California  
December 2007

**Dynamic Science, Inc.  
Crash Investigation  
Case Number: DS08002**

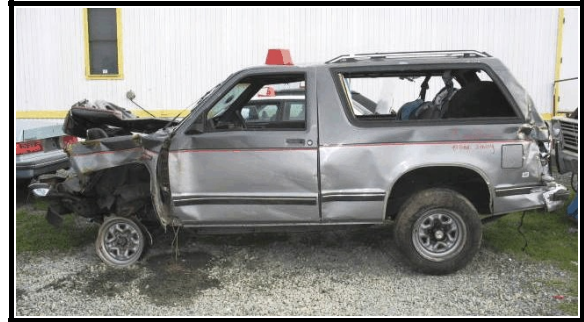
**Figure 1.** Subject vehicle, 1989 GMC Jimmy S-15

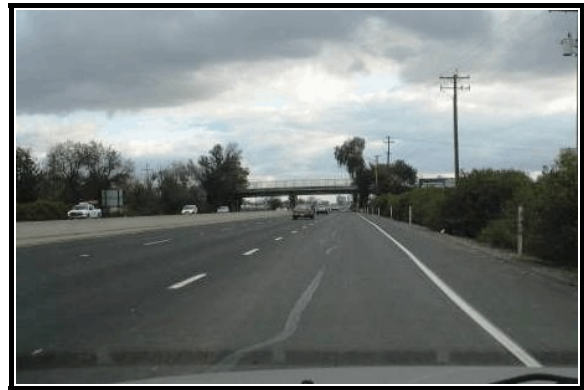
This two-vehicle crash occurred in the southbound lanes of a divided north/south state highway. The roadway comprised two through lanes in each direction with an auxiliary lane in the southbound direction for traffic entering the highway from an on-ramp. The on-ramp comprised a right curve alignment and joined the straight auxiliary lane, which then merged with the outboard southbound through lane (**Figure 2**).

**Figure 2.** Southbound approach, subject vehicle
