## ON-SITE CHILD SAFETY SEAT INVESTIGATION

CASE NUMBER - IN08005

VEHICLE - 2000 PLYMOUTH NEON LX

CRASH DATE - December 2007

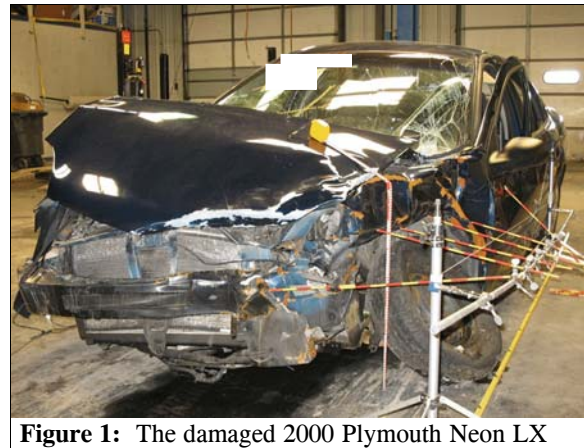
This crash was brought to National Highway Traffic Safety Administration's attention on or before January 7, 2008 by the sampling activities of the National Automotive Sampling System. The crash involved a 2000 Plymouth Neon LX (**Figure 1**) and a 2006 Ford Explorer XLT. The crash occurred in December 2007, at 0105 hours, in Illinois and was investigated by the applicable city police department. This crash is of special interest because the Plymouth's second row center passenger (2-year-old, male) was seated in a Cosco Alpha Omega child safety seat (CSS). This contractor inspected the Plymouth and interviewed the Plymouth's driver on February 19, 2008, and inspected the scene on February 20, 2008. The Ford had been repaired and was not inspected. This report is based on the police crash report, an interview with the Plymouth's driver, scene and vehicle inspections, occupant medical records, occupant kinematic principles, and this contractor's evaluation of the evidence.

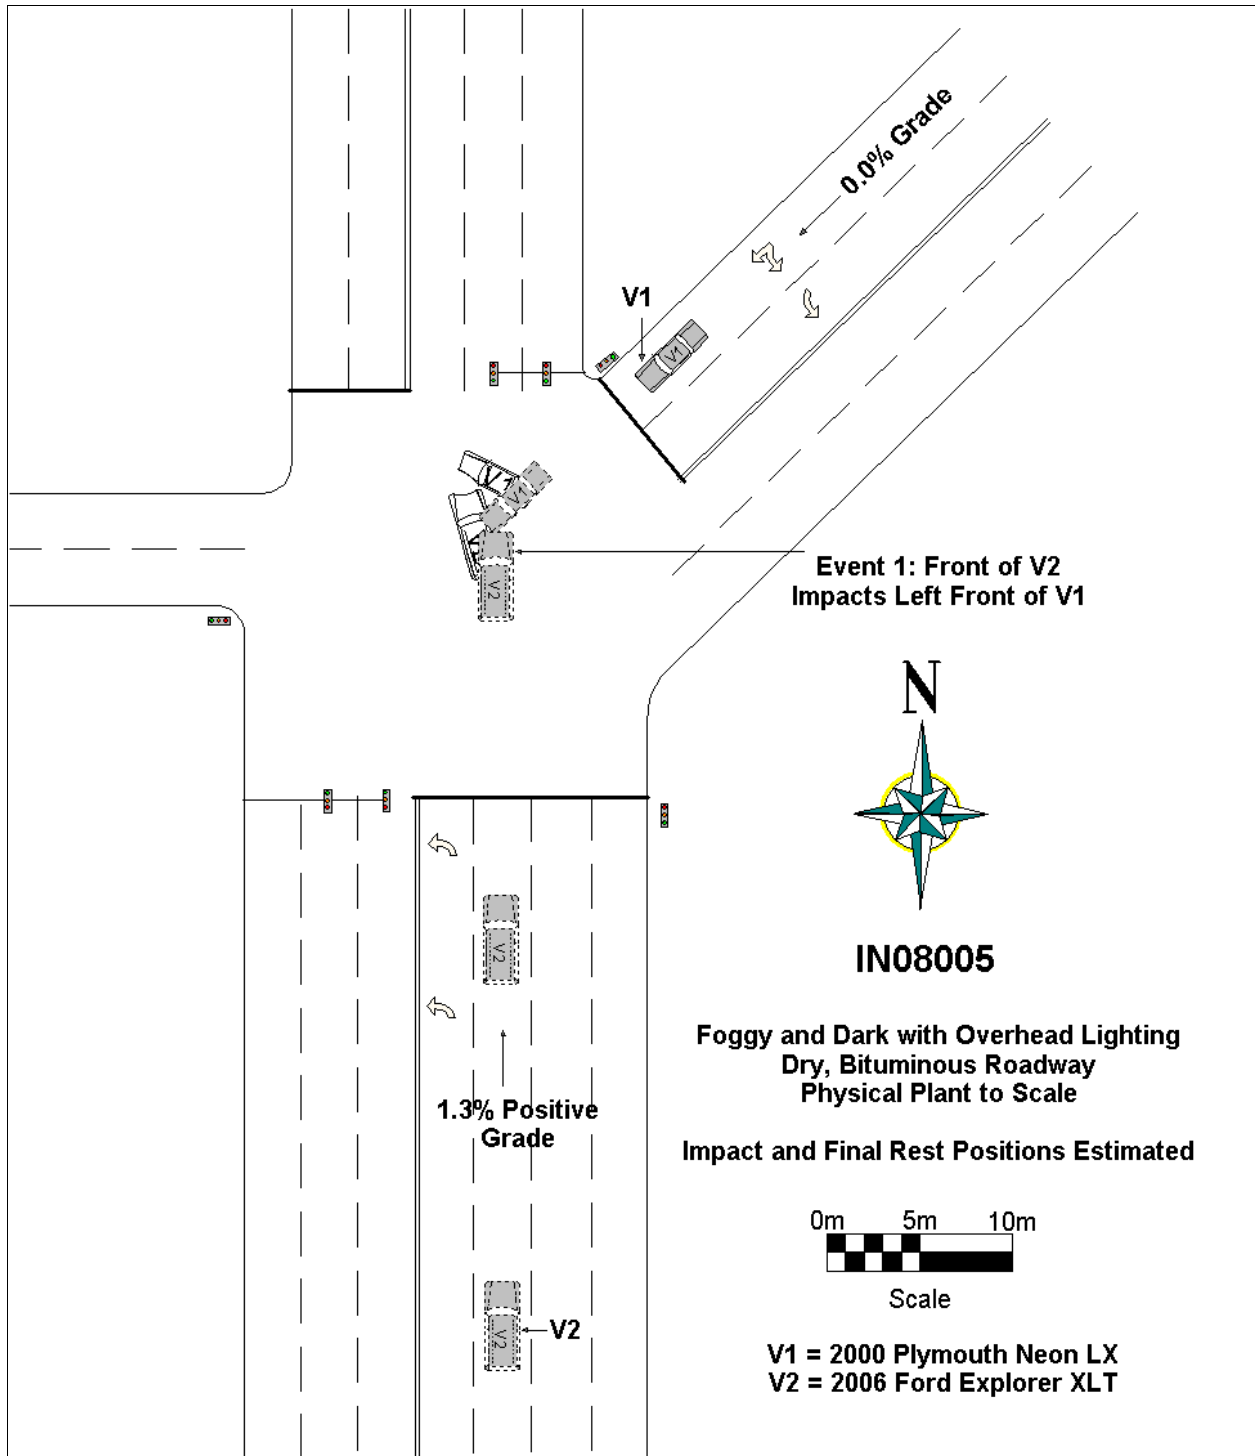
**Crash Environment:** This crash occurred within a 4-leg urban intersection that was controlled by multiple 3-phase traffic signals. The trafficway on which the Plymouth was traveling was a level, 4-lane, undivided, city street that traversed in a northeasterly-southwesterly direction, and the Plymouth was traveling southwest. The southwesterly roadway consisted of one through/left turn lane and one left turn lane (**Figure 2**). Each lane was nominally 3.5 meters (11.5 feet) in width and the pavement markings consisted of a solid white lane line, solid yellow double centerline, and a solid white stop bar at the intersection. The trafficway on which the Ford was traveling was a 7-lane, undivided, city street that traversed in a north-south direction, and the Ford was traveling north (**Figure 3**). The north roadway consisted of one right turn lane, two through lanes, and a left turn lane. Each lane was nominally 3.1 meters (10.2 feet) in width and the roadway had a positive 1.3% grade. The pavement markings consisted of broken white lane lines, white left turn only arrows, and a double yellow centerline. The posted speed limit for both vehicles was 48 km/h (30 mph). At the time of the crash, the light condition was dark with overhead lighting, the atmospheric condition was foggy, and the roadway pavement was dry bituminous. The traffic density was light and the site of the crash was urban commercial. See the crash diagram on page 12 of this report.
