ON-SITE SIDE IMPACT INFLATABLE OCCUPANT PROTECTION INVESTIGATION

CASE NUMBER - IN08015

VEHICLE - 2004 CADILLAC CTS

CRASH DATE - February 2008

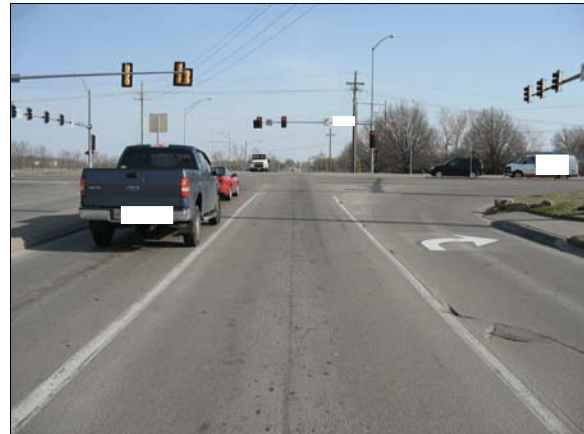
Pre-Crash: The Cadillac was occupied by a restrained 82-year-old female driver and was stopped at the intersection in the through lane (**Figure 2**). The driver intended to proceed north through the intersection. The Chevrolet was occupied by a restrained 62-year-old female driver and was stopped at the intersection in the left turn lane (**Figure 2**). The driver intended to turn left and proceed west. The Jeep was occupied by a restrained 31-year-old male driver and a restrained 32-

Figure 2: Cadillac and Chevrolet's approach to the intersection; the Cadillac was stopped in the through lane and the Chevrolet was stopped in the left turn lane

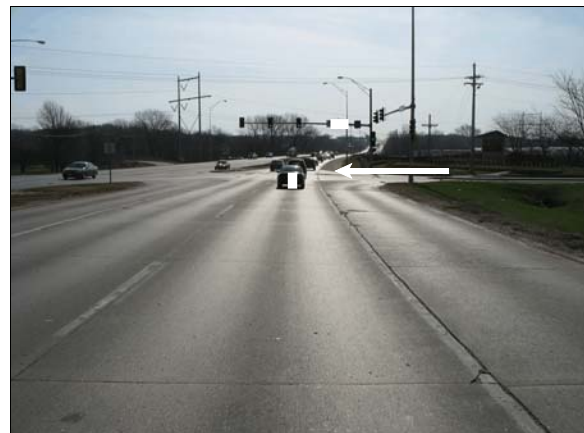
year-old female front right passenger and was traveling east in the outside through lane (**Figure 3**). The driver intended to continue east through the intersection. The Cadillac's EDR data indicated that the vehicle accelerated to 18 km/h (11 mph) at 1 second prior to Algorithm Enable (AE). The Cadillac's driver stated during the interview that she did not take any actions to avoid the crash. The EDR recorded the brake switch circuit as on from 8 to 6 seconds prior to AE and off from 5 to 1 seconds prior to AE.

Figure 3: Approach of the Jeep eastbound to the intersection; arrow shows the approach of the Cadillac and Chevrolet to impact in the intersection
