On-Site Rollover Investigation
Dynamic Science, Inc. (DSI), Case Number DS08019
2007 Ford F150
Oregon
June 2008

1. Report No. DS08019	2. Government Accession No.		3. Recipient Catalog No.	
4. Title and Subtitle Rollover Investigation		5. Report Date December 16, 2008

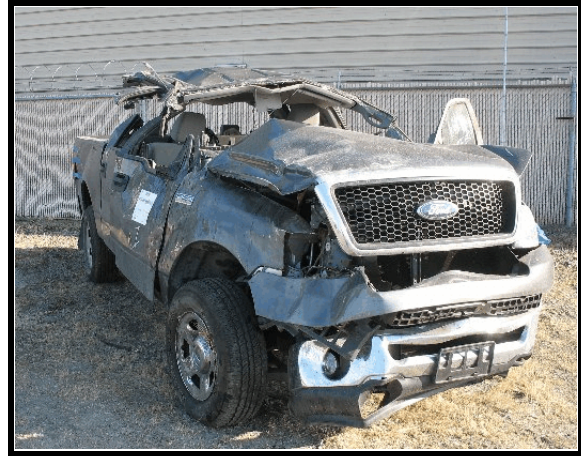
This on-site investigation focused on a 2007 Ford F150 that was involved in a rollover crash (**Figure 1**). The subject vehicle was occupied by a restrained 41-year-old female driver, a restrained 51-year-old female front right passenger, and three male children in the rear seat, ages 3, 5, and 6. The 3-year-old and 5-year-old children were seated in booster seats in the outboard positions and were restrained by the vehicle's lap and shoulder belts. The 6-year-old was seated in the middle seat position and was restrained by the vehicle's lap and shoulder belt. The Ford was traveling northbound in the inboard lane of an interstate highway and was passing an empty log truck. The Ford was pulling a travel trailer. As the Ford changed lanes, the trailer began to sway. The driver was unable to control the motion and the left side of the trailer contacted the center divider. The driver steered back to the right and Ford began a clockwise rotation. The trailer separated from the Ford and both the Ford and the trailer departed the roadway to the east and overturned. The driver and front right passenger were entrapped in the Ford and required extrication. The driver sustained multiple contusions and abrasions, in addition to unspecified injuries to her hip and right leg. The front right passenger sustained a right side skull fracture, a large laceration, a spinal injury, and had internal bleeding. She was transported to a local hospital and then transferred to an area trauma center. According to the interviewee, the three children sustained minor seat belt related abrasions. The Ford and the trailer were both towed from the scene. The Ford was later declared to be a total loss by the insurance company.

Figure 1. Subject vehicle, 2007 Ford F150

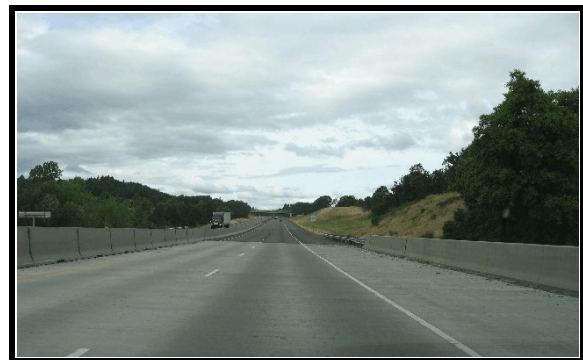
Figure 2. Overview of crash site (north)

This single vehicle crash occurred on a divided interstate highway in June 2008 (**Figure 2**). At the time of the crash, there were no adverse weather conditions and the asphalt roadway surface was dry. The roadway had a positive 3.6 percent grade. The northbound roadway was configured with two northbound lanes that were separated by dashed white lines. The roadway was bordered to the west by a solid yellow line and a concrete median barrier and to the east by a solid white line and an asphalt shoulder with a rumble strip. Beyond the shoulder was a 1.9 m (6.4 ft) area of gravel with negative 18 percent grade followed by an area of grass with a negative 19 percent grade. The posted speed limit was 105 km/h (65 mph).
